Holy Spirit Catholic Community Saint Cyril and Methodius Church & Rectory Evaluations

633 Bridger Ave, Rock Springs, WY 82901 March 24, 2025

Re: Saint Cyril and Methodius: Church and Rectory Study

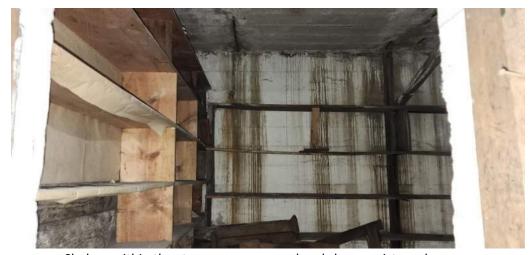
Some of the framing in place within one of the storerooms adjacent to the boiler room. There is significant water damage visible. Further investigation of the cause should be performed and any necessary sealing from above performed.

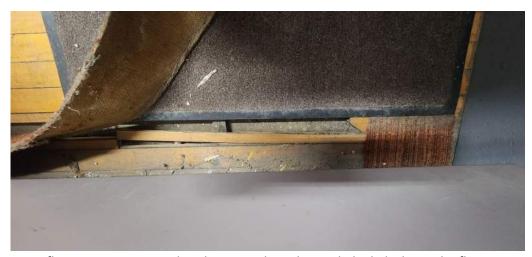
The landing is adequate at the tope of the stairs. The door into one of the mechanical/storage spaces encroaches within the clear egress path of the designated exit door.

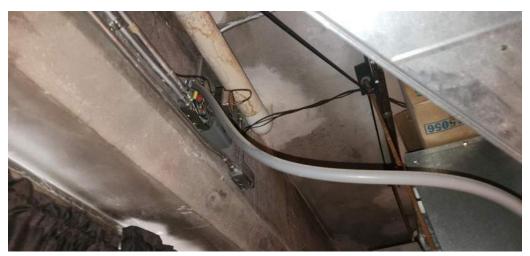
Panels have been converted into junction boxes (see electrical report for additional info)

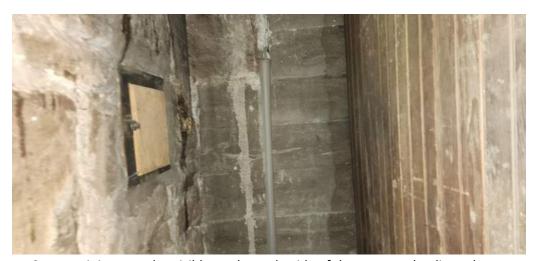
The small portions of the building remain with a sandstone foundation or load bearing wall. Toward the south and under the main entry stair, some water staining was visible on the stones. No excessive wear is visible and the stones remain in good condition.

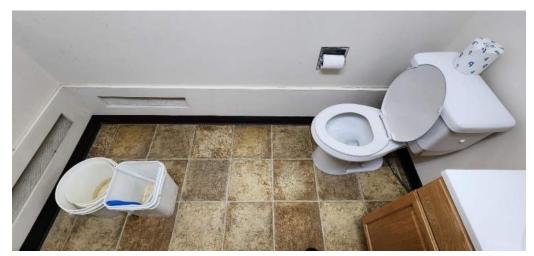
The small restroom exists under an exterior stair landing that access the sanctuary area. A recent leak has been resolved and drainage modified on the landing on the exterior side. Due to the size of the crack, a more structural repair should be made.

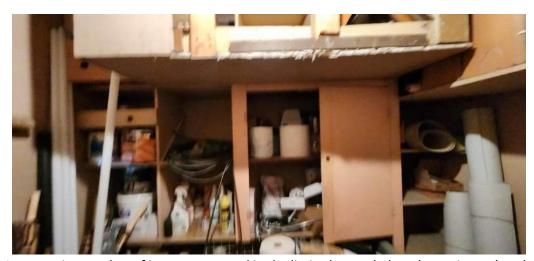
The old projector booth remains with some finishes removed for access. A code compliant access should be constructed, or the booth should be removed in its entirety to remove the hazard of the unoccupied space which has furnishings within it.

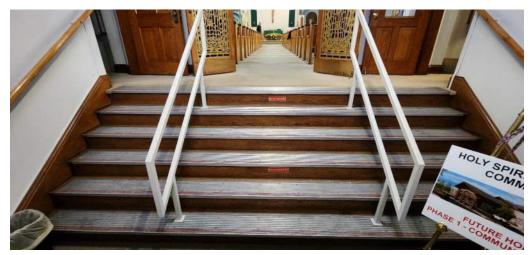
An accessible route for a wheel chair is not present into the Confessional. The door for the room lacks clear floor area on the strike side. The Nave doors disrupt access due to their projection on the landing.

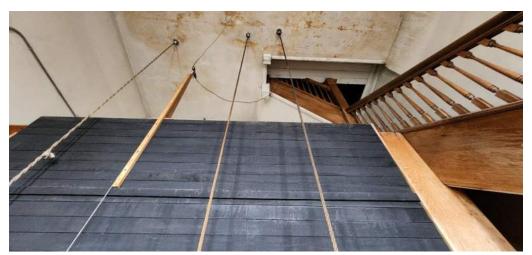
Alternate access to Attic & Belfry – Door swings over steps, inadequate landing area. 2024 IBC, Chapter 10 infraction.

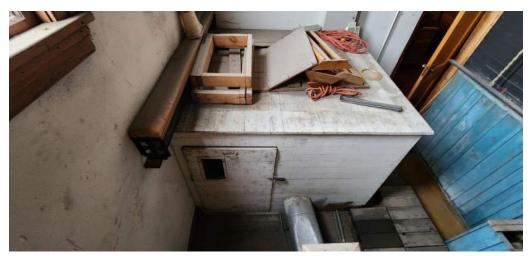
Moisture damage visible, with minor cracking in walls of main Belfry area.

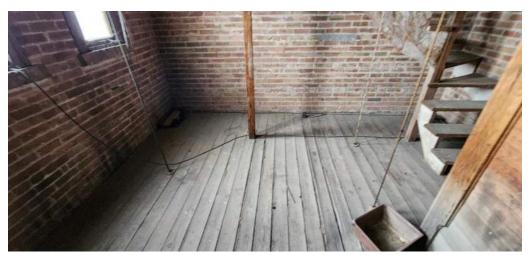
Interior of upper Belfry, masonry appears in good condition. Wood structure shows signs of water damage from previous leaks.

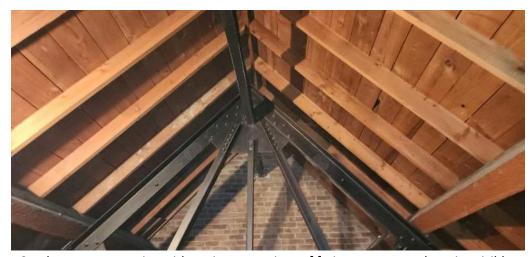
Wood staining from previous moisture infiltration appears dry since the roof replacement and any subsequent repairs were completed. Roof replaced in 1990, repairs/warranty claim made 2010.

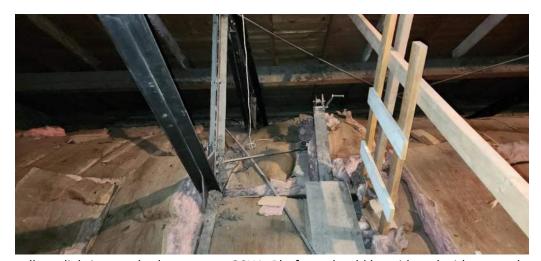
Attic has clear access from one end to the other for servicing. Catwalk width appears to meet 18" OSHA minimum. Handrails are not OSHA compliant. Missing sections, likely are not 200lbs lateral resistant.

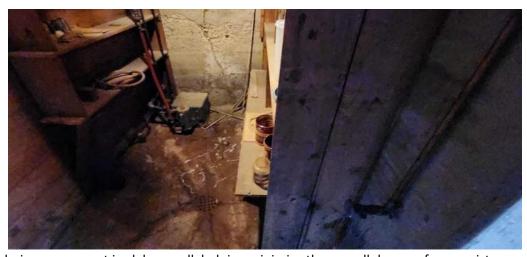
The rectory foundation is concrete below grade. There are several areas where old penetrations in the wall have suffered moisture infiltration and show damages. Movement does not appear excessive and repairs can be made to the visible fractures.

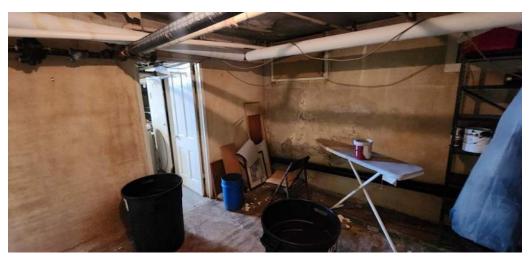
The basement is divided into several rooms for storage or other uses. Framed walls also show significant moisture staining.

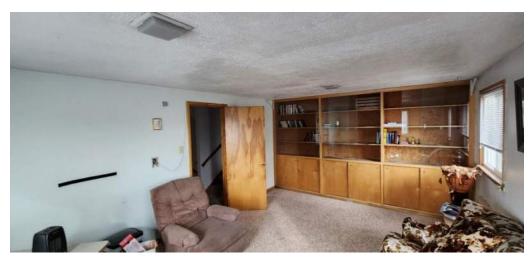
An existing wall box is open with wiring visible. It is unclear the purpose of the wire and needs corrected.

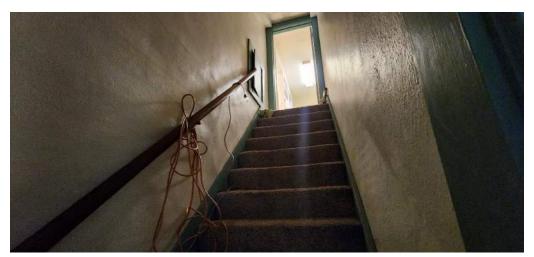
The stairway from kitchen to upper level is lacking a continuous handrail between levels.

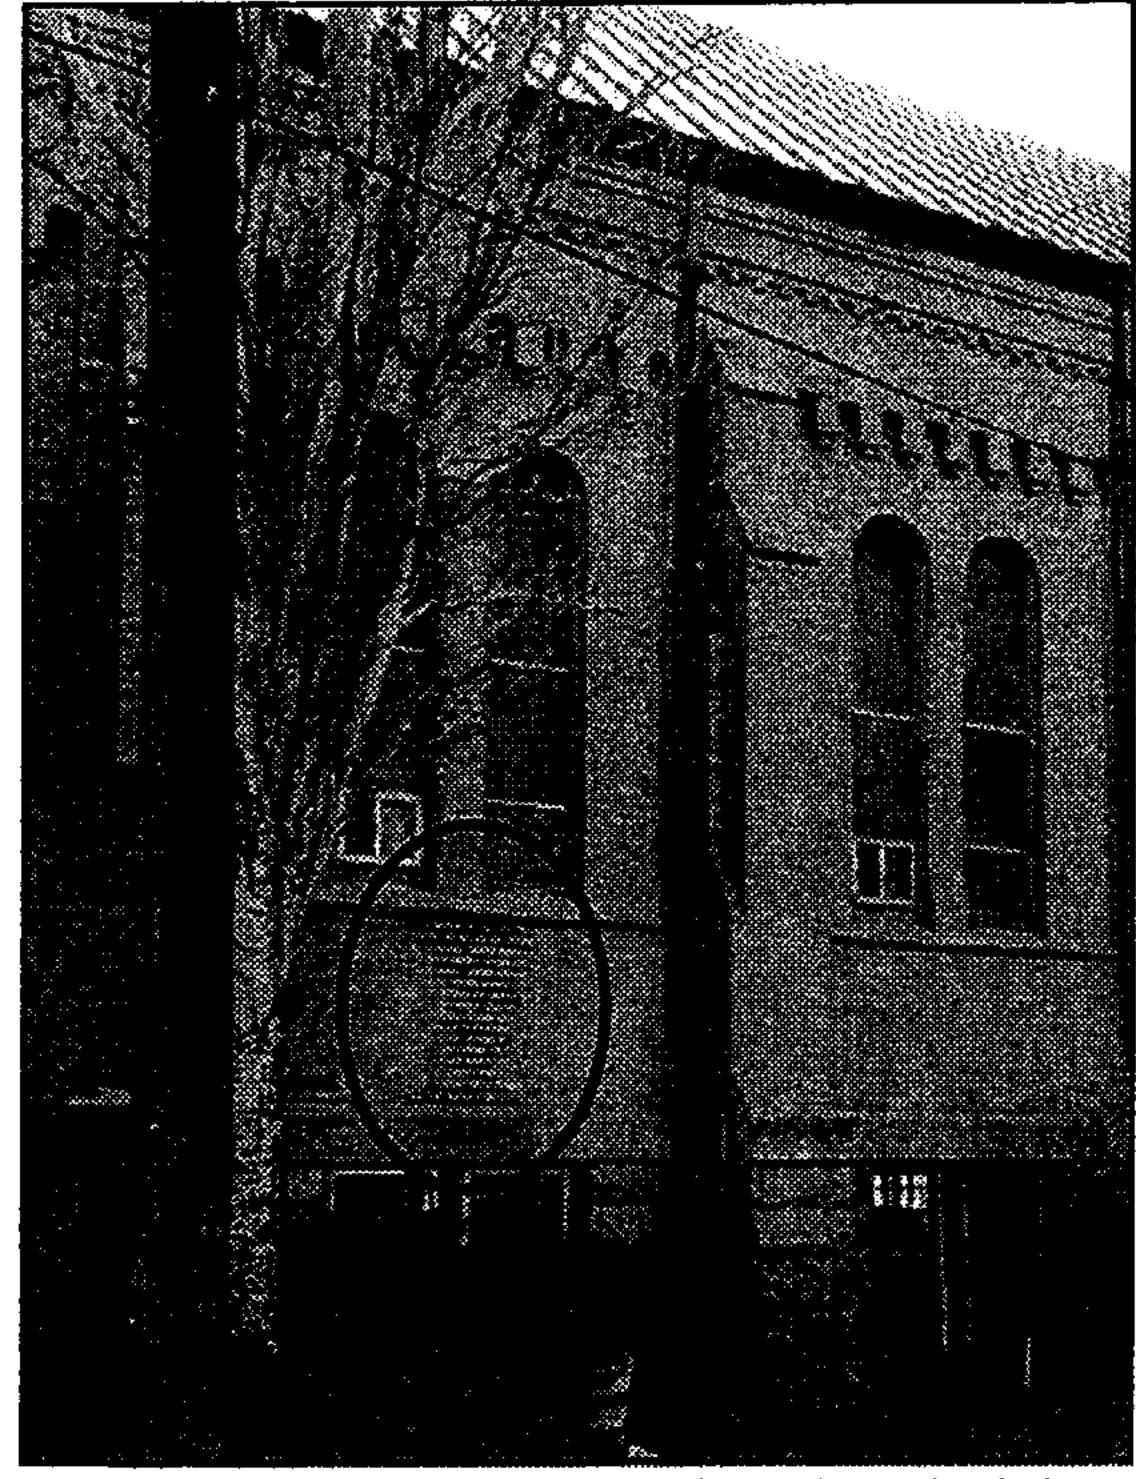
Note: Deterioration of brick beneath window.

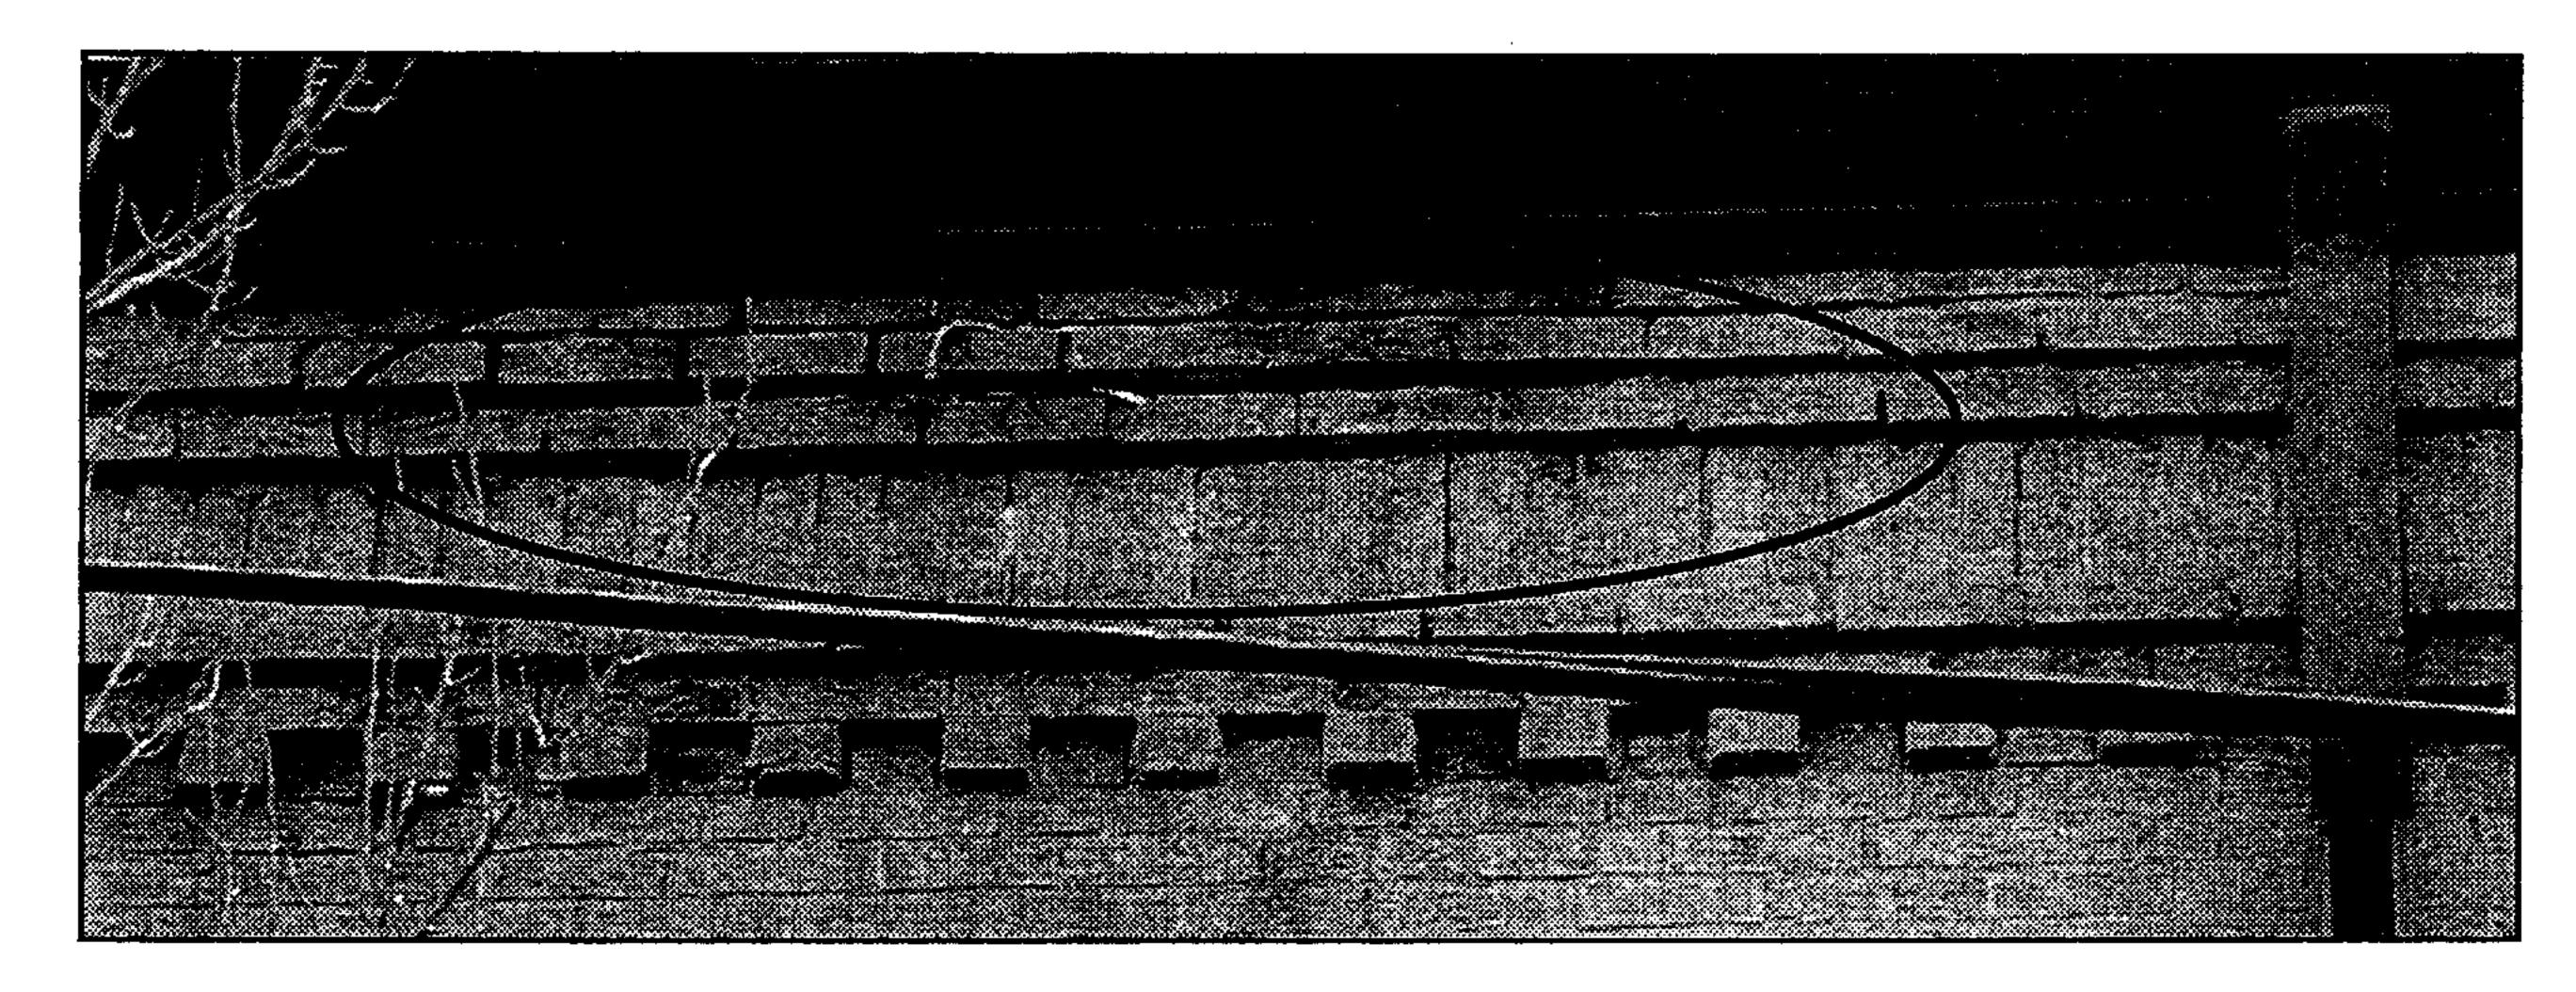
Note: Deterioration of brick beneath gutters.

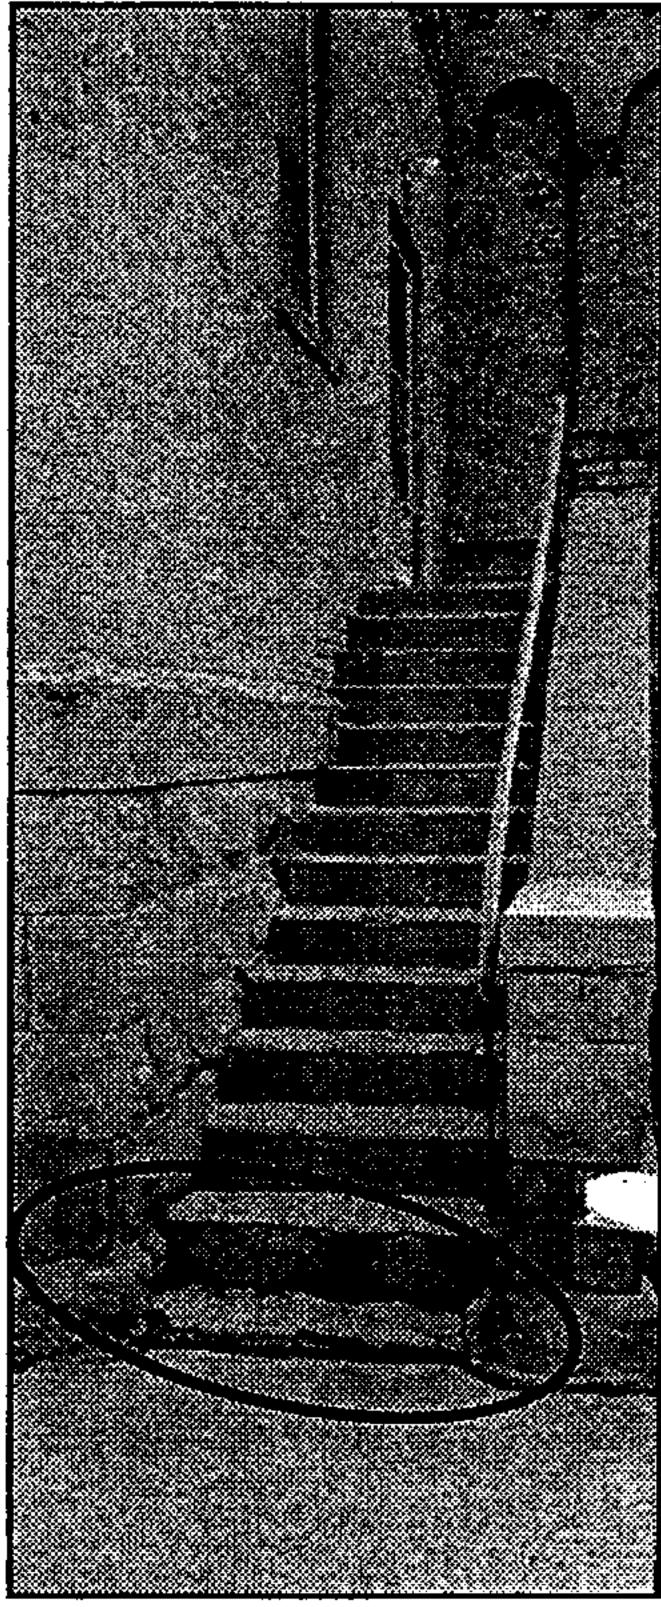
Note: Water damage on landing.

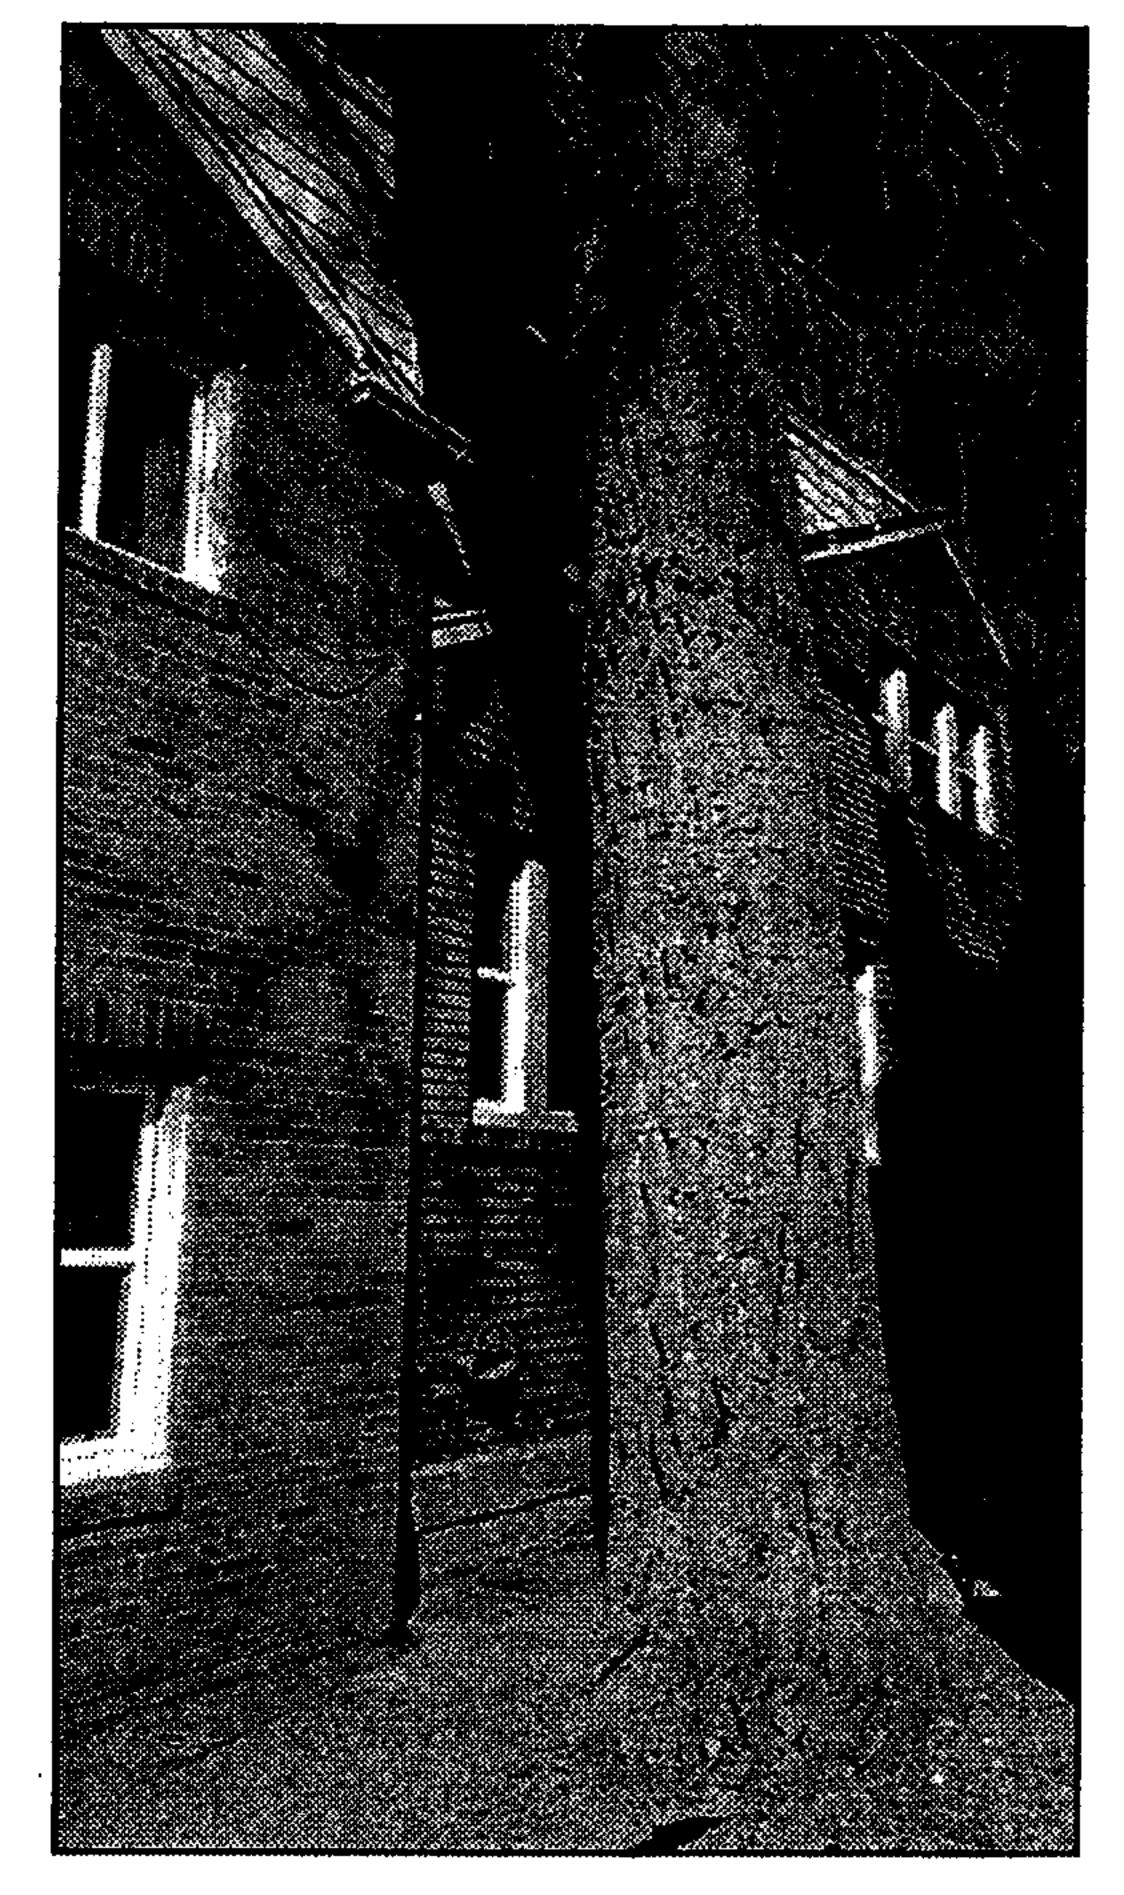
Note: Large tree between rectory and church foundations.

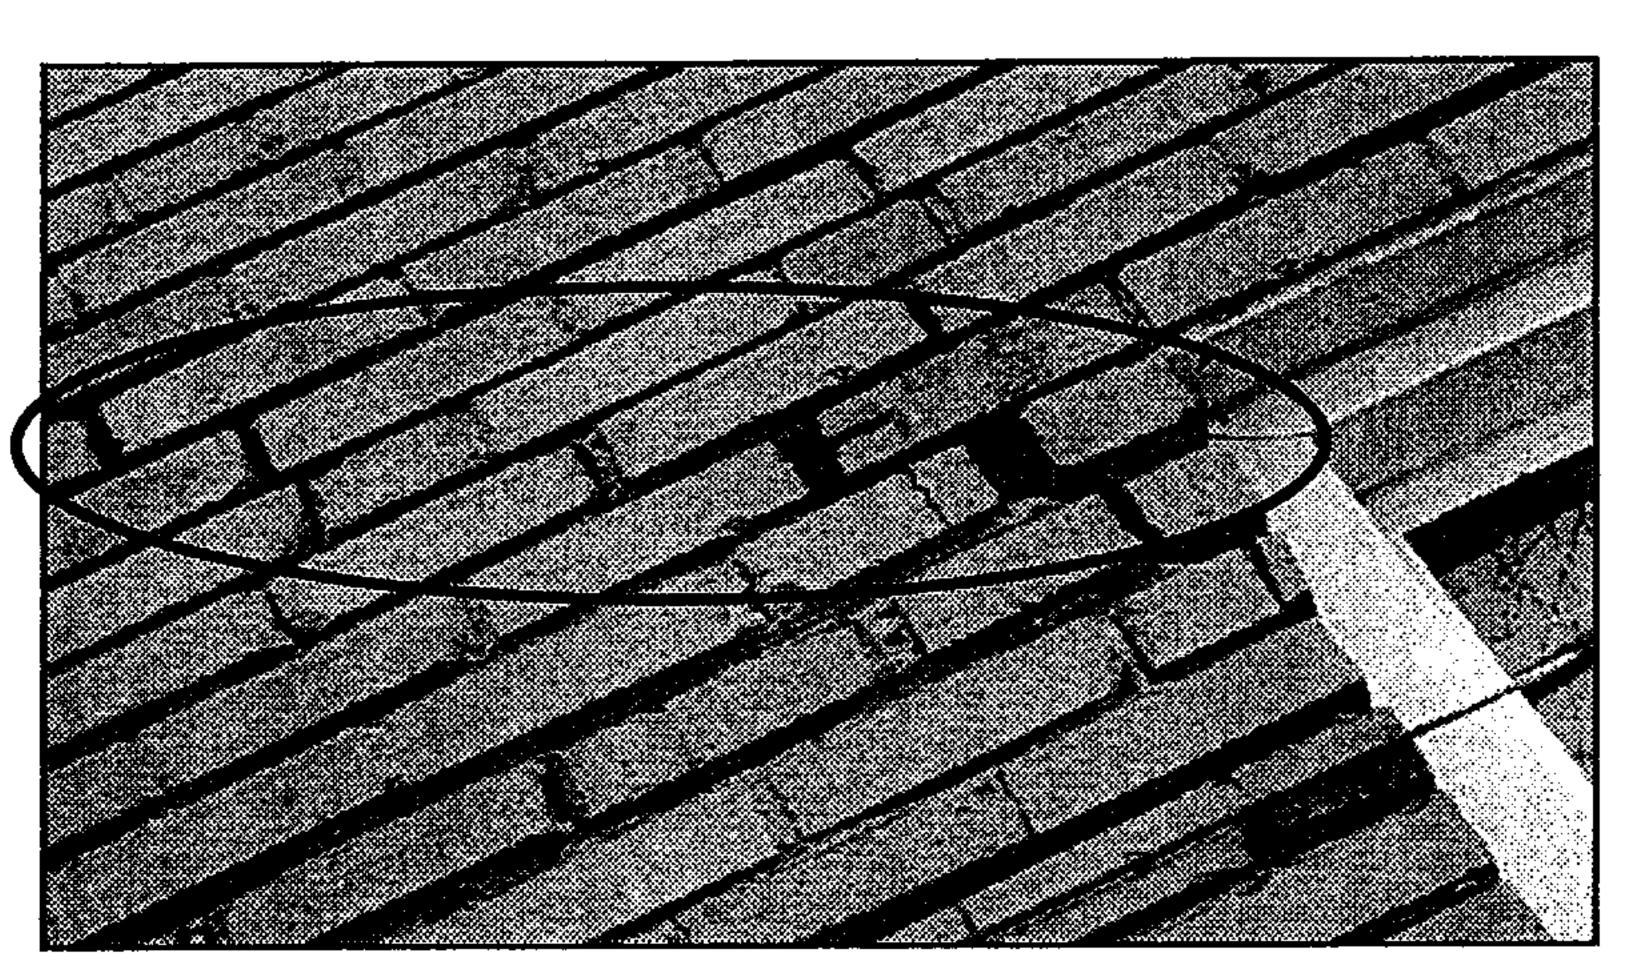
Note: Settlement evident
