**PROPERTY CONDITION REPORT
with 10-YEAR CAPITAL NEEDS**

**St. Pius X Catholic Parish
7200 Sarto Drive
Indianapolis, IN 46240**

Prepared for: **St. Pius X Catholic Parish**

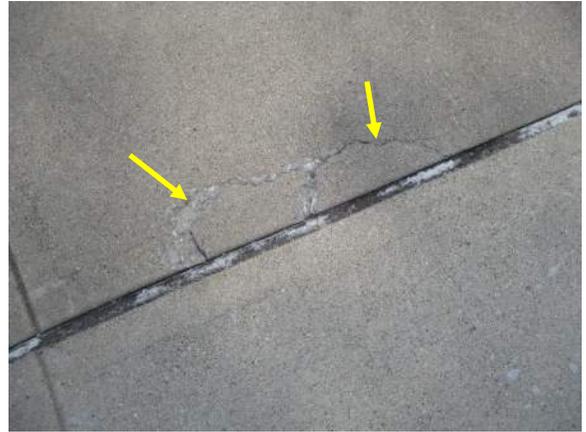
Image A19

2. Separation cracks, spalls and displaced concrete sections were observed at various locations along the concrete curbs and walkways (Images A19 through A28). Pitted concrete sections were also observed at select locations from apparent ice melt (Images A29 and A30). **We recommend sealing cracks in the concrete curbs and walkways to prevent water migration and further deterioration [Year 1 - \$2,500]. Additionally, we recommend cutting out spalled and displaced sections and patching in new concrete sections to eliminate potential tripping hazards [Year 1 - \$3,000].**

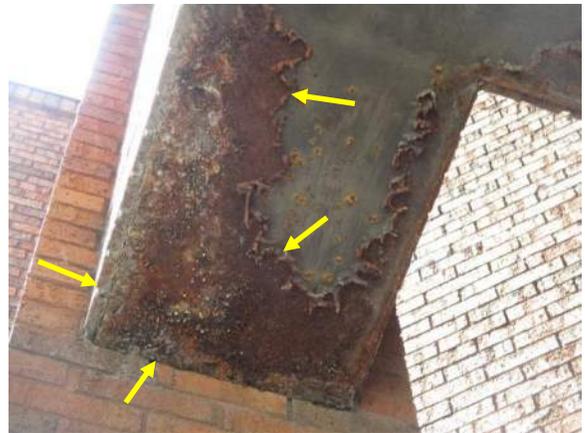
Image A3

1. Structural steel plates and HSS (hollow structural steel) tube members at the exterior bell tower were observed with significant corrosion (Images A1 through A4). **While the structural members appear to be structurally stable, we recommend engaging a structural engineer to inspect the members and confirm excess section loss has not occurred, and then providing a rust inhibiting application and paint coating to protect them from the weather and further deterioration [Year 1 - \$16,000].**

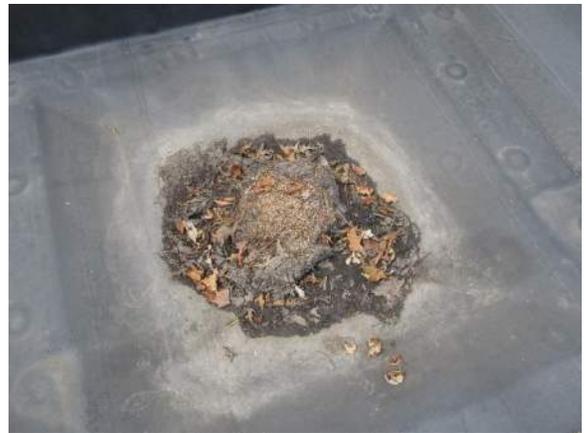
Image B9

1. Select roof drains were observed to be clogged from leaves and debris with evidence of ponding water (Images B8 through B12). **We recommend clearing the leaves and debris from these roof drains as part of general maintenance so stormwater can drain properly.**
2. We observed several locations where evidence of ponding water exists due to insufficient slope to the drains (Images B2, B4 and B7). **Minimal ponding water is generally not a concern on 90-mil EPDM roofing systems like this one; however, we recommend monitoring these conditions and engaging the roofing contractor to make repairs as necessary if they continue to worsen [Year 3 - \$11,000].**

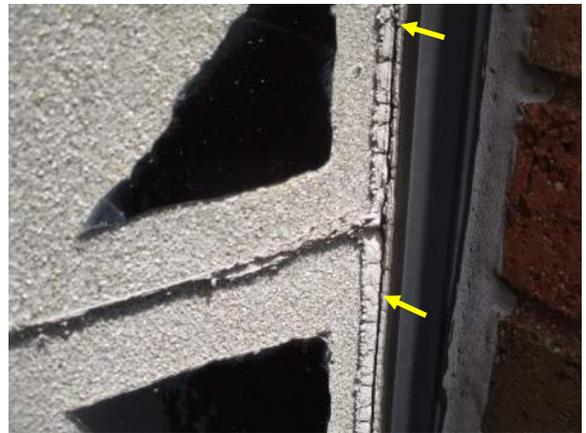
Image C15

2. Deteriorated sealant joints were observed around the perimeter of the stained-glass and concrete windows at the roof level (Images C15 and C16). **We recommend removing and replacing the deteriorated and failed sealant joints [Year 2 - \$7,300].**

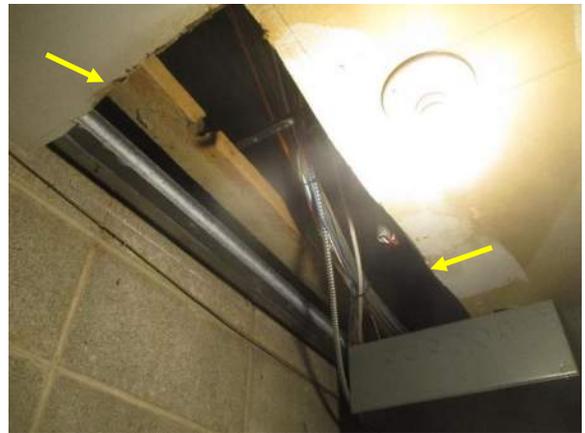
Image D15

3. Damaged gypsum board ceiling finishes were noted within a mechanical room, likely the result of previous roof leaks (Images D15 and D16). **We recommend repainting the ceiling at this location in the near future from a cosmetic standpoint [Year 1 - \$1,400].**

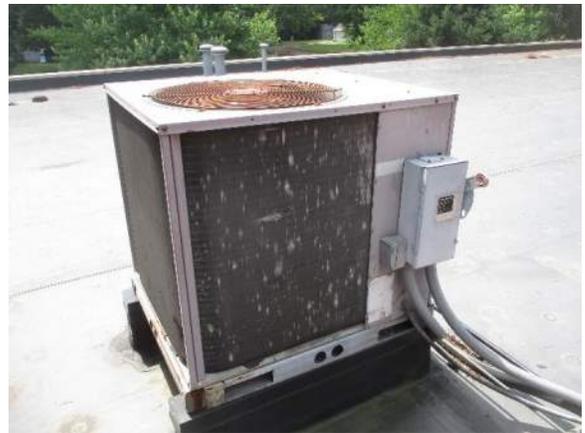
Image E9

- Supply and return air ductwork are located above the ceiling assemblies that provide conditioned air to the spaces they serve.
- A ventilation fan was observed on the roof for ventilation of the toilet rooms at the south end of the building (Image E9).
