Holy Spirit Catholic Community Saint Cyril and Methodius Church & Rectory Evaluations

633 Bridger Ave, Rock Springs, WY 82901 March 24, 2025

Re: Saint Cyril and Methodius: Church and Rectory Study

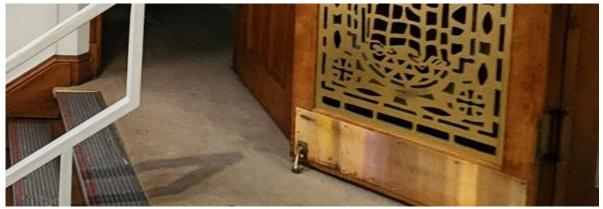
The Church also lacks accessible access to the Nave, as the Limited Use Limited Access (LULA) Elevator cannot be properly accessed at the ground level, nor does it meet minimum widths of the car itself. If assistance is given, an individual that finds themselves in the Nave, are limited to the main area itself, with restricted access to the Cry Room and Confessional. No ramp is present allowing for wheel chair access to the Altar as well.

Constrained access to Cry Room and Confessional lack clear floor area of an Accessible Route

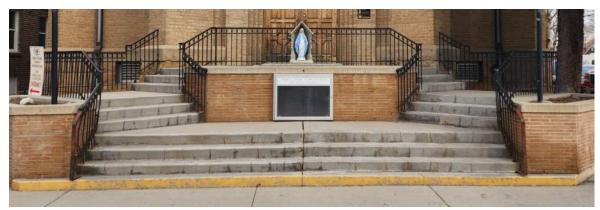
The main entry to the facility has several deficiencies that challenge its existence and function as it remains today. Handrails lack proper extensions at the outer rails at the top. The interior handrails lack extensions at the intermediate landing. An intermediate handrail is lacking on the lower run of stairs. The biggest challenge is the handrail extensions at the lower run of stairs. Because the lowest stair (painted yellow for hazard) adjoins the public right-of-way, handrail extensions cannot be provided as they would impede the path of passersby. Correction at this location would likely require a complete reconstruction of the stairs.

The main stairs lack handrail returns or extensions at various landings.

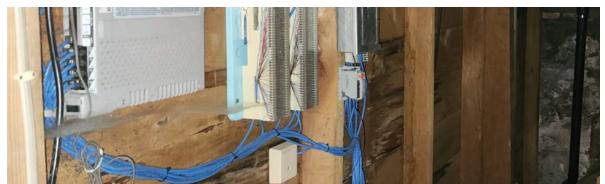
The basement has a number of walls that show moisture staining and damage. For example, within the crawlspace, the wall supporting communication equipment has a number of stains on the wood framing.

Staining on wood planks and efflorescence on the foundation wall are visible

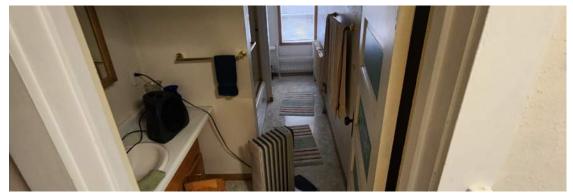
Typical bathroom requires updating and has limited space within

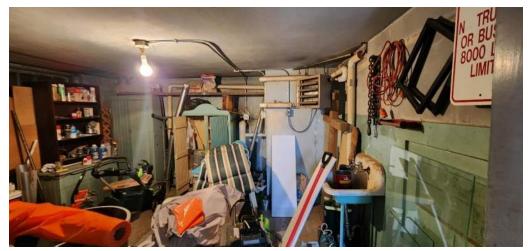
Storage and the main boiler are located in rooms under the sanctuary, accessible from the exterior. The rooms are packed with a number of items from lawn equipment to household goods.

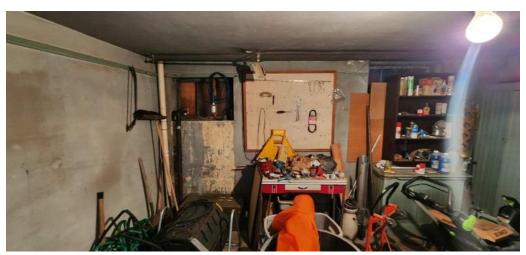
Storage and the main boiler are located in rooms under the sanctuary, accessible from the exterior. The rooms are packed with a number of items from lawn equipment to household goods.

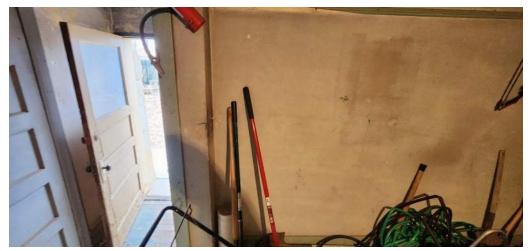
The access to the space is narrow. Creating a challenge for boiler replacement if required.

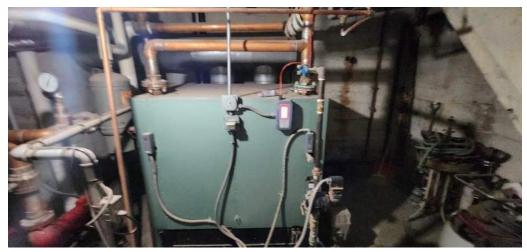
The existing boiler is aged and appears to be similar to the boiler in the Rectory, which recently failed.

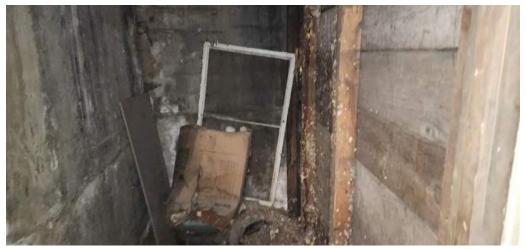
In the deeper areas of the boiler room, trash and other things remain. These items should be cleared and the area cleaned to prevent rodent infestation.

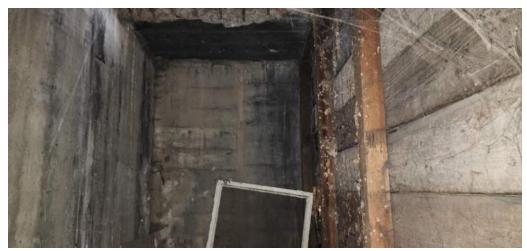
There was areas of damage under the slab above where rebar was visible. This should be prepped and patched, and the top surface confirmed no point of infiltration remains.

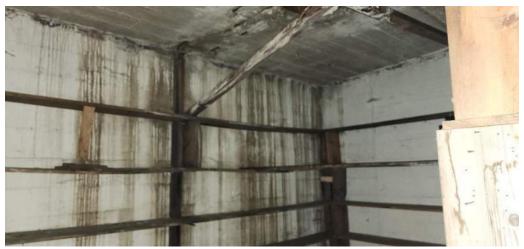
Some of the framing in place within one of the storerooms adjacent to the boiler room. There is significant water damage visible. Further investigation of the cause should be performed and any necessary sealing from above performed.

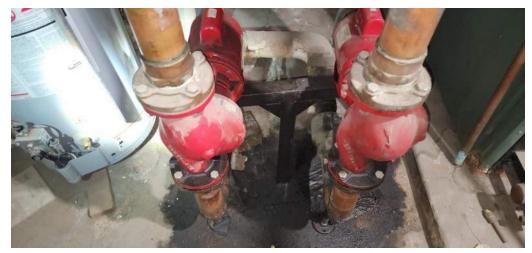
Circulation pumps for the heating system appear to have leaked, oil residue is present on the coupling and the ground around the units.

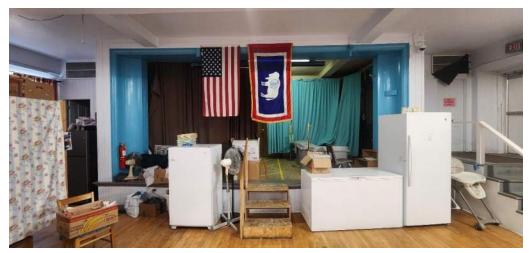
Stage does not have a code compliant access (Stair or Ramp) for users.

Currently mostly used for storage.

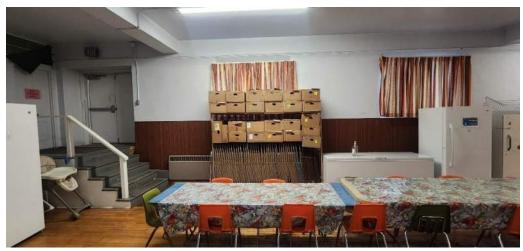
Exterior loading/egress door lacks operation of the second leaf in an emergency. Current codes require both leaves to become active in an emergency. The stair does not have a compliant handrail with extensions and balusters.

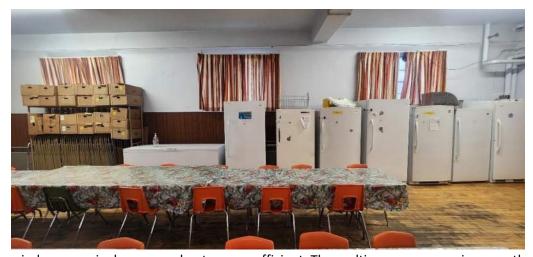
Exterior windows are single pane and not energy efficient. The multi-purpose space is currently used as a soup kitchen, an abundance of cold storage (fridge/freezers) are present.

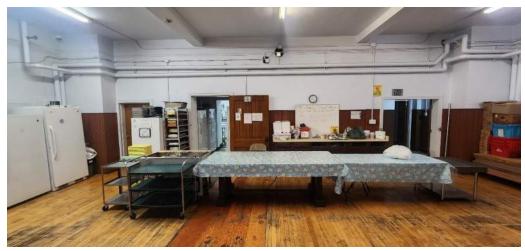
In review of the basement, which now operates primarily as a soup kitchen, improvements for sanitary purposes should be made. Items such as the worn wood floor where food is served should be repaired or replaced.

The floor is worn and requires repair for sanitary use within an eating establishment.

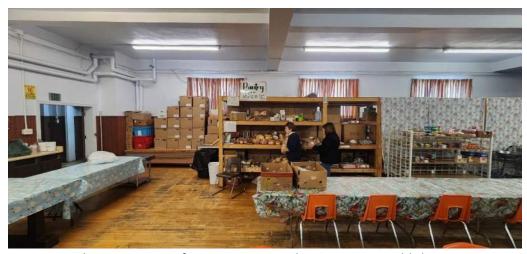
The floor is worn and requires repair for sanitary use within an eating establishment. A pantry and dry storage area are designated with. The space has been adapted by any means to provide the services of a soup kitchen.

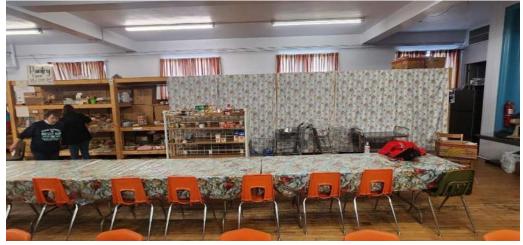
The floor is worn and requires repair for sanitary use within an eating establishment. A pantry and dry storage area are designated with. The space has been adapted by any means to provide the services of a soup kitchen.

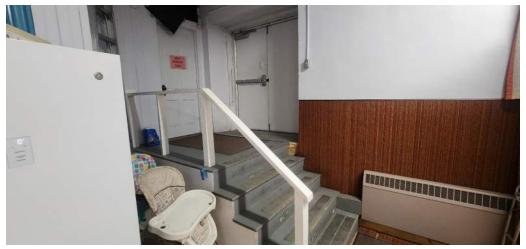
The stair does not have a compliant handrail with extensions and balusters.

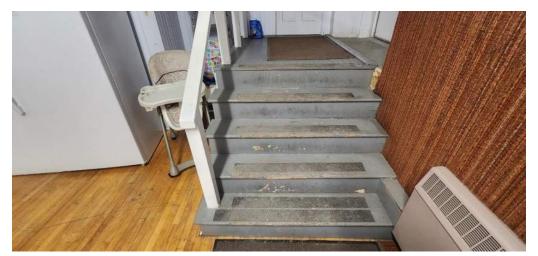
The stair does not have a compliant handrail with extensions and balusters.

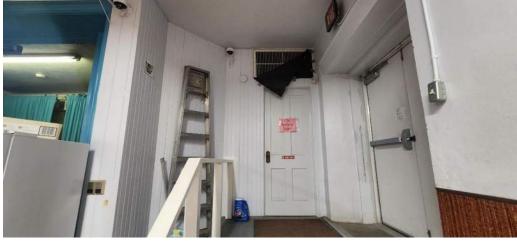
The landing is adequate at the tope of the stairs. The door into one of the mechanical/storage spaces encroaches within the clear egress path of the designated exit door.

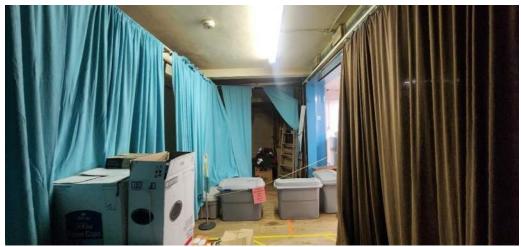
Stage has been primarily used for storage. Curtains are present to help hide various items stored. The use of curtains to separate storage, unless flame resistant, are also concerning.

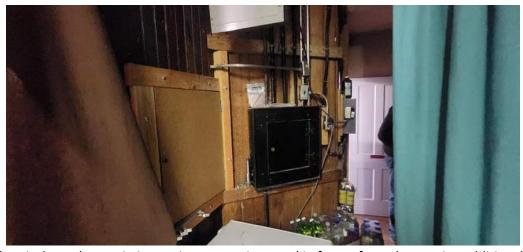
Older electrical panels remain in use, items remain stored in front of panels, creating additional hazard.

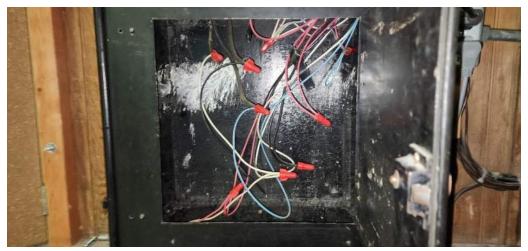
Panels have been converted into junction boxes (see electrical report for additional info)

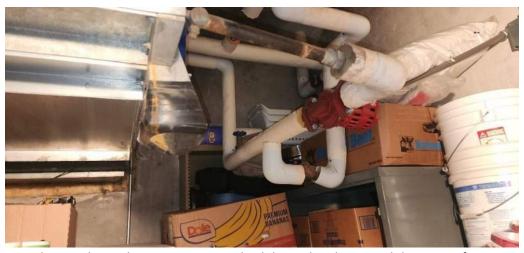
Storage within mechanical spaces is creating both hazard and serviceability issues for equipment.

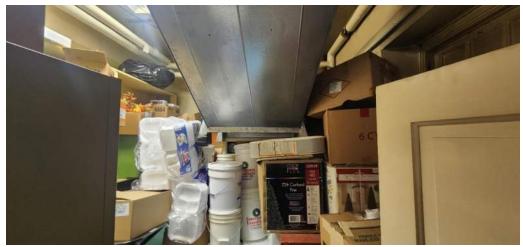
Storage within mechanical spaces is creating both hazard and serviceability issues for equipment.

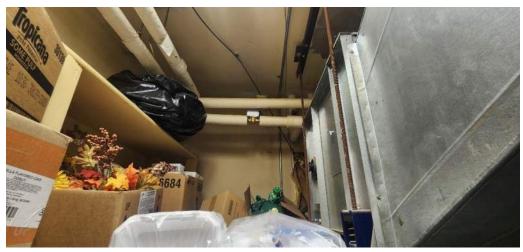
Storage within mechanical spaces is creating both hazard and serviceability issues for equipment.

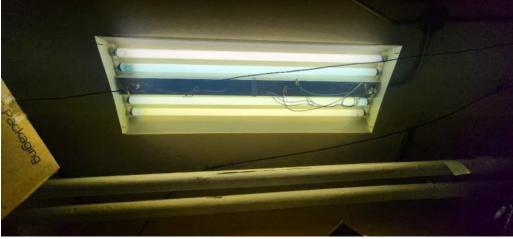
Lighting has been retrofitted at some point in time, this is evident by the amount of surface conduits visible. In some instances, light fixtures remain open and wires exposed, a violation of the National Electric Code.

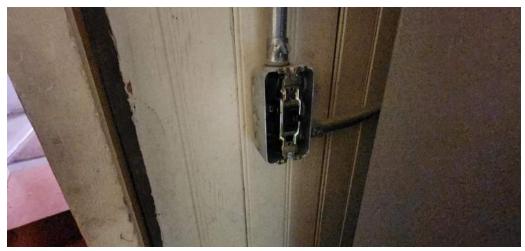
A light switch was missing its cover plate, a violation of the National Electric Code.

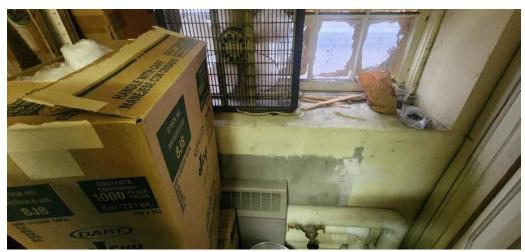
The basement is cast concrete and remains in good shape.

Basement windows are single pane and lack efficiency or compliance with modern codes.

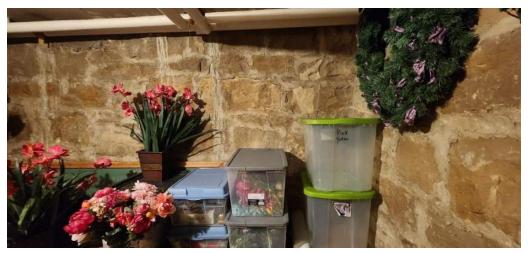
The small portions of the building remain with a sandstone foundation or load bearing wall. Toward the south and under the main entry stair, some water staining was visible on the stones. No excessive wear is visible and the stones remain in good condition.

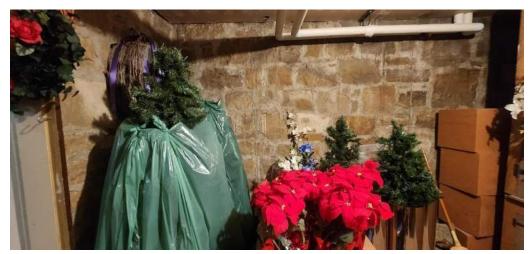
The small portions of the building remain with a sandstone foundation or load bearing wall. Toward the south and under the main entry stair, some water staining was visible on the stones. No excessive wear is visible and the stones remain in good condition.

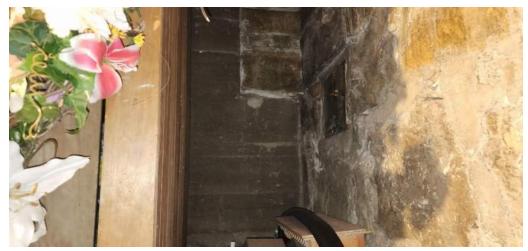
Some staining was also visible on the underside of the concrete landings above.

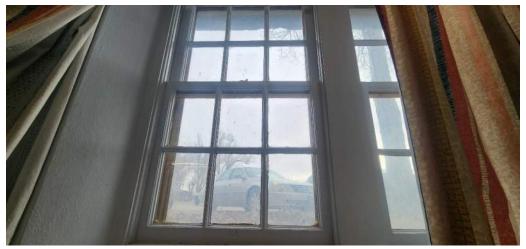
Existing basement windows are single pane and at grade, lacking energy efficiency.

They do not meet current efficiency and energy code standards.

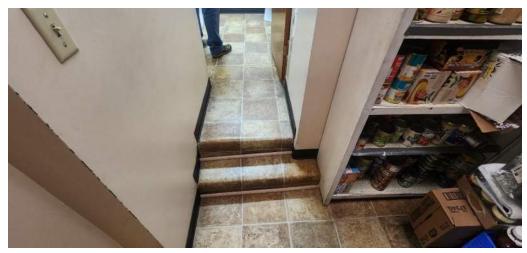
Flooring from the dry storage to the small staff restroom lack handrails, they also are finished in a way that make them non compliant for nosing requirements under Chapter 10 of the 2024 IBC.

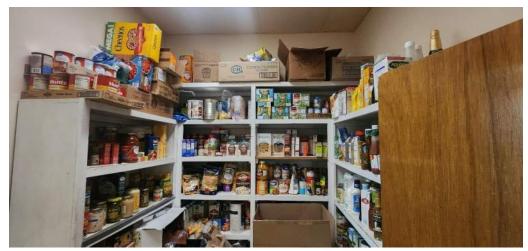
The storage room has both dry and wet goods stored within it.

Shelving should be non-porous for food service needs.

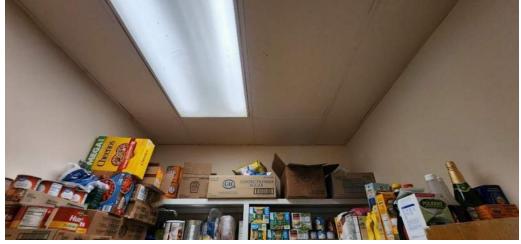
Items are stored within 18" of a ceiling, non-compliant with the International Fire Code, Chapter 3.

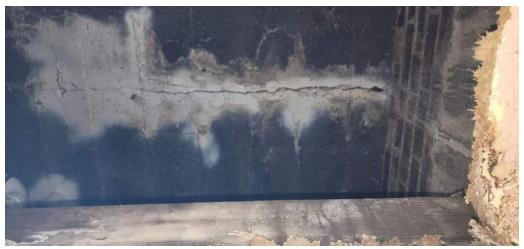
The small restroom exists under an exterior stair landing that access the sanctuary area. A recent leak has been resolved and drainage modified on the landing on the exterior side. Due to the size of the crack, a more structural repair should be made.

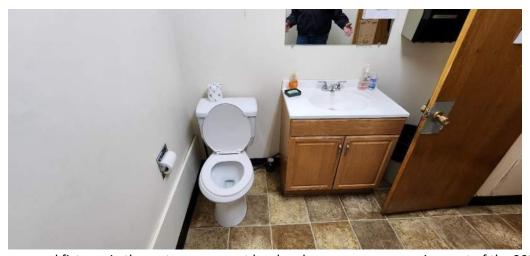
Finishes around fixtures in the restroom are not hard and non-porous, a requirement of the 2024 IBC under Chapter 12, and as required by Local Authorities having Jurisdiction (AHJ).

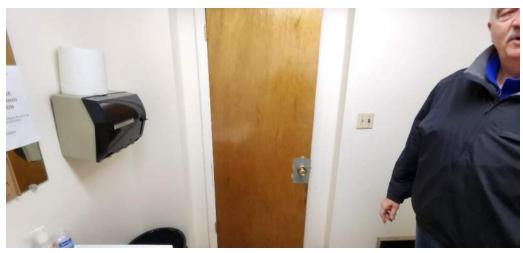
Doors are narrow and limit access to more able bodied individals.

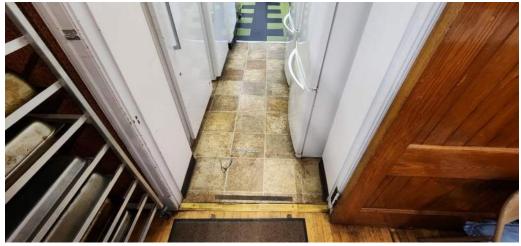
Access to the kitchen obstructed by a number of fridges/freezers for cold storage. The flooring is torn and create sanitary concerns for spills, etc. Flooring should be non-slip, non-porous, and resistant to grease and other chemicals/fluids.

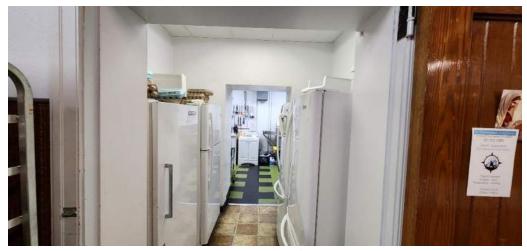
Access to the kitchen obstructed by a number of fridges/freezers for cold storage. The flooring is torn and create sanitary concerns for spills, etc. Flooring should be non-slip, non-porous, and resistant to grease and other chemicals/fluids.

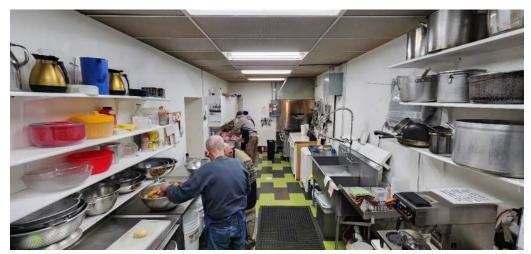
The kitchen has bare minimums for compliance, i.e., a suppression hood over the stove and a 3-compartment sink. Other items lack sanitary requirement. I.E. pours wood surfaces or worn laminate on wood. Items should be replaced with stainless food service grade equipment.

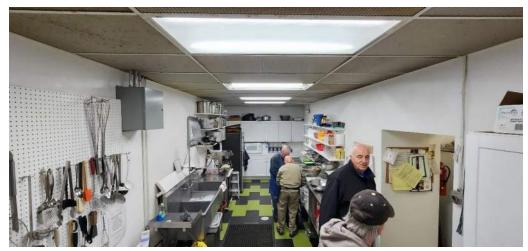
The ceiling within the kitchen appears aged and in need of cleaning/replacement.

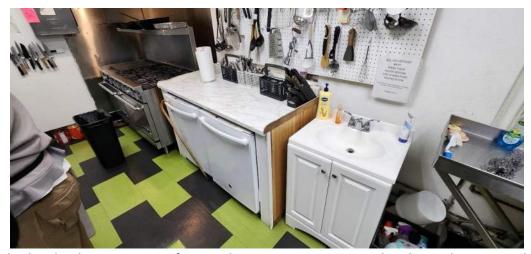
The kitchen has bare minimums for compliance, i.e., a suppression hood over the stove and a 3-compartment sink. Other items lack sanitary requirement. I.E. pours wood surfaces or worn laminate on wood. Items should be replaced with stainless food service grade equipment.

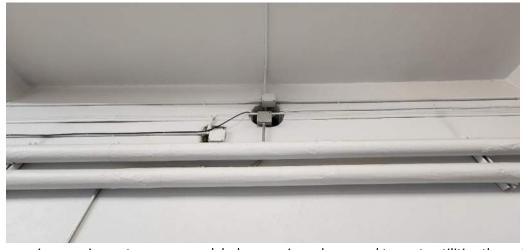
Where previous equipment was removed, holes remain and are used to route utilities through. The above was where a projector once shone through.

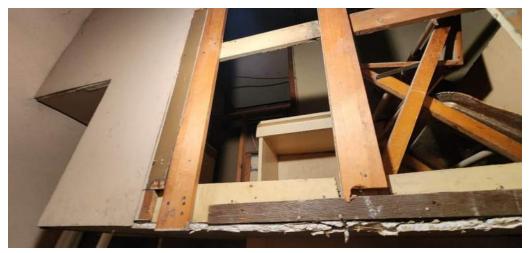
The old projector booth remains with some finishes removed for access. A code compliant access should be constructed, or the booth should be removed in its entirety to remove the hazard of the unoccupied space which has furnishings within it.

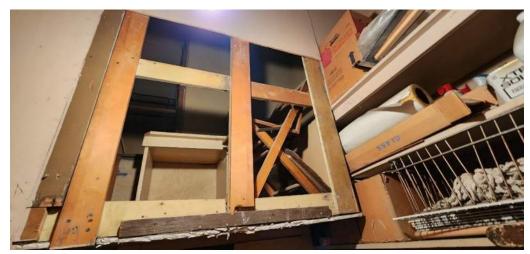
The old projector booth remains with some finishes removed for access. A code compliant access should be constructed, or the booth should be removed in its entirety to remove the hazard of the unoccupied space which has furnishings within it.

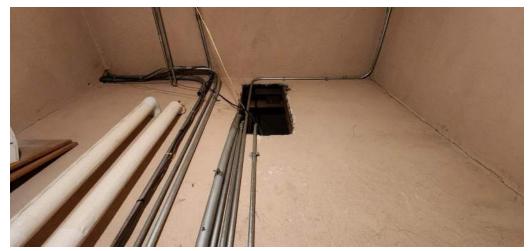
Excessive cut out remains in a storage room for utility upgrades. The wall should be patched back.

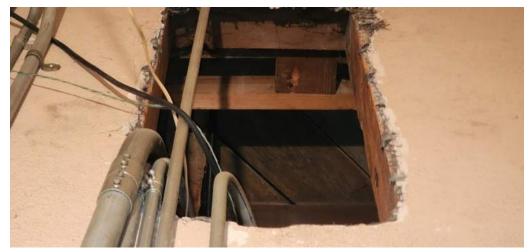
Excessive cut out remains in a storage room for utility upgrades. The wall should be patched back.

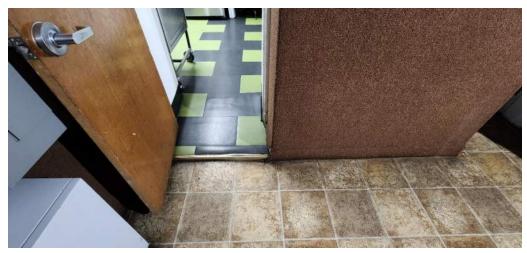
An inconsistent floor transition exists at one of the kitchen entry ways. This is a small hazard when accessing the work space with items in hand and should be corrected to a sloped transition.

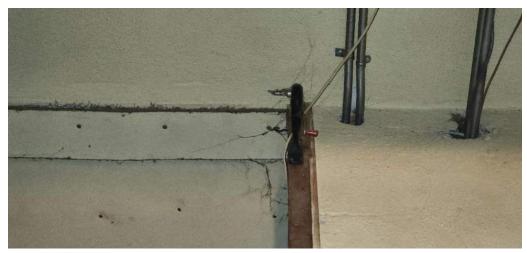
Penetrations through various walls should be patched to improve fire safety characteristics of the walls throughout the basement.

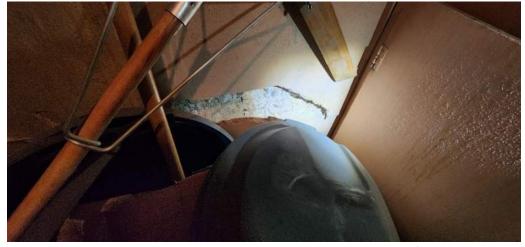
In the storage room near the kitchen, there is evident water damage at the foundation. There was at one time a water line leak that existed for an extended period of time. Damage should be repaired.

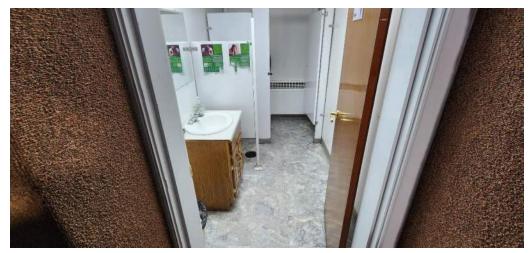
There is a larger toilet room with both urinal and toilet stall. Again the hard and non-absorbent finishes around fixtures as outlined in the International Building Code.

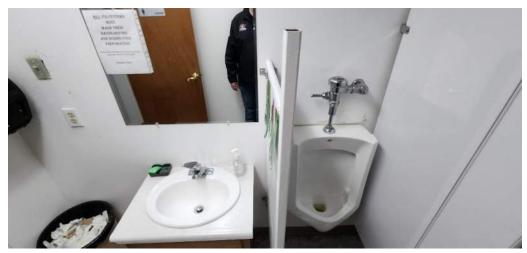
There is a larger toilet room with both urinal and toilet stall. Again the hard and non-absorbent finishes around fixtures as outlined in the International Building Code.

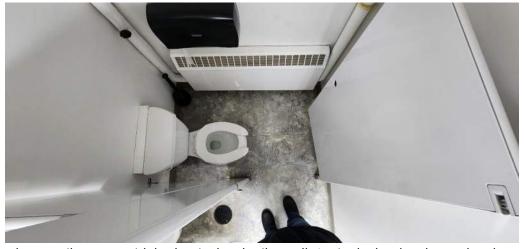
There is a larger toilet room with both urinal and toilet stall. Again the hard and non-absorbent finishes around fixtures as outlined in the International Building Code.

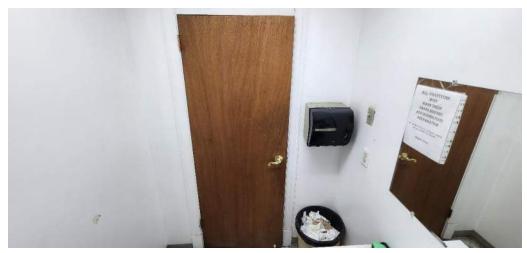
Churches are exempt from Title III of the ADA, thus were not required to be brought to compliance within the limitation period. However, for use by elderly or those with disability, the facility should be upgraded accordingly. Upgrades would be required to comply with the IBC and the ANSI A117.1, which churches and places of worship are not exempt from. Renovations to the church must then comply.

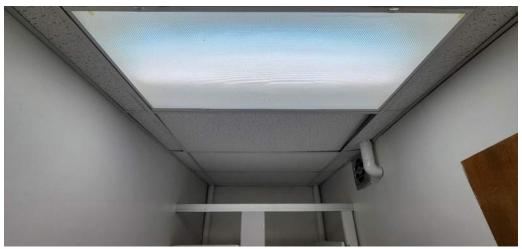
A ventilation fan was visible in the wall of the restroom, however, the fan did not operate during our walk. Proper ventilation to the restroom should be provided.

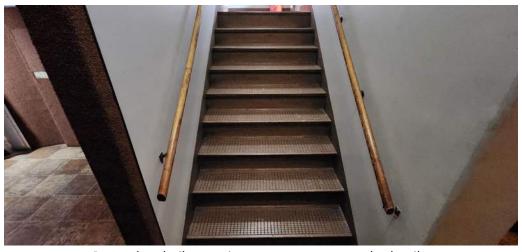
Proper handrail extensions are not present on both rails.

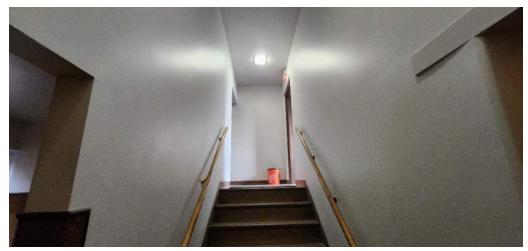
Landings and stair widths are adequate in the addition to be considered for path of egress.

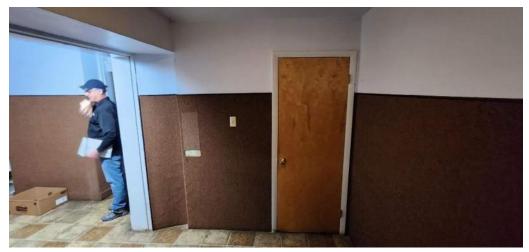
Many of the doors within the space are not 36" wide, thus are not barrier free compliant.

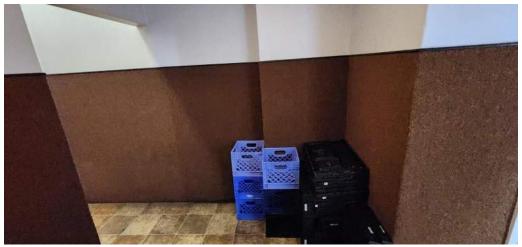
Carpet is applied to walls for acoustics. The lower level is used as a soup kitchen. Though the carpet appears to be clean, it should be note that as a wall finish with food prep in the area, sanitary finishes should be utilized.

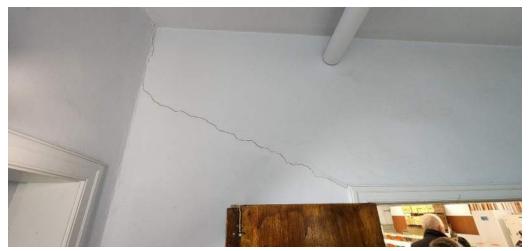
There is settlement visible where the elevator addition adjoins the building. This movement appears to have stopped and is not excessive. Walls should be properly repaired to conceal past settling.

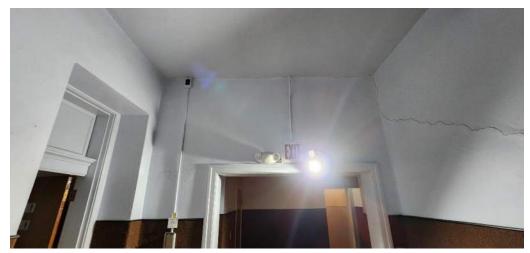
Multiple types of egress lighting is present, however, exit signage did not light up as required. New egress fixtures should be considered.

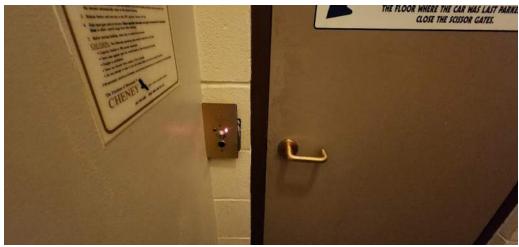
Elevator controls are keyed, and are directly adjacent to the door.

Barrier free clear area at doors is not present.

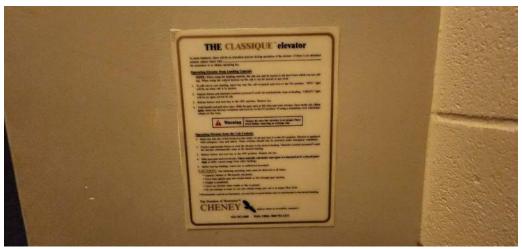
The elevator is considered "Limited Use/Limited Access" (LULA) under the current building codes. Meaning it is allowed to a component of the accessible route, but has limitations. This unit does not have an automatic return to floor function upon loss of power, leaving users stranded.

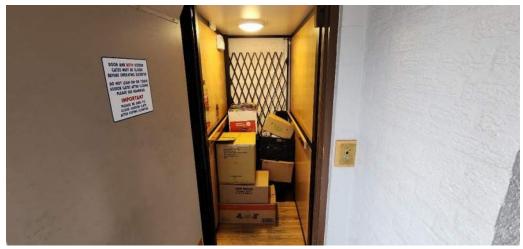
The dimension of the car is restricted to the width of the door and does not comply with the current 48" minimum cab width of a LULA. Accessible space at the door is not present.

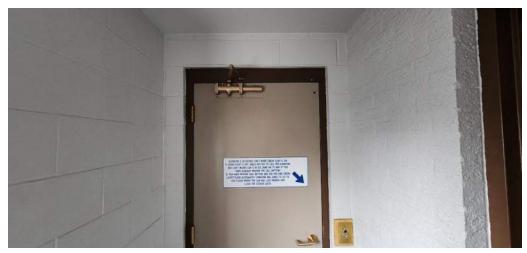
The door is equipped with a closer, latch, and handle. Without clear area adjacent to the door, a person in a wheelchair cannot operate the machine solo, it requires assistance.

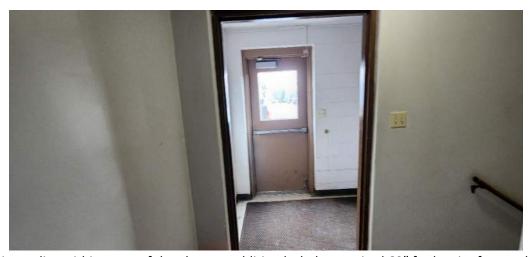
Turning radius within areas of the elevator addition lack the required 60" for barrier free usability.

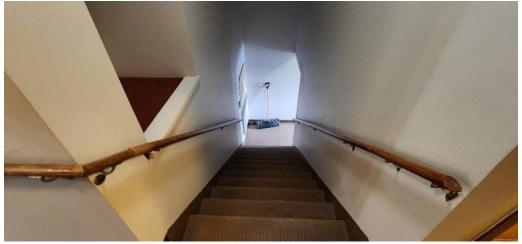
Handrail extensions to the basement were provided on 1 side, other side is non-compliant.

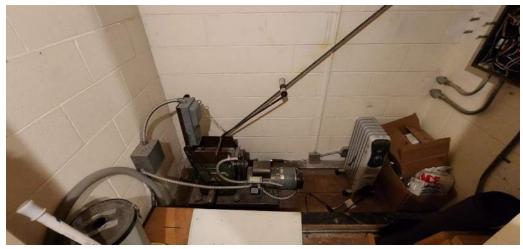
The elevator equipment is aged. It is a cable driven lift system with parts no longer in production.

Replacement would require reconstruction of the entire hoistway.

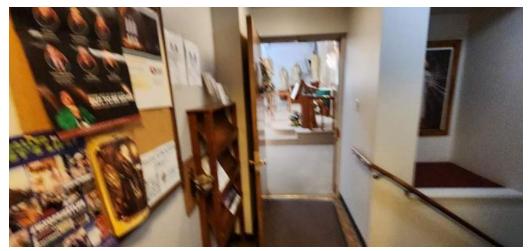
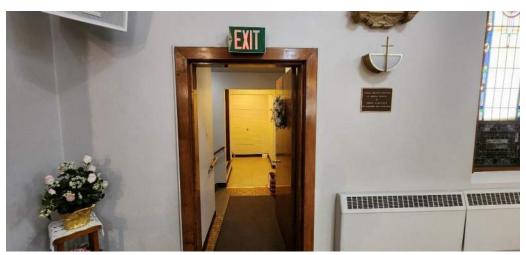
The accessible route from the addition into the church is restricted. Without the door, complies with minimum requirements.

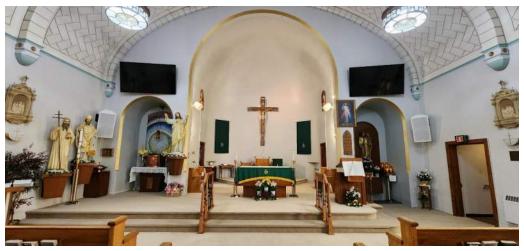
The existing Sanctuary and Altar are well maintained. New displays and audio have been added in the past using surface mounted raceways. Handrails are present at the Altar steps, however, no means for barrier free compliance are provided.

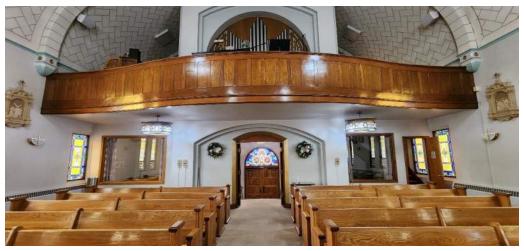
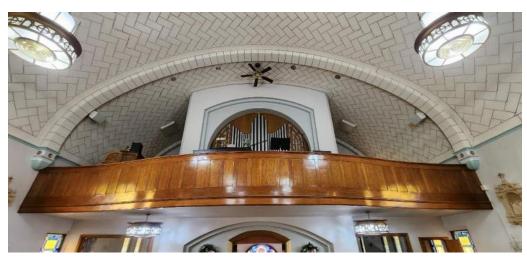
The Choir and Organ balcony is also well maintained. Narrow stairs are present for able body access, no means for disability access exists to the balcony, limiting its use.

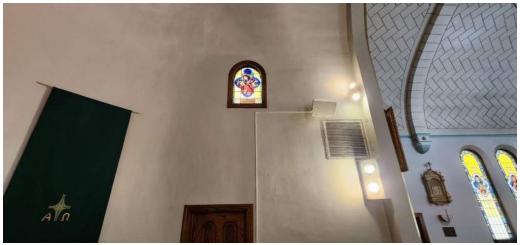
Additional speakers and lighting can be seen installed on wall.

Ventilation serving the space has been modified with certain registers blocked off from use.

Free air ventilation required by code may be impeded as a result.

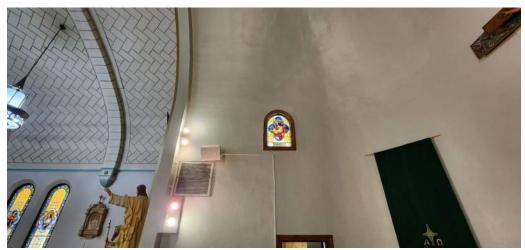
A step in the doorway is present from Altar to Sacristy without proper landing on swing side.

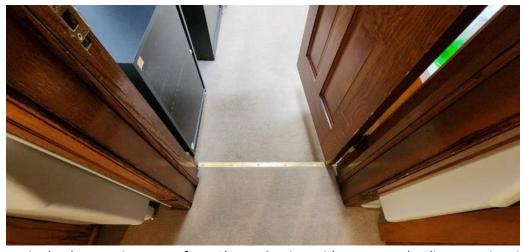
The Sacristy contains plumbing and electronics for music and bells. The space appears to be in overall good condition. A level room-to-room transition would allow for barrier free access.

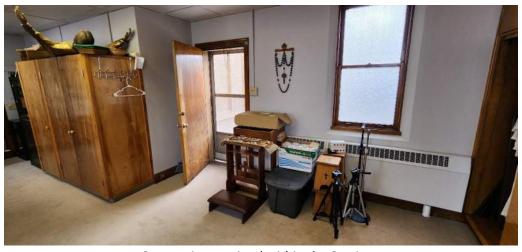
Exterior windows in the church, Sacristy included, do not meet current energy conservation codes.

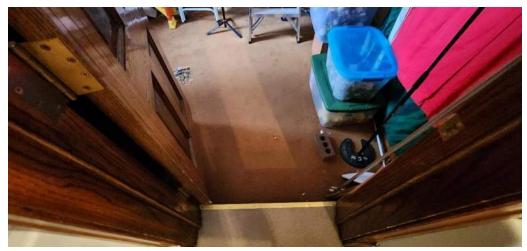
A smaller storage room exists off the Altar, also with a step in the doorway and lack of landing.

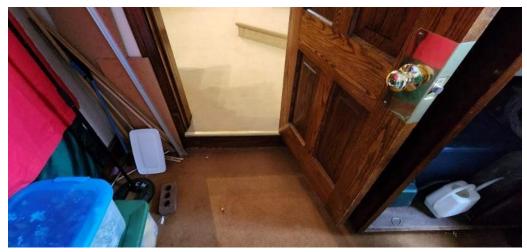
A smaller storage room exists off the Altar, also with a step in the doorway and lack of landing.

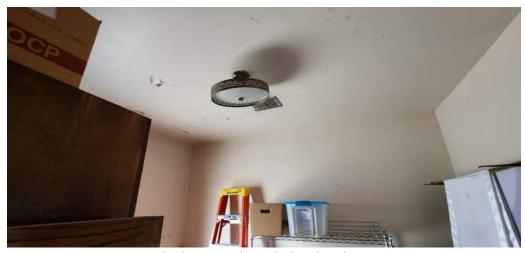
Paint had previously peeled within the space.

Both the Sacristy and this store room are located under flat roof structures with single-ply membranes. Visible paint damage appears to be aged and in need of repair.

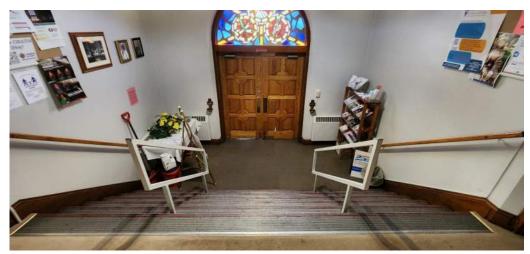
Intermediate handrails at the main entry stairs are present as required. However, all rails present have some form of deficiency for code compliance either in height or extension at the ends. Doors lack egress hardware and rely on manual unlocking for exiting. Daylight is visible through the system, indicating it poor sealing. Repairs have also been made as mating plates are visible on only one of two leaves.

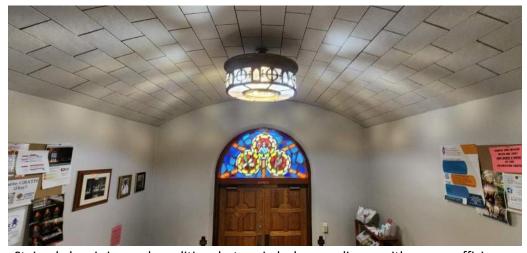
Stained glass is in good condition, but again lacks compliance with energy efficiency.

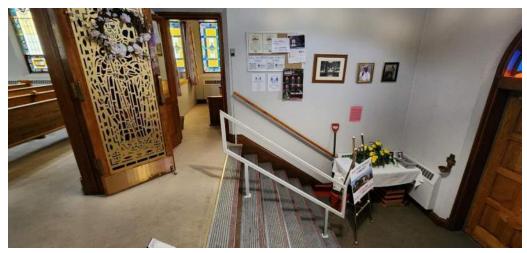
An accessible route for a wheel chair is not present into the Cry Room. The door for the room lacks clear floor area on the strike side. The Nave doors disrupt access due to their projection on the landing.

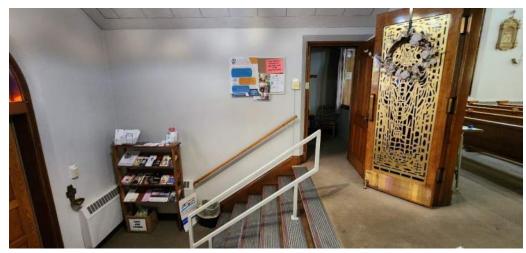
An accessible route for a wheel chair is not present into the Confessional. The door for the room lacks clear floor area on the strike side. The Nave doors disrupt access due to their projection on the landing.

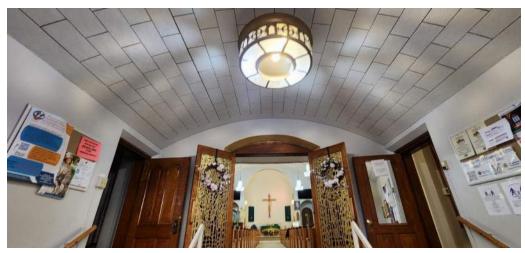
The ceiling in the entry is in good shape and shows no sign of issue. Lighting within the space remains aged and could be upgraded (bulb or fixture), for energy efficiency.

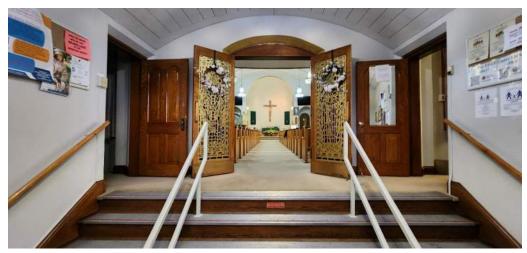
Doors into the Nave, Confessional, and Cry Room, all limit ease of access to various spaces when fully opened, restricting barrier free accessibility.

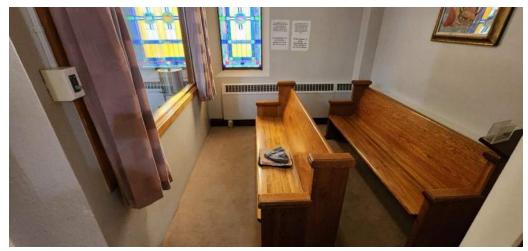
The Cry Room has no area for accessible use, restricting barrier free use if needed.

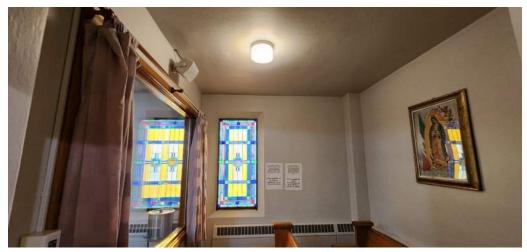
Stained glass windows remain in good condition, but lack multi-pane design and energy efficiency.

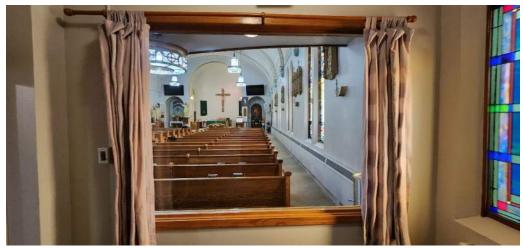
The glazing pane in the cry room is single pane, it could be replaced with a more acoustically private pane design. A dual pain or thicker piece of glazing are both options.

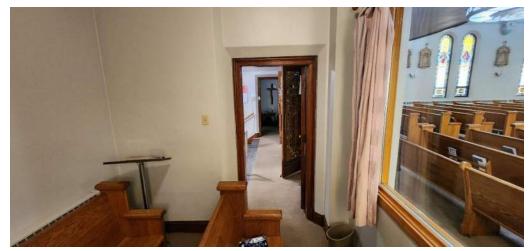
Accessibility into the room is not available.

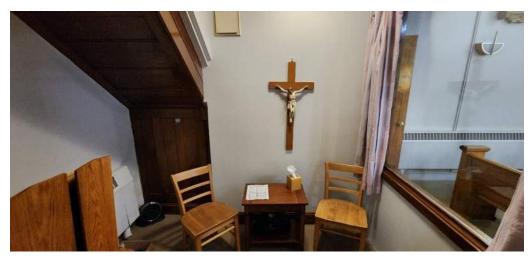
The Confessional has no area for accessible use, restricting barrier free use if needed.

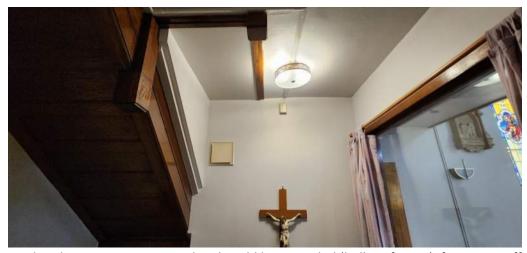
Lighting within the space remains aged and could be upgraded (bulb or fixture), for energy efficiency.

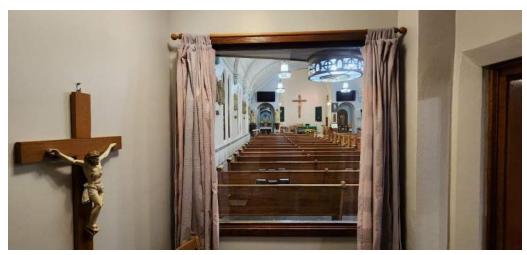
Similar to the Cry Room, glazing could be improved upon. It appears from the railing construction to the Choir Balcony, this room my have been later constructed throughout the history of the church.

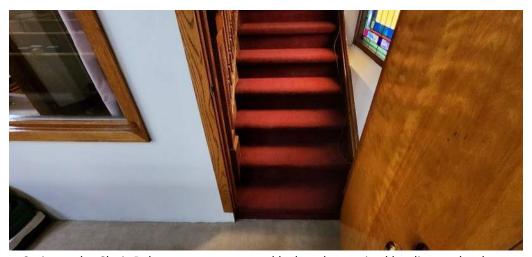
Stairs to the Choir Balcony are narrow and lack code required landing at the door.

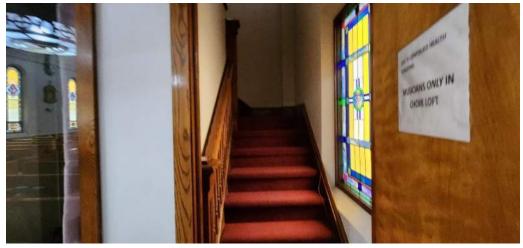
The stairs have an intermediate landing as required, but have handrail on one side. Modern codes require hand rails on both sides of flights of stairs.

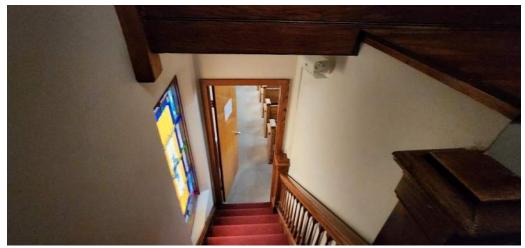
The stairs have an intermediate landing as required, but have handrail on one side. Modern codes require hand rails on both sides of flights of stairs.

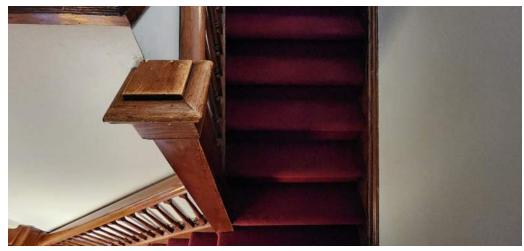
Stair width is reduced due to the handrail and is non-compliant as a result. Adding a second rail would further hinder compliance.

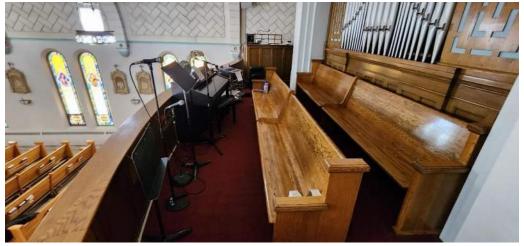
Modern instruments are in use on the balcony, including a small piano, making space available minimized. A hazard is created due to the presence of equipment in the event the balcony was used to its potential.

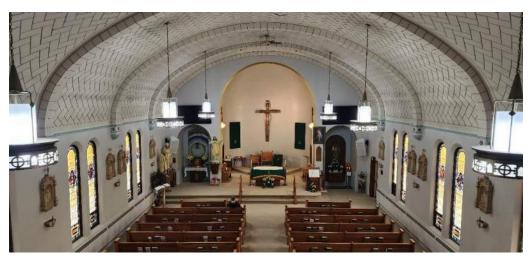
Nave is in a condition to be expected for age and use.
A number of items could be upgraded/modernized.
Other items should be considered such as barrier free access.

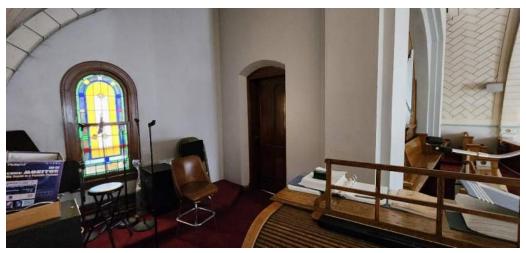
Another access point to the Belfry exists on the balcony. As noted elsewhere, safe egress is compromised from within the Belfy.

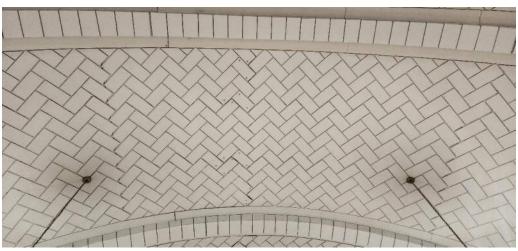
Historically, the roof has leaked. Repairs have been made.

Tiles have been resecured to the ceiling along the ridge where necessary.

Tiles remain secure, however, could be cosmetically repaired to conceal the past work.

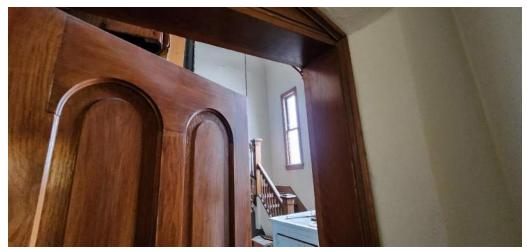
Door to Attic & Belfry cannot open due to construction of organ.

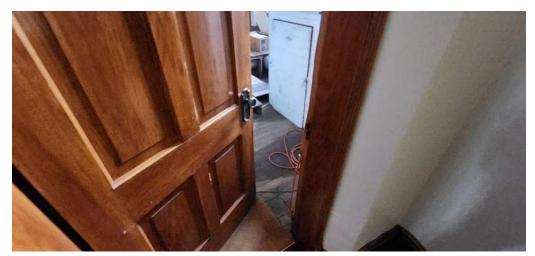
Door to Attic & Belfry cannot open due to construction of organ.

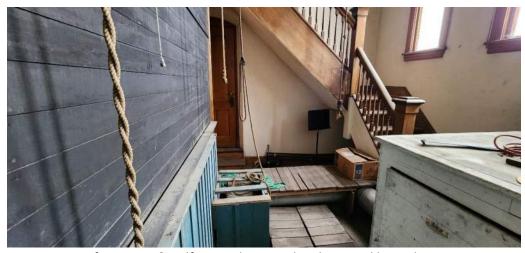
Egress from Attic & Belfry are obstructed with vertical hazards present.

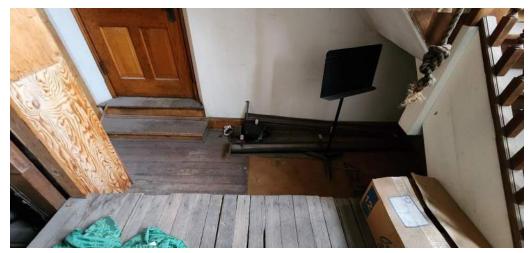
Alternate access to Attic & Belfry – Door swings over steps, inadequate landing area. 2024 IBC, Chapter 10 infraction.

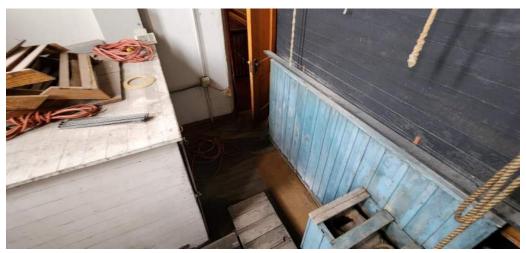
Door to Attic & Belfry cannot open due to construction of organ.

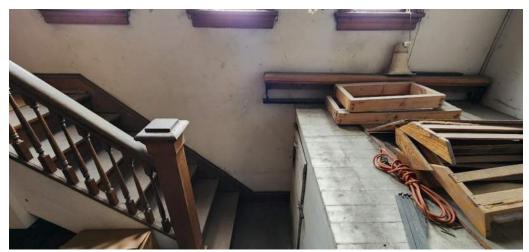
Compressor "room" interrupts landing at lower stair within Belfry. 2024 IBC, Chapter 10 infraction.

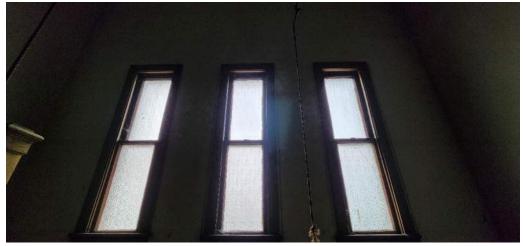
Exterior windows of the Belfry are single pane glazed. Poor energy efficiency, non-current code compliance (not required).

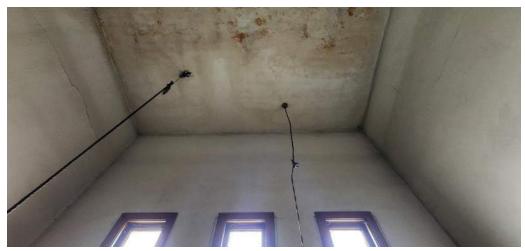
Moisture damage visible, with minor cracking in walls of main Belfry area.

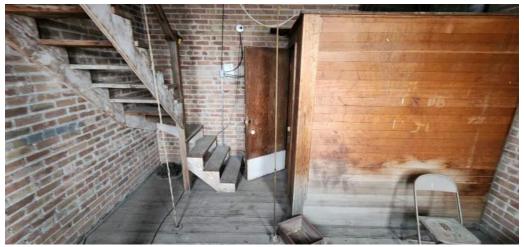
Organ compressor "room" has limited services space and adversely interrupts safe egress.

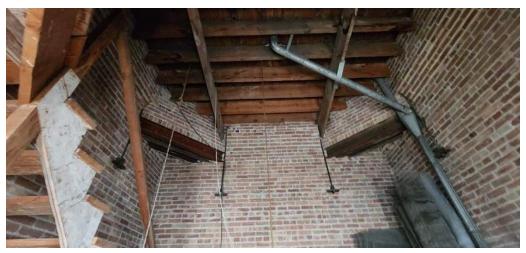
Stairwell from upper Belfry lacks consistent handrails full length. Stair handrail also lacks balusters/spindles for guardrail purposes.

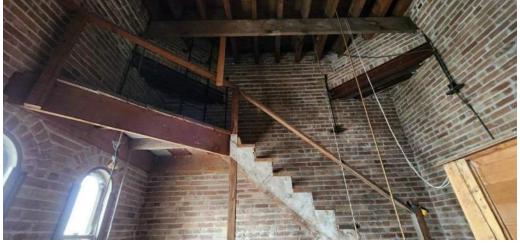
Floor of upper Belfry is curled from moisture infiltration. Structure remains sound, but is also shows sign of excessive drying due to UV.

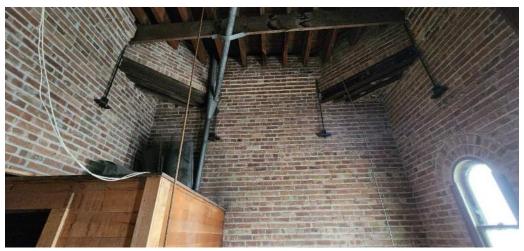
Floor of upper Belfry is curled from moisture infiltration. Structure remains sound, but shows sign of excessive drying.

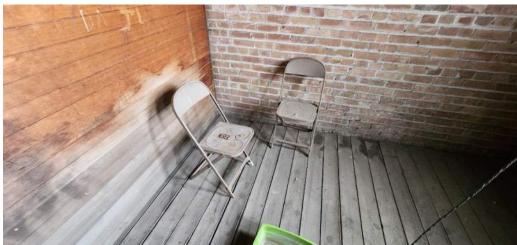
Brick in the upper Belfy appears in good condition. Structural connections for the main belltower above appear in good condition.

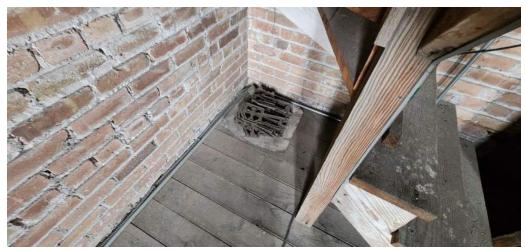
Floor of upper Belfry is curled from moisture infiltration. Structure remains sound, but shows sign of excessive drying.

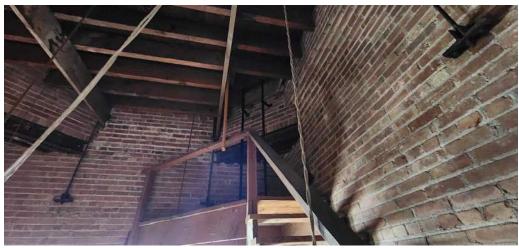
Misc. items remain within Belfry, appears hand forged.

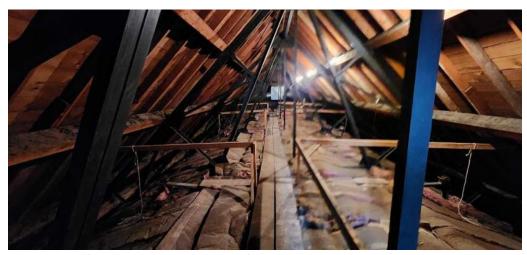
Access to the main bell room above is tight with little landing area to access. Structural connections to the room above remain in tact. Some water staining remains visible on structure from previous moisture infiltration.

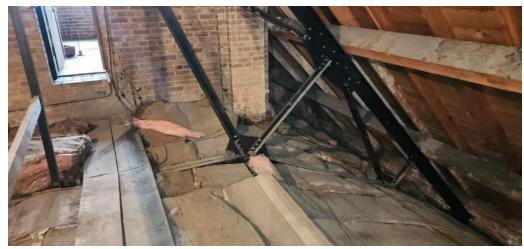
Attic has clear access from one end to the other for servicing. Catwalk width appears to meet 18" OSHA minimum. Handrails are no OSHA compliant. Missing sections, likely are not 200lbs lateral resistant.

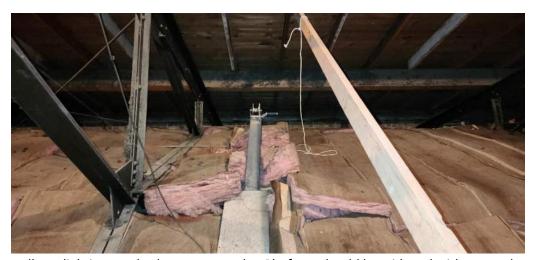
Steel structure remains without issue, no signs of fatigue, rust, or otherwise visible.

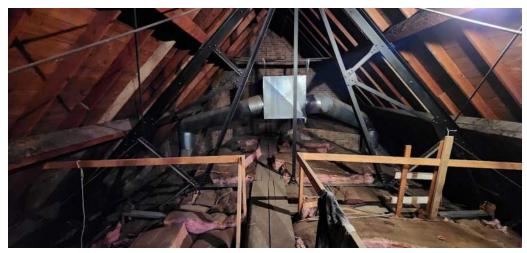
Access walks to lighting cranks do not meet osha. Platform should be widened with proper handrails.

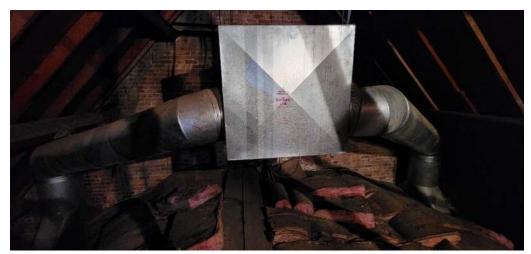
Access walks to lighting cranks do not meet OSHA. Platform should be widened with proper handrails.

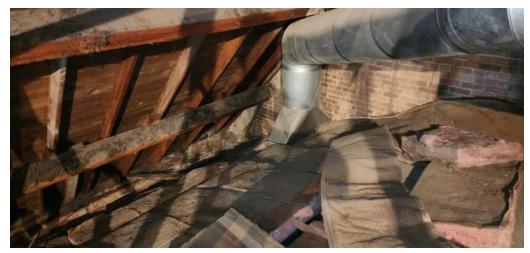
A large mechanical duct is present with round ducts splitting of to feed the Nave below. Any access required beyond or around this unit, does not have compliant platform or rails. Insulation has been placed in a haphazard manner and should be reinstalled neatly.

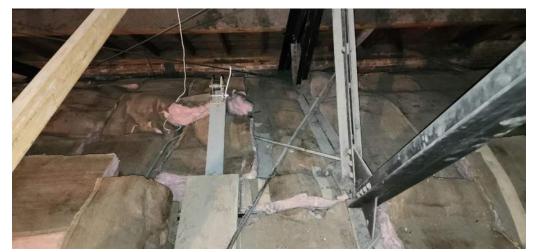
Insulation has been placed in a haphazard manner and should be reinstalled neatly. An excessive amount of bird dropping or bat guano is present. Though not directly influencing the HVAC system serving the Nave, removal should be considered for safety reasons.

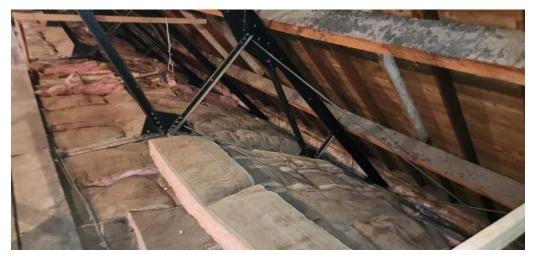
Access walks to lighting cranks do not meet osha. Platform should be widened with proper handrails.

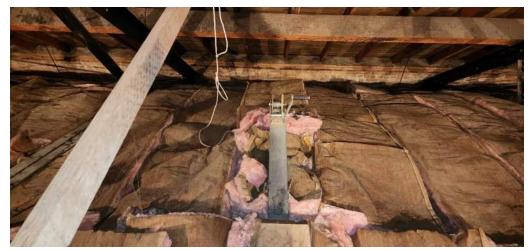
An excessive amount of bird dropping or bat guano is present. Though not directly influencing the HVAC system serving the Nave, removal should be considered for safety reasons.
