Holy Spirit Catholic Community Saint Cyril and Methodius Church & Rectory Evaluations

633 Bridger Ave, Rock Springs, WY 82901 March 24, 2025

Re: Saint Cyril and Methodius: Church and Rectory Study

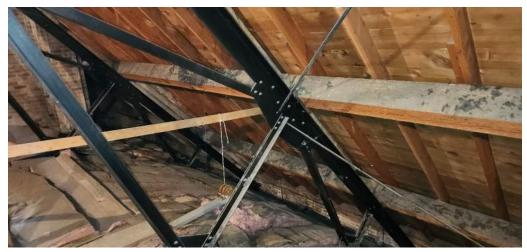
Access walks to lighting cranks do not meet osha. Platform should be widened with proper handrails.

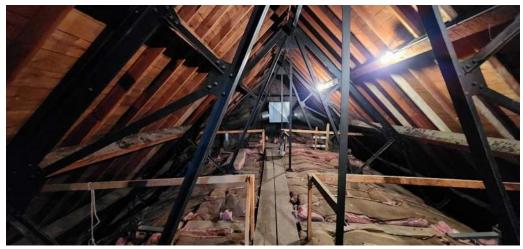
Steel structure remains without issue, no signs of fatigue, rust, or otherwise visible.

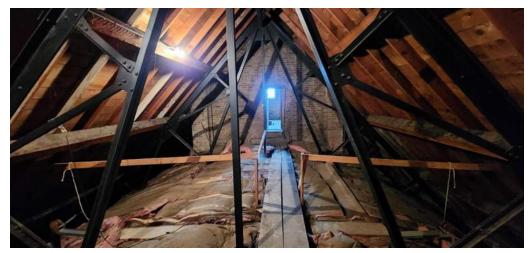
Attic has clear access from one end to the other for servicing. Catwalk width appears to meet 18" OSHA minimum. Handrails are no OSHA compliant. Missing sections, likely are not 200lbs lateral resistant.

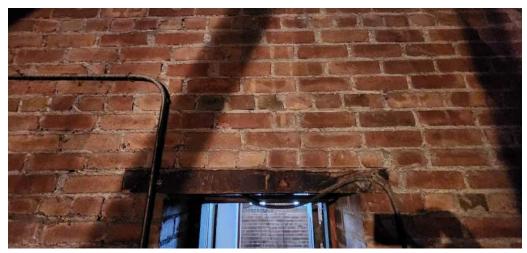
Attic has clear access from one end to the other for servicing. Catwalk width appears to meet 18" OSHA minimum. Handrails are no OSHA compliant. Missing sections, likely are not 200lbs lateral resistant.

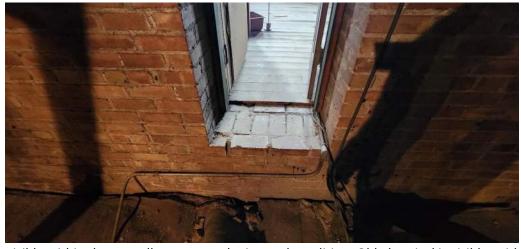
Brick visible within the catwalk appears to be in good condition. Old electrical is visible, with new conduit having been installed for attic access lighting.

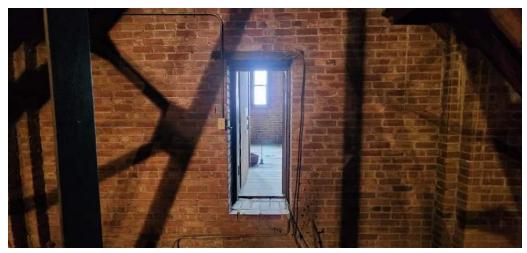
Brick visible within the catwalk appears to be in good condition. Old electrical is visible, with new conduit having been installed for attic access lighting.

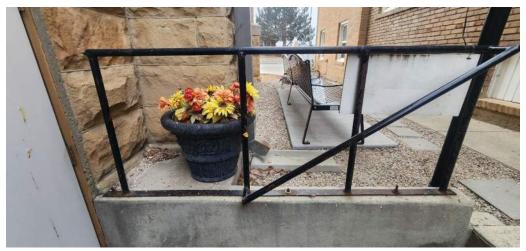
The stair from the basement meets necessary egress widths as it is used for loading/unloading as well. Handrails are present, however, do not have proper extensions. Code infraction, Chapter 10, 2024 IBC.

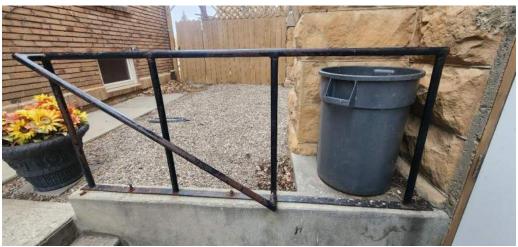
Handrails are present, however, do not have proper extensions.

This is a code infraction, Chapter 10, 2024 IBC.

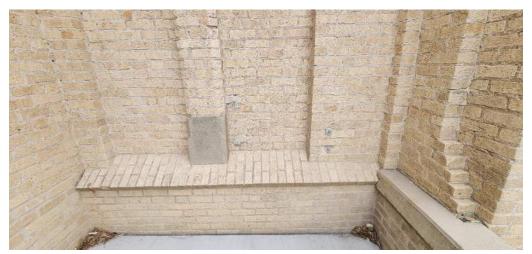
A new concrete topping was applied to the landing outside of the Sacristy. It previously did not drain, causing damage to the underside above the restroom below. Some bricks were punched through to allow drainage. Additional sealant and mortar repair should be performed to prevent further damage.

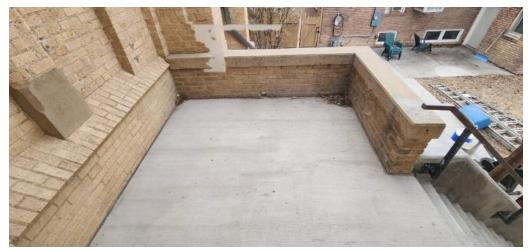
One handrail is present, a second could not be due to the disruption in plain as materials change.

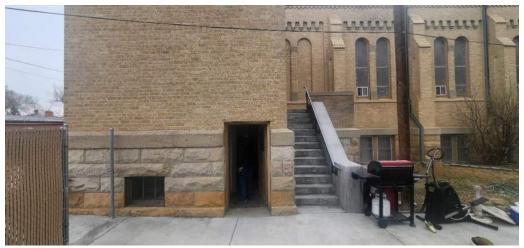
The brick parapet around the landing requires repointing of the mortar and a number of locations.

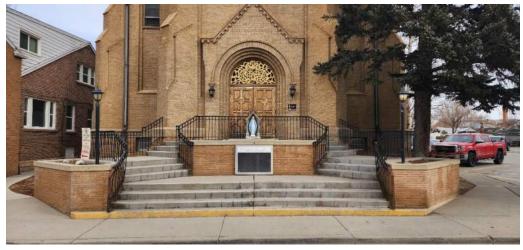
The stone base appears to be in good shape around the exterior.

Brick requires repointing at a number of locations.

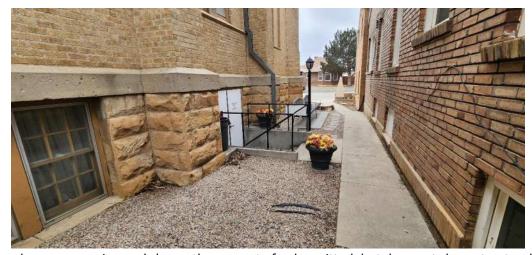
The stone base appears in good shape, the concrete fap has pitted, but does not show structural failure.

The brick as mentioned throughout, require repointing in a number of locations.

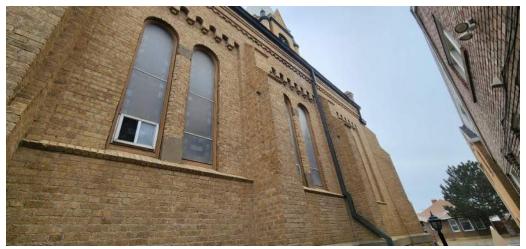
The stone base appears in good shape, the concrete fap has pitted, but does not show structural failure.

The brick as mentioned throughout, require repointing in a number of locations.

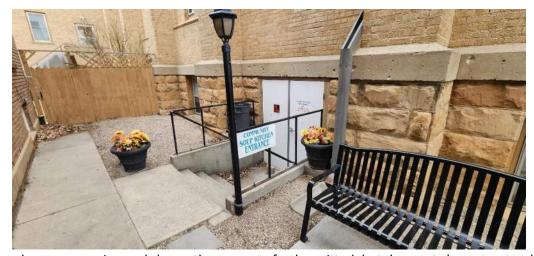
The stone base appears in good shape, the concrete fap has pitted, but does not show structural failure.

The brick as mentioned throughout, require repointing in a number of locations.

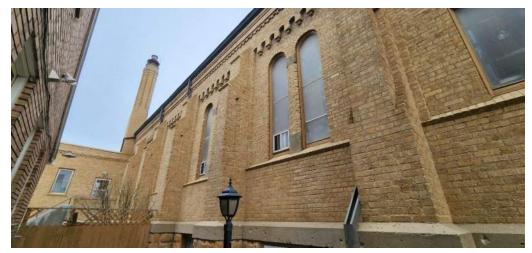
The stone base appears in good shape, the concrete fap has pitted, but does not show structural failure.

The brick as mentioned throughout, require repointing in a number of locations.

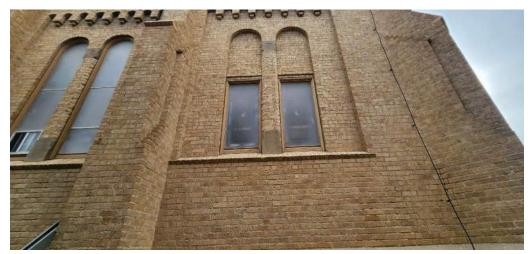
The original stain glass windows have had a storm glass system installed on the exterior to protect them. The system has retro-fit operable portions. The glazing system itself is not energy efficient and lacks compliance with modern codes. Brick requires repointing throughout.

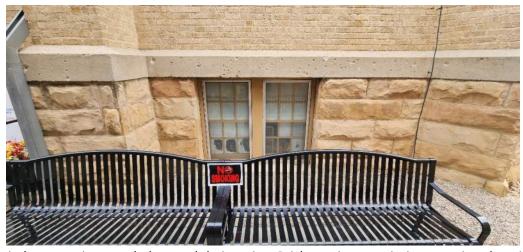
All windows require resealed around their casing. Brick requires repointing at various locations.

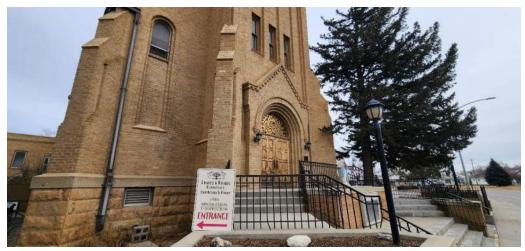
The main doors are stained and require refinishing. Brick requires repointing at various locations. Windows are not energy efficient. Staining is visible on various areas of brick.

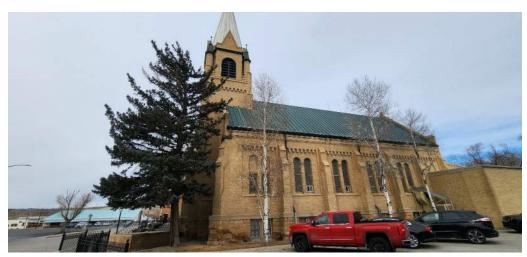
The existing metal roof system was installed circa 1990 based on available records. It was recoated within its warranty period. The coating shows signs of weathering, but does not show significant failure.

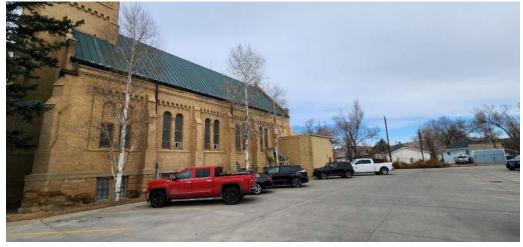
The existing metal roof system was installed circa 1990 based on available records. It was recoated within its warranty period. The coating shows signs of weathering, but does not show significant failure.

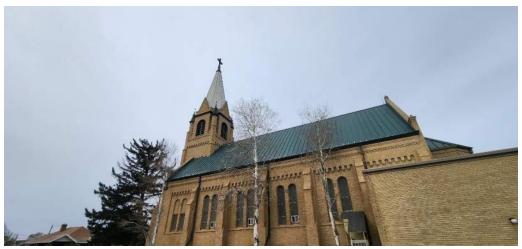
The existing metal roof system was installed circa 1990 based on available records. It was recoated within its warranty period. The coating shows signs of weathering, but does not show significant failure.

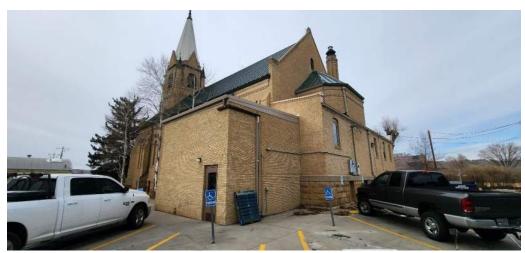
Roofing on the rear portions of the building is a single-ply. Date of install is unknown. No signs of failed performance were viewed. Gutters and downspouts are present and functioning to help manage runoff away from doors.

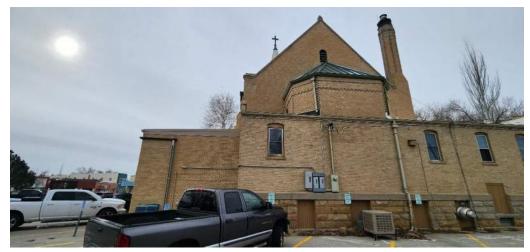
The electrical service has been upgraded, a number of surface mounted conduits are visible as a result.

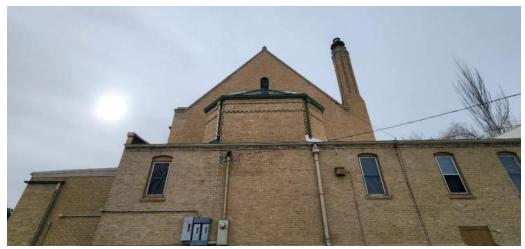
Roofing on the rear portions of the building is a single-ply. Date of install is unknown. No signs of failed performance were viewed. Gutters and downspouts are present and functioning to help manage runoff away from doors.

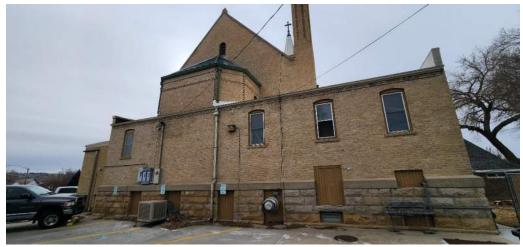
A swamp cooler is visible feeding the kitchen as well. There are no signs of make up air supplying the grease hood, signifying the hood does not comply with all required portions of the 2024 IMC.

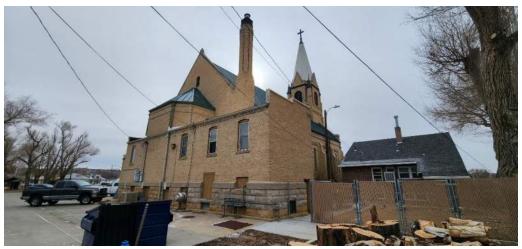
Brick requires repointing throughout at a number of locations. Due to the sporadic nature of failed mortar, it is noted that repointing is likely required on roughly no more than 15% of all brick.

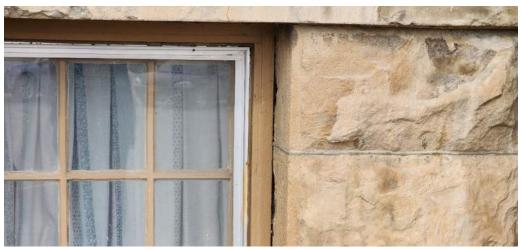
Exterior window casings show significant dry rot at the sills. Casings should be replaced, along with windows that meet the Historic Preservation requirements, as well as the requirements of the current International Energy Conservation Code.

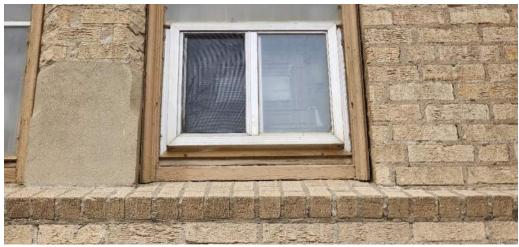
Casings are also not sealed, allowing moisture to infiltrate the sides of the casings, which creates additional damage to brick in areas not normally visible. Repointing in these cavities is likely required.

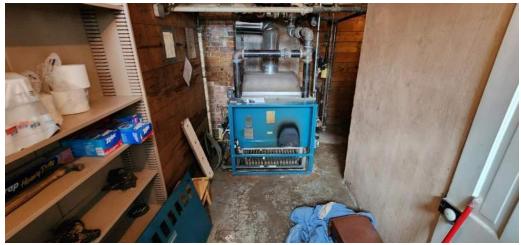
The existing boiler has failed and caught fire.

The unit is slated for replacement in the immediate future as it has impacted the heating of the Rectory.

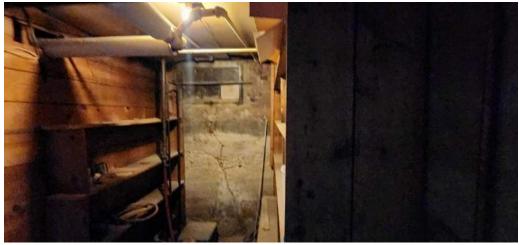
The rectory foundation is concrete below grade. There are several areas where old penetrations in the wall have suffered moisture infiltration and show damages. Movement does not appear excessive and repairs can be made to the visible fractures.

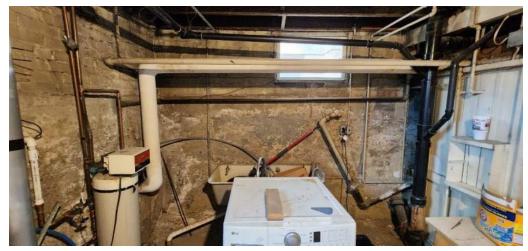
Though movement appears minimal, the amount of efflorescence visible on the concrete, indicates that moisture has been present for an extended period of time. Without exposing the foundation from the exterior, it is unclear to what degree damage has been done. Concrete is spalling and brittle.

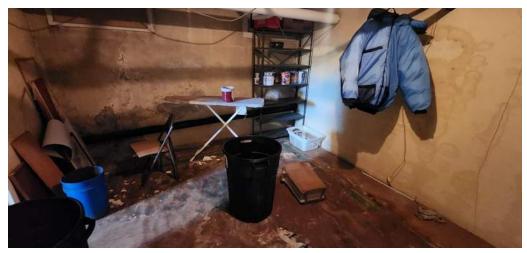
The basement is divided into several rooms for storage or other uses. Framed walls also show significant moisture staining.

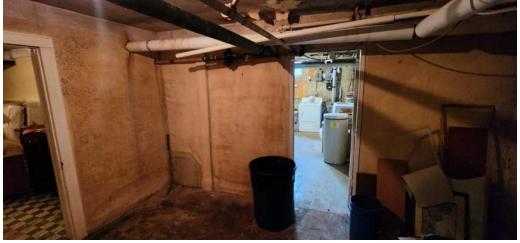
Various rooms have had repairs to ceilings or other patches made. Some rooms have flooring while others are painted or exposed concrete.

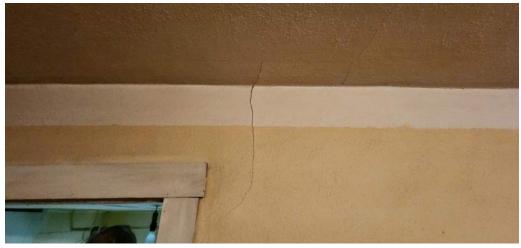
Cracks are not excessive and appear to have stopped. Assuming the foundation condition below grade is confirmed and repairs made to concrete, interior cracks could also be repaired.

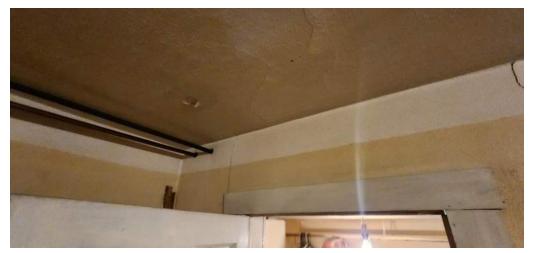
Cracks are not excessive and appear to have stopped. Assuming the foundation condition below grade is confirmed and repairs made to concrete, interior cracks could also be repaired.

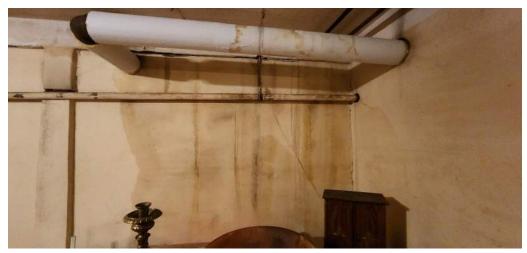
There is evidence of existing plumbing having leaked over time as well. Insulation is saturated at a number of locations and corrosion is visible on various pipe unions.

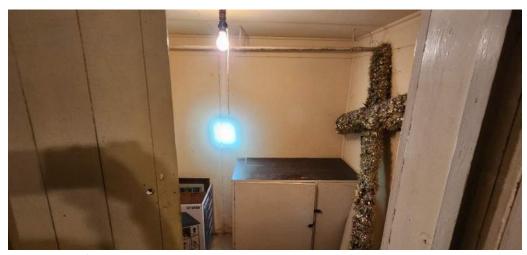
A storage room with framed walls, has moisture staining at the sill plates, indicating moisture has been present at the floor level for extended periods of time in the past.

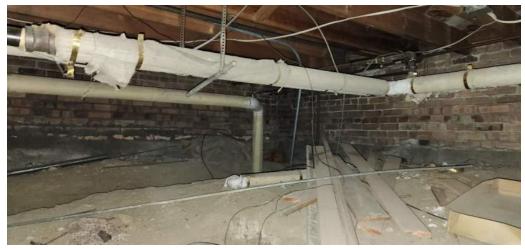
The basement turns to a crawlspace at the southern end of the original Rectory structure. Sections of insulation wrap are damaged on pipes, or missing at some locations.

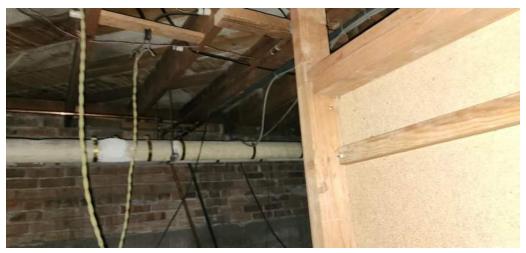
Insulation on plumbing has been patched at various locations. It is not confirmed, however, components of the insulation may contain asbestos.

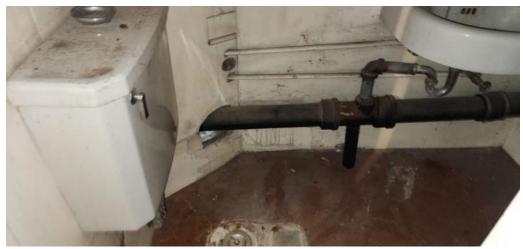
Partial plumbing fixtures remain where a toilet was removed. Only a rubber plug remains at the floor termination. It is unclear why the toilet was abandoned, however, deteriorated plumbing below the floor slab is likely the cause.

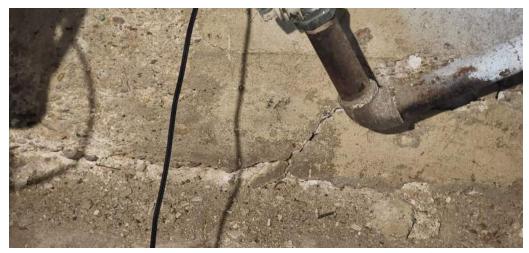
A closeup of the spalling and fractured concrete previously noted. At the floor/wall intersect, is where the concrete shows the most damage. This is the result of long-term moisture influence from leaks, as well as exterior below grade.

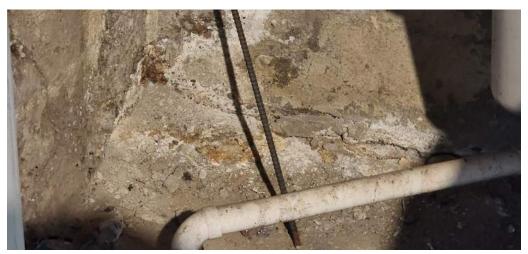
A second closeup of the spalling and fractured concrete previously noted.

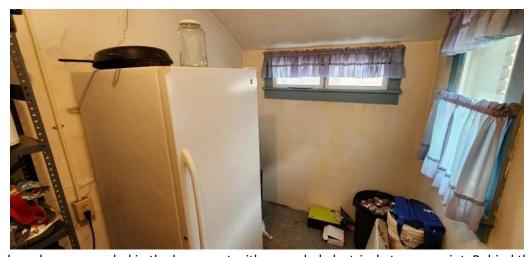
Utilities have been expanded in the basement with upgraded electrical at some point. Behind the fridge and as low as the outlet, more cracking and spalling in the wall are visible.

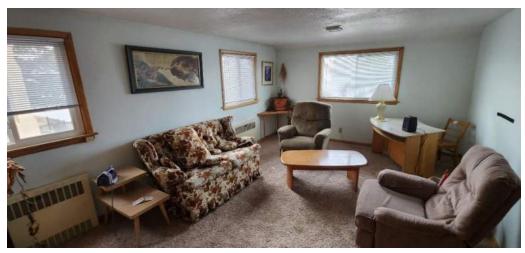
The rectory is multi-level and in fair condition.

Materials and utilities are dated and upgrades should be considered.

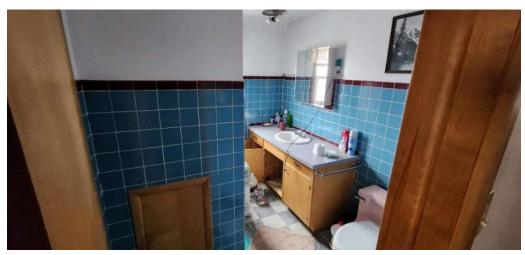
Wall tiling in the bathroom is in good condition. The flooring is aged. Fixtures are original.

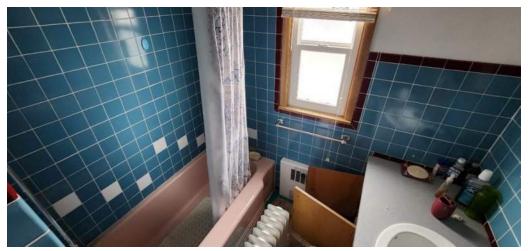
Wall tiling in the bathroom is in good condition. The flooring is aged. Fixtures are original.

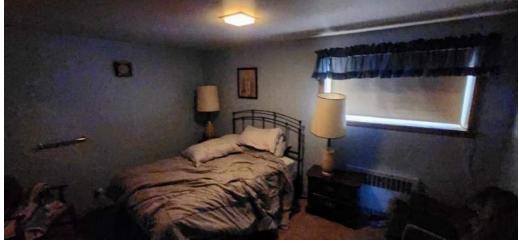
Sleeping rooms have all been painted different colors.

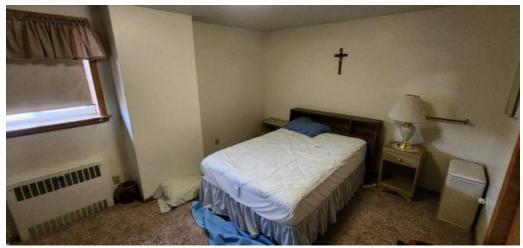
Sleeping rooms have all been painted different colors.

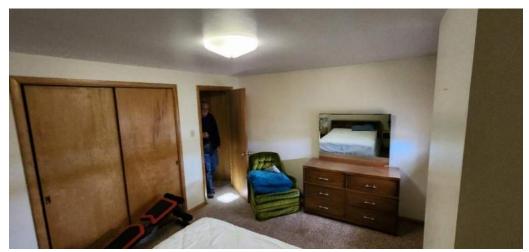
Sleeping rooms have all been painted different colors.

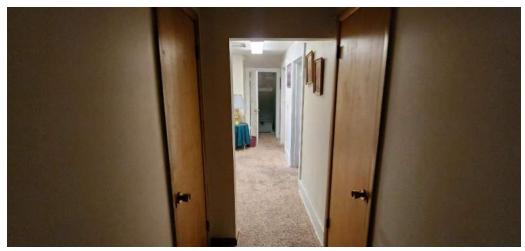
The hallway was constructed between the upper levels of the addition and the original Rectory.

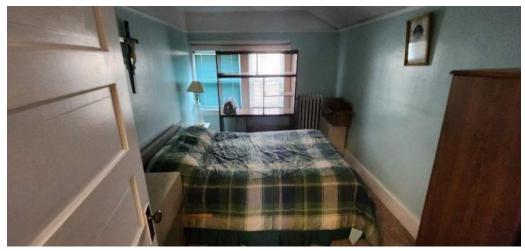
Doors throughout appear to all be original and in satisfactory condition.

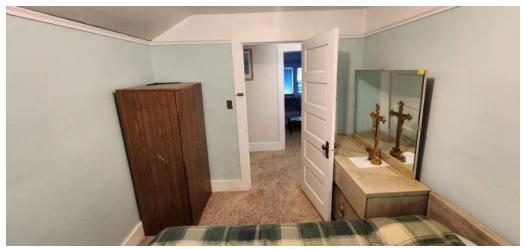
Doors throughout appear to all be original and in satisfactory condition. Sleeping rooms have all been painted different colors.

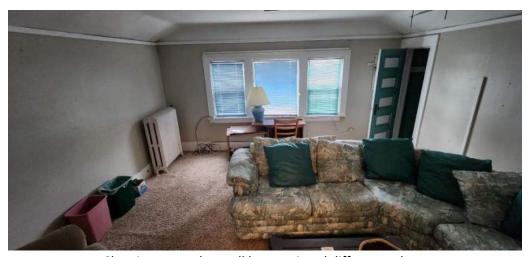
Sleeping rooms have all been painted different colors.

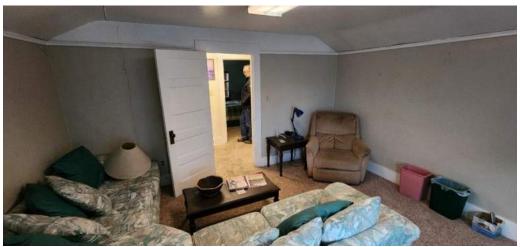
Sleeping rooms have all been painted different colors.

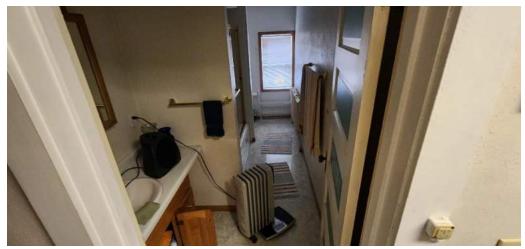
Lighting throughout is aged and should be upgraded throughout. Some signs of settling were visible in few walls of the upper level. Cracking does not show signs of continued growth and could be repaired.

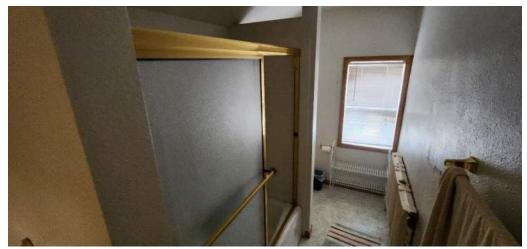
Bathroom is in decent overall condition. There are devices that have been abandoned and should be removed in their entirety. There is some cracking visible on walls.

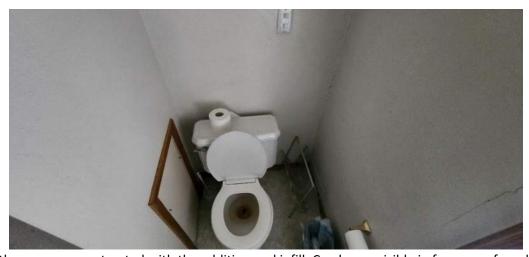
Finishes are dated, sheet flooring in the bathroom did not show significant signs of failure. Paint is peeling above the radiator and some signs of cracking are visible around the window. Finishes should be repaired.

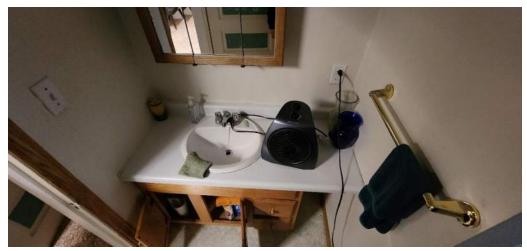
The bathroom was constructed with the addition and infill. Cracks are visible in few areas from building settling. There is no obvious evidence of continued growth in the cracks.

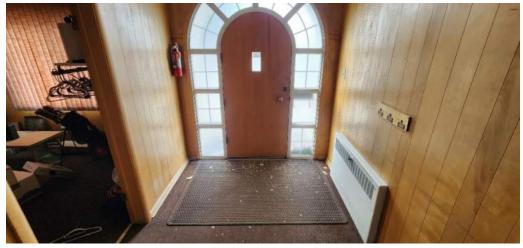
Heaters have been placed to assist in providing heat and preventing pipes from freezing.

Replacement of boiler required (as noted in Basement)

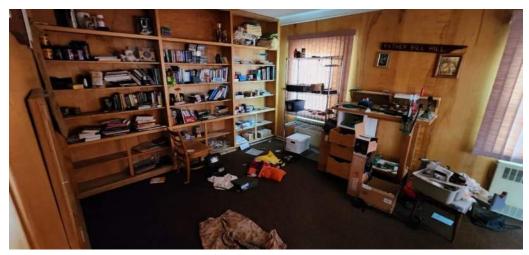
The offices within the Rectory have an older low-pile carpet. It does not appear to show significant failure, but does show wear in various areas.

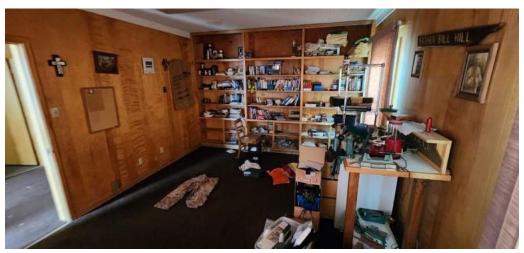
Built in furnishings remain in use.

Overall condition appears satisfactory as they remain occupied by books and other items.

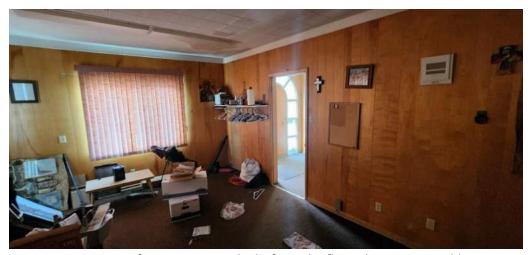
Built in furnishings remain in use.

Overall condition appears satisfactory as they remain occupied by books and other items.

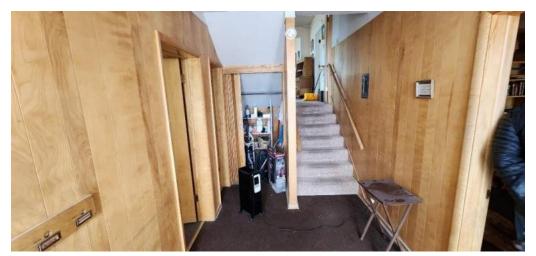
Some signs of previous water leaks from the floor above were visible.

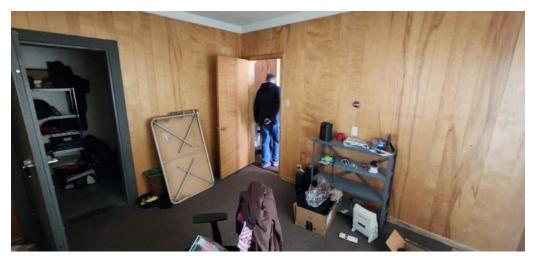
Finishes are aged but do not show significant failures or signs of potential failure.

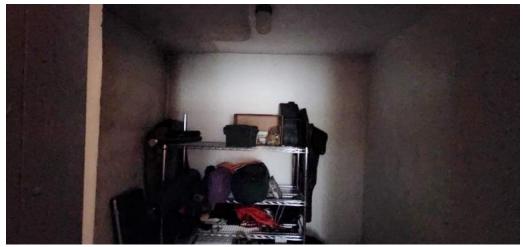
Finishes are aged but do not show significant failures or signs of potential failure.

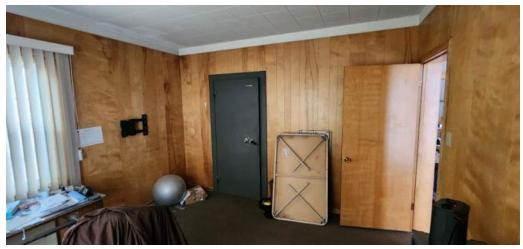
A vault room is present within one of the offices. The door is operational as indicated during our visit.

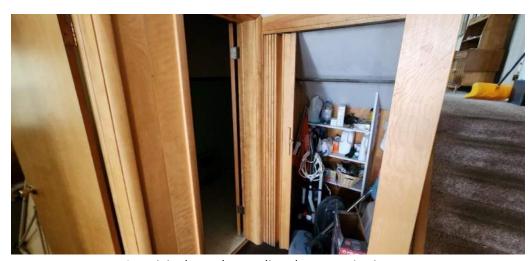
Finishes are aged but do not show significant failures or signs of potential failure.

There are signs of previous ceiling repairs made at the exterior wall.

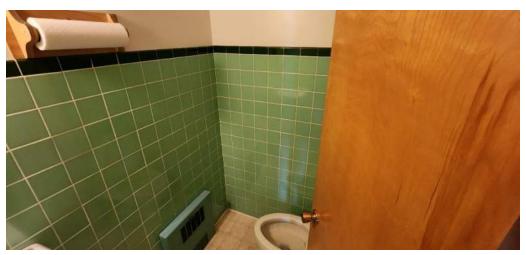
Wall tiling in the bathroom is in good condition. The flooring is aged. Fixtures are original.

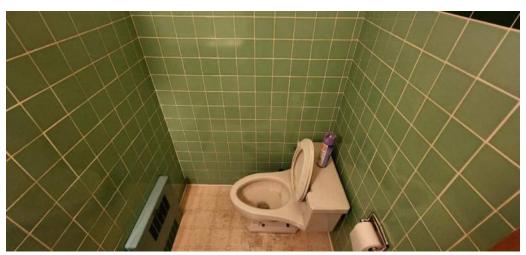
Wall tiling in the bathroom is in good condition. The flooring is aged. Fixtures are original.

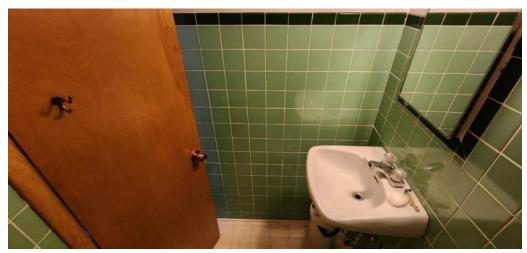
Wall tiling in the bathroom is in good condition. The flooring is aged. Fixtures are original.

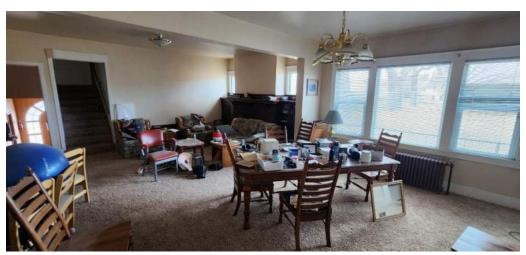
Due to the abondance of furnishings present, access to walls was limited. No significant damages were noted.

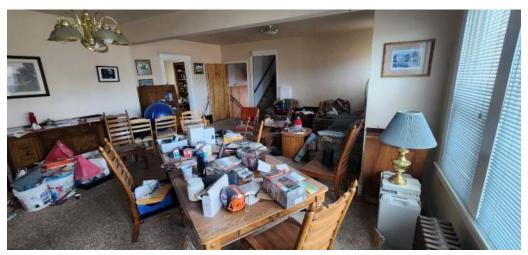
There were some casings around openings that have been altered.

Casings should be replaced to match original styles.

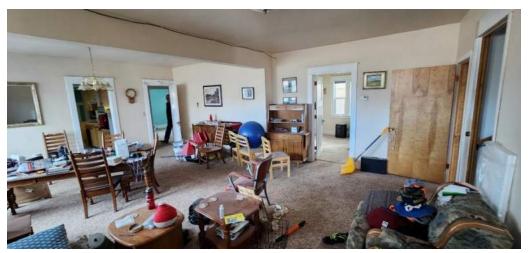
Due to the abondance of furnishings present, access to walls was limited. No significant damages were noted.

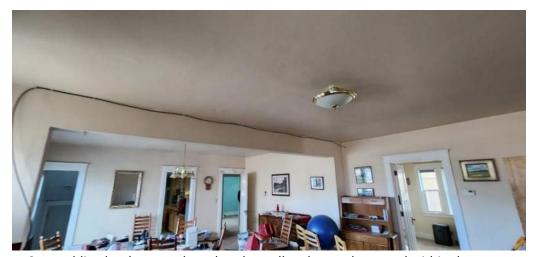
Some signs of carpet stretch were visible in different rooms. This could be resolved by re-stretching where occurs or replacing if desired.

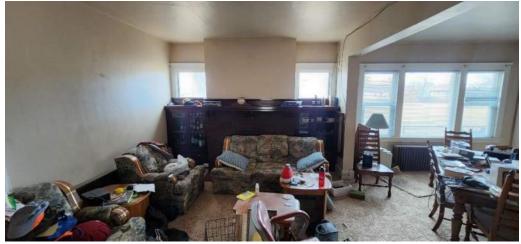
Coax cabling has been anchored to the wall and routed exposed within the room.

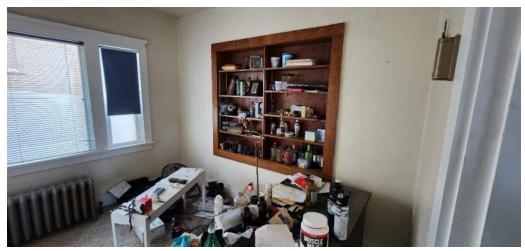
An old fireplace has been filled in, the mantle and casework around it remain.

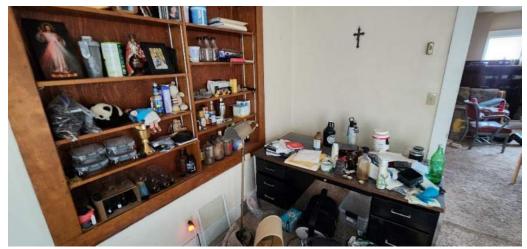
Various styles of window blinds are present in the windows.

Abandoned components of the call system exist throughout and should be removed or upgraded.

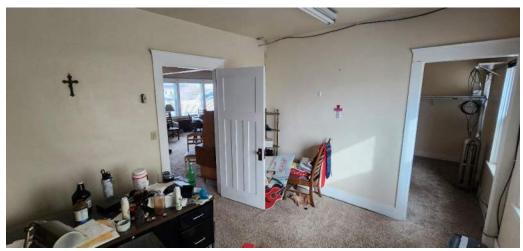
In wall cabinets remain in use.

Basic wear is visible throughout due to the previous occupancy of the Rectory.

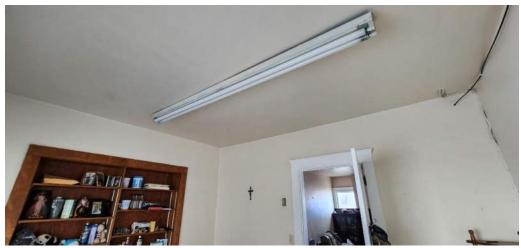
Lighting is aged and should be replaced/upgraded.

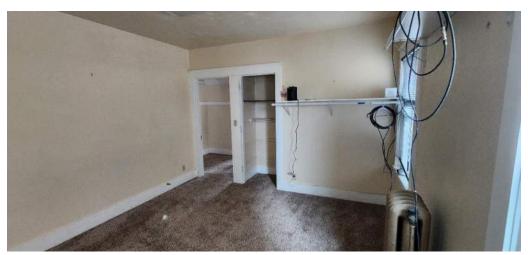
Usual wear from occupancy is visible. Walls require some touch up or patching of small holes.

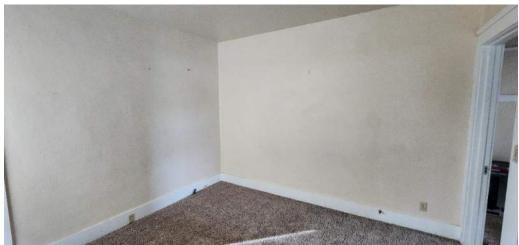
Usual wear from occupancy is visible.
Walls require some touch up or patching of small holes.

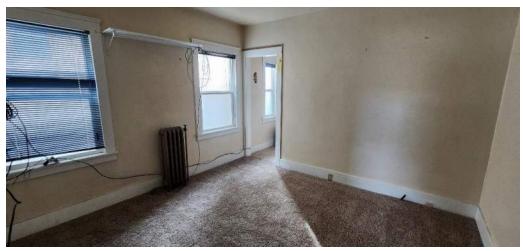
Usual wear from occupancy is visible. Walls require some touch up or patching of small holes.

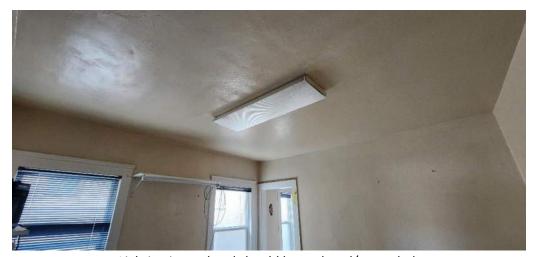
Lighting is aged and should be replaced/upgraded.

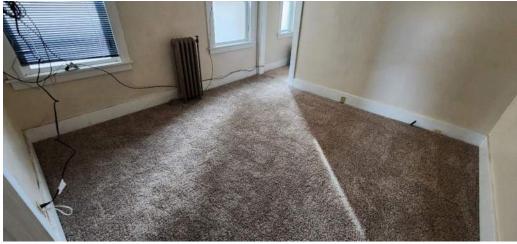
Carpet was clean and taut.

An outlet has been added in the baseboard, inconsistent with other outlets in the room.

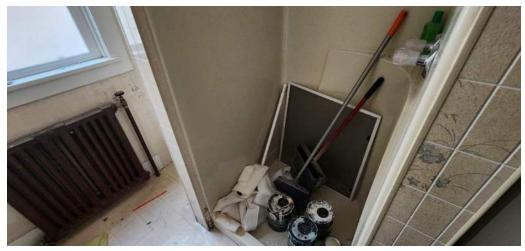
Bathroom has FRP instead of tiling.

The FRP is dated and various termination/transition strips are showing signs of failure.

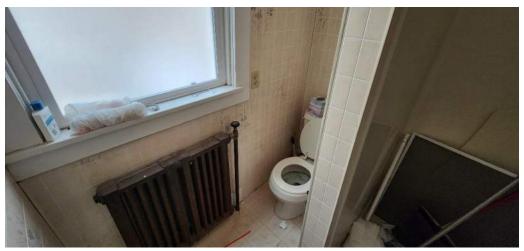
Flooring and fixtures are aged and show wear. Replacement/upgrade should be considered.

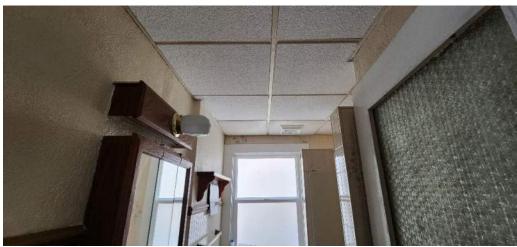
Lighting and fixtures are aged and should be upgraded/replaced.

Suspended ceilings in a bathroom require a hardened or scrubbable surface, tiles should be replaced.

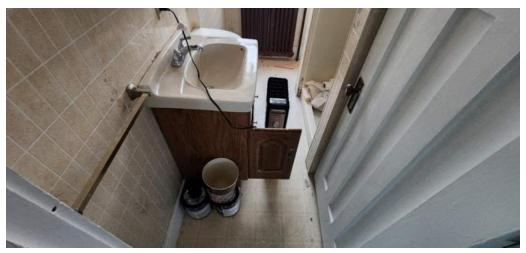
Flooring and fixtures are aged and show wear. Replacement/upgrade should be considered.

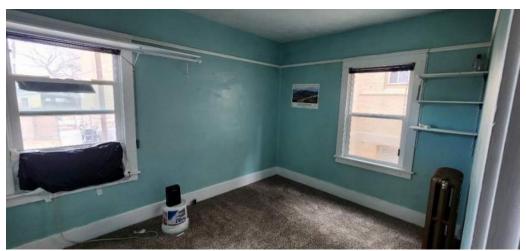
A window AC unit was present in one room and should be removed through winter.

Usual wear from occupancy is visible.

Walls require some touch up or patching of small holes.

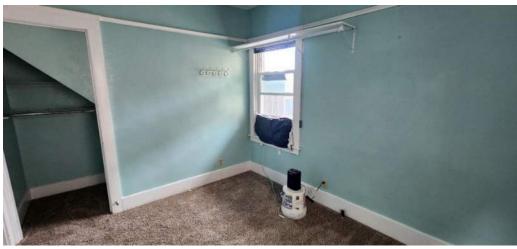
Usual wear from occupancy is visible. Walls require some touch up or patching of small holes.

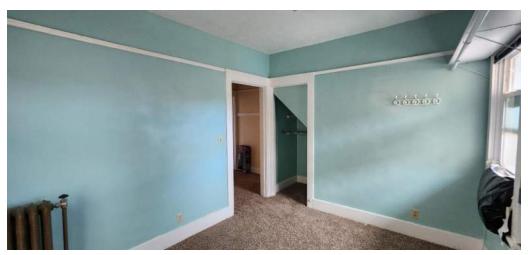
Usual wear from occupancy is visible. Walls require some touch up or patching of small holes.

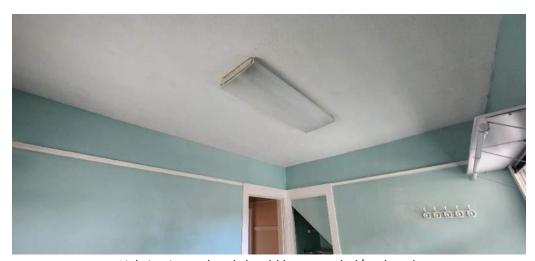
Lighting is aged and should be upgraded/replaced.

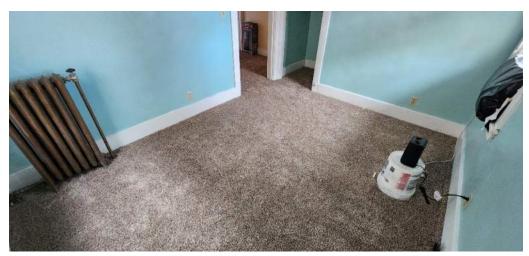
Carpet was clean and taut. No flooring concerns noted.

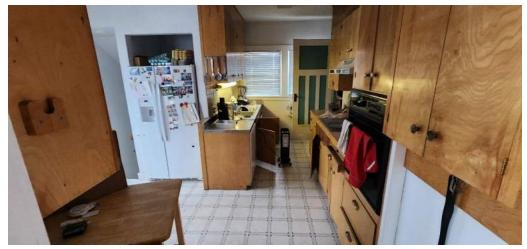
Kitchen is original, cabinets doors were all operable, however drawers show signs of wear. Modernization of the kitchen is recommended. Flooring is aged and shows wear.

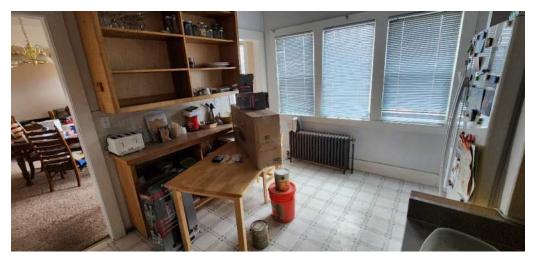
Kitchen is original, cabinets doors were all operable, however drawers show signs of wear. Modernization of the kitchen is recommended. Flooring is aged and shows wear.

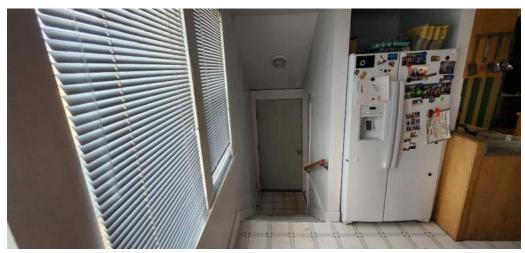
Flooring in the kitchen shows wear.

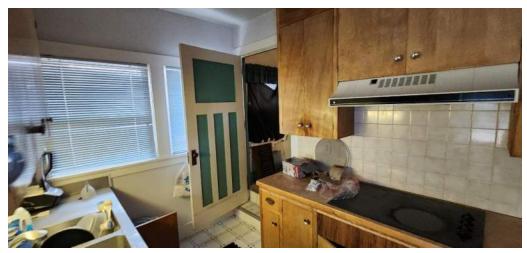
The kitchen has a split stair entry from stairway to the upper level. One stair remains visible on the kitchen side when closed, which is a hazard and not compliant with current codes.

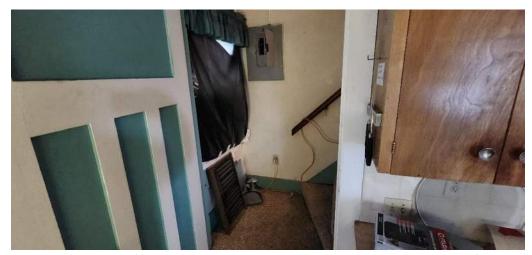
It is evident the stairs were framed however possible to provide entry to the kitchen from the rooms above. Aside from the door and stair overlap, a single angled stair is present at the landing.

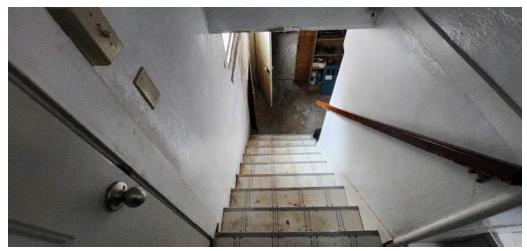
Flooring to the basement is significantly worn and should be replaced.

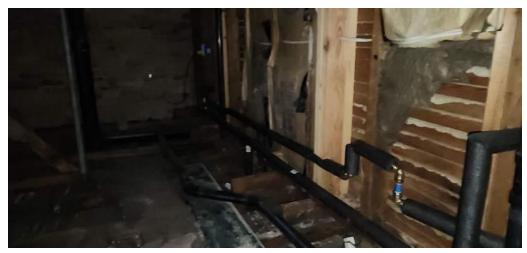
Where infill between the original Rectory and its later addition exists, an uninsulated attic space exists. The space also lacks ventilation required by current building codes. Plumbing within is limited but not well protected. The area should have insulation and code compliant ventilation added.

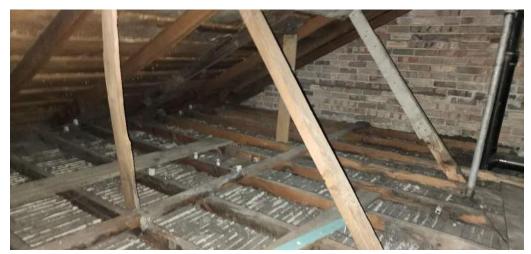
Where infill between the original Rectory and its later addition exists, an uninsulated attic space exists. The space also lacks ventilation required by current building codes. Plumbing within is limited but not well protected. The area should have insulation and code compliant ventilation added.

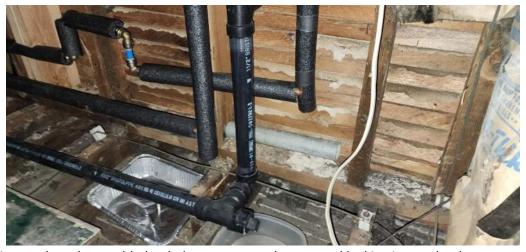
Drain pans have been added to help manage condensate and leaking issues that have occurred.

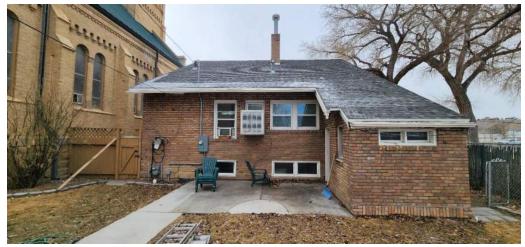
The original rectory is a red brick and is showing age. The mortar is weathered significantly.

Sill brick along several windows is excessively deteriorated as well.

The shingles have been upgraded in the past, no concern of roof failure noted.

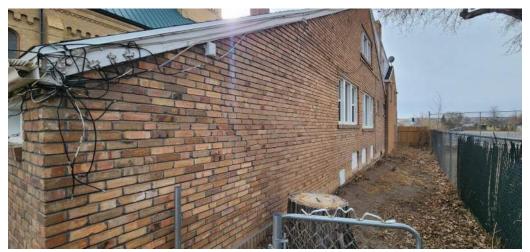
There are a number of settling cracks within the masonry that have gone without repair.

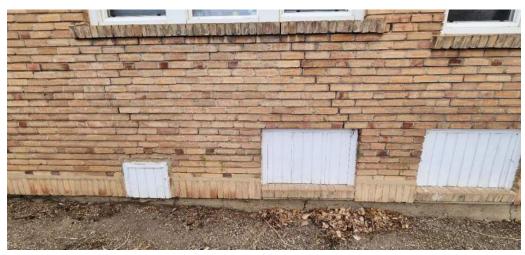
Various windows have been filled in at the top of foundation. These are the locations where more moisture damage is present within the basement. Movement can be seen in the mortar lines as well.

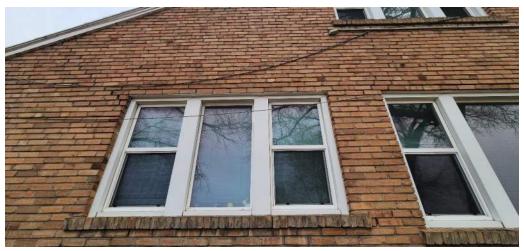
Windows have been retrofit with dual-pane vinyl and cased with aluminum trims.

Sill brick at several locations is broken or deteriorated.

Sealant needs replaced at various locations as well.

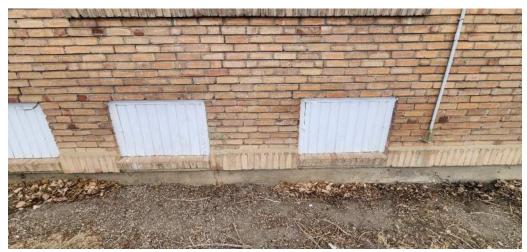
Various windows have been filled in at the top of foundation. These are the locations where more moisture damage is present within the basement. Movement can be seen in the mortar lines as well. At these locations, there is concrete pitting and signs of wear visible above the grade line as well.

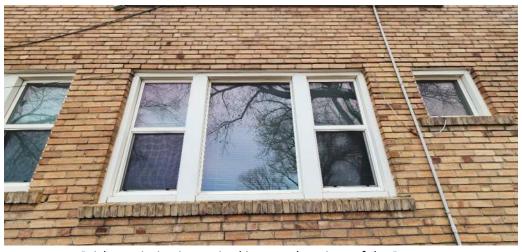
Brick repointing is required in many locations of the Rectory.

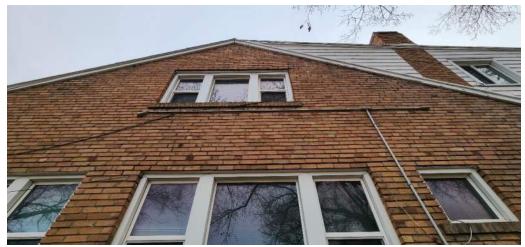
Windows do not stack with parallel jambs, witch makes brick prone to movement from floor to floor. Larger mortar gaps are visible between the left hand jambs of the center and upper window.

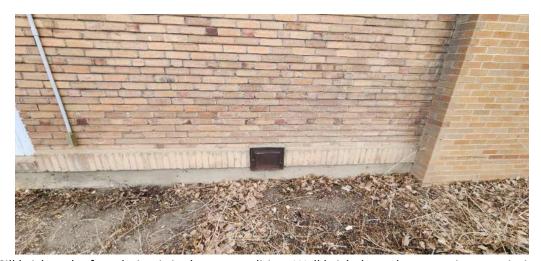
Sill brick at the foundation is in decent condition. Wall brick throughout requires repointing.

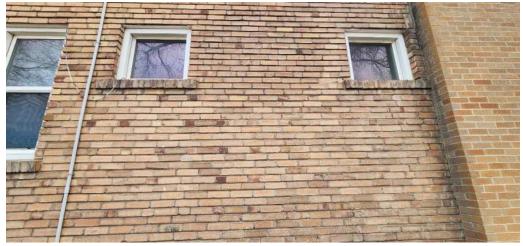
Windows have been upgraded and flashed. The joint between the original Rectory and its addition does not have a control joint, brick is butted together. This should have a flexible joint with sealant.

Several bricks show significant moisture damage and staining at this joint.

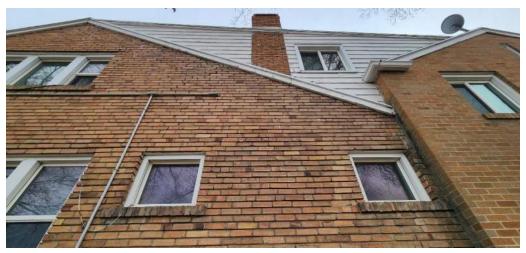
The addition was infilled with a second floor between at the roof level.

The exterior wall suffers a break in continuity where the chimney remains.

Wood siding requires repainting and resealing around windows.

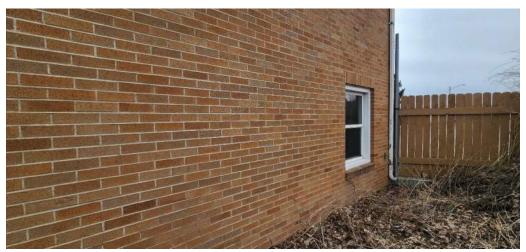
Brick at the Rectory addition is in good condition.

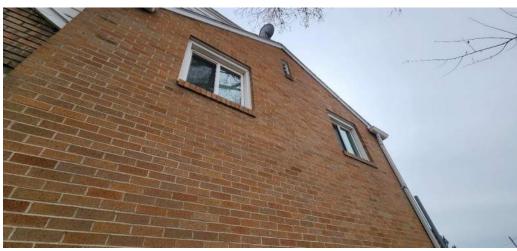
Windows on both portions of the Rectory are the same. Seals/flashings one newer portion are in better condition than that of the old.

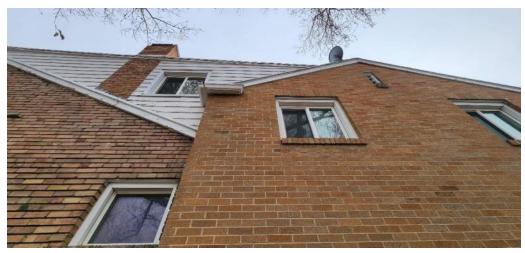
The view of the infill construction above. This also creates a conduit for moisture runoff where all three systems tie together, accelerating the wear on the brick and materials below.

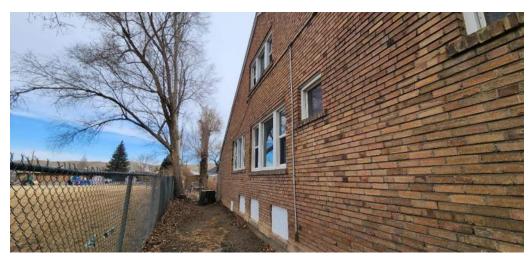
Repointing of the brick is necessary on the original Rectory. Where some bricks are excessively worn or damaged, replacement of similar type should be considered.

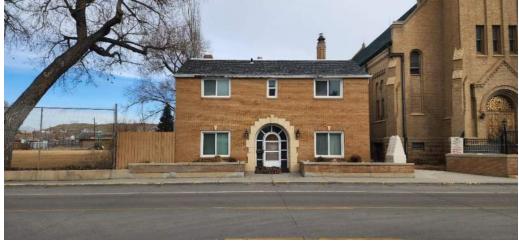
Some settling has occurred at the front, brick repointing and repair is necessary. The finish on the gutters is also failing and peeling. Gutters should be replaced with new.

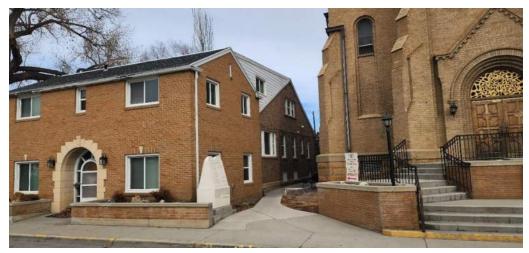
The space between the Rectory and Church is small and allows for moisture runoff of both buildings, and the ground area, to accumulate.

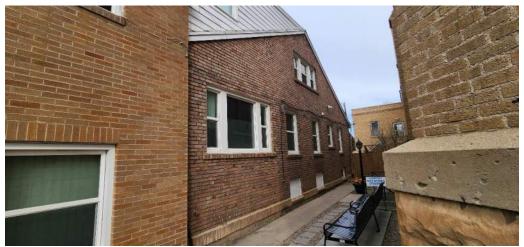
The view of the infill construction above. This also creates a conduit for moisture runoff where all three systems tie together, accelerating the wear on the brick and materials below.

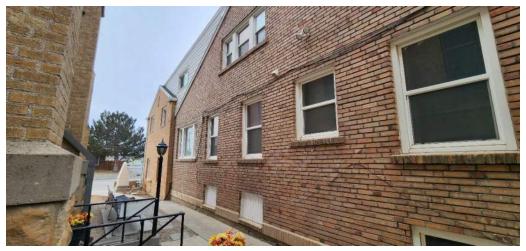
Utilities can be seen anchored to the façade of the Rectory.

There is a sidewalk along the foundation, and a permeable surface next to that.

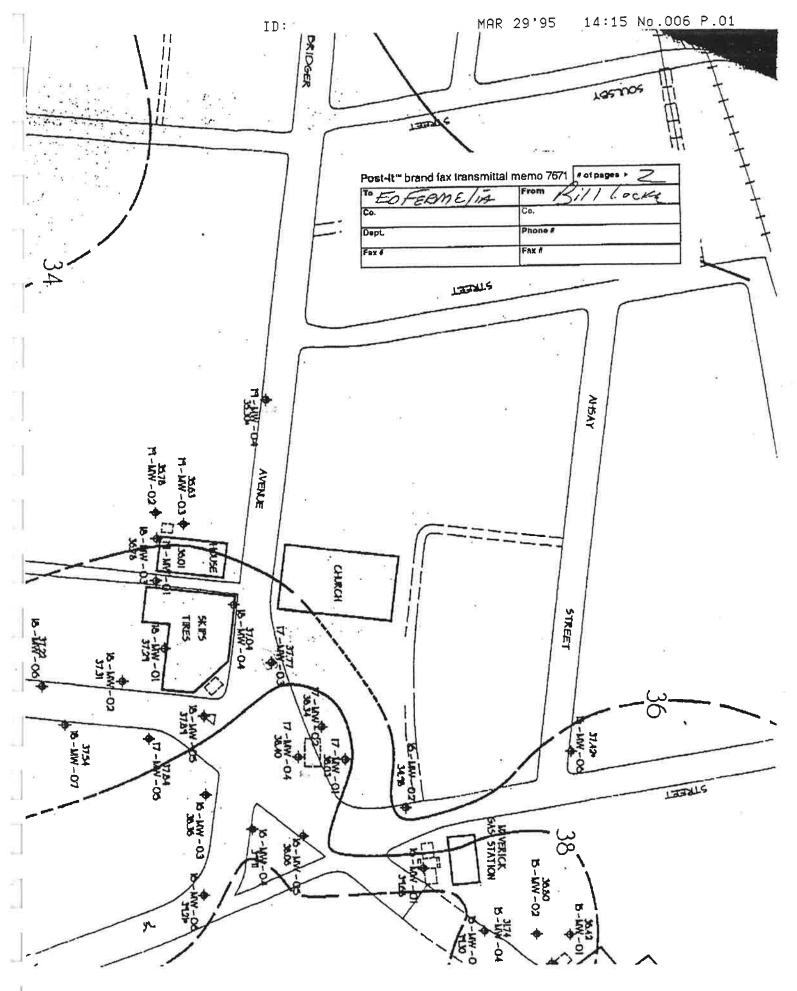
FIGURE 1

Water levels were studied for four monitor wells located within the immediate area of the Church. Figure 1 indicates the locations of the wells along Pilot Butte. Three of the wells are to the east of the Church and the other is to the west. Water levels in the wells were measured during August of 1992, October of 1992 and recently during April of 1995.

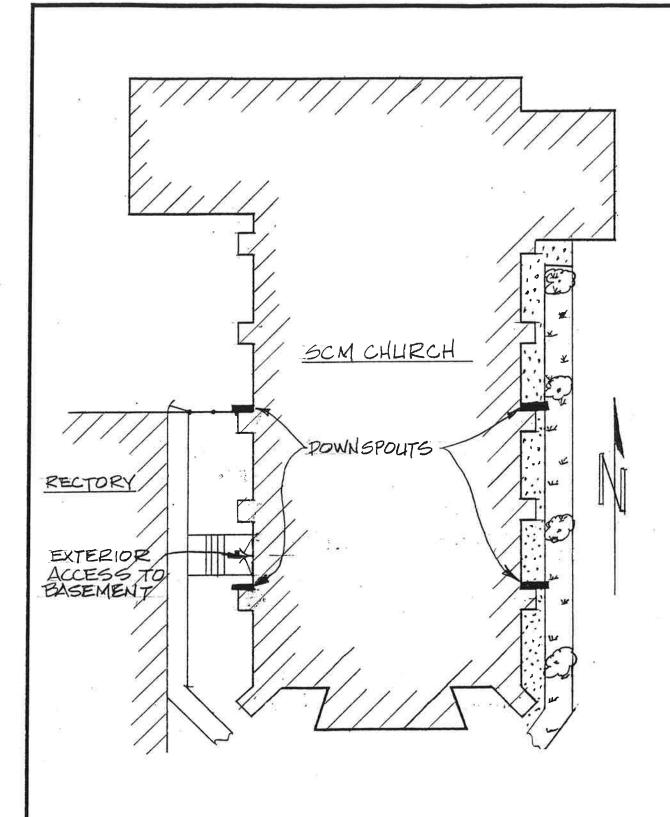
FIGURE 2

A metal roof has been installed on the Church with gutters and downspouts. Two downspouts discharge near the building on the east and west sides. The area surrounding the Church is flat with no positive drainage away from it. The drainage from the roof tends to concentrate along the east and west walls before it flows away from the building. This situation causes the water to percolate into the subsurface soils and increase the percentage of moisture in these soils. (See Figure 2)

BAI recommends that prior to replacing the floor, measures are taken to protect the new floor from contact with moisture. This may be accomplished by installing a vapor barrier such as a polyethylene sheeting (Visqueen) between the subbase and the floor. BAI also recommends that moisture be drained well away from the building foundations. This may be accomplished by rerouting the outside drain pipes so that moisture is carried away from the building. Further, the site should be graded to drain away from foundations. A minimum surface drainage gradient of two percent is recommended.
