Holy Spirit Catholic Community Saint Cyril and Methodius Church & Rectory Evaluations

633 Bridger Ave, Rock Springs, WY 82901 March 24, 2025

Re: Saint Cyril and Methodius: Church and Rectory Study

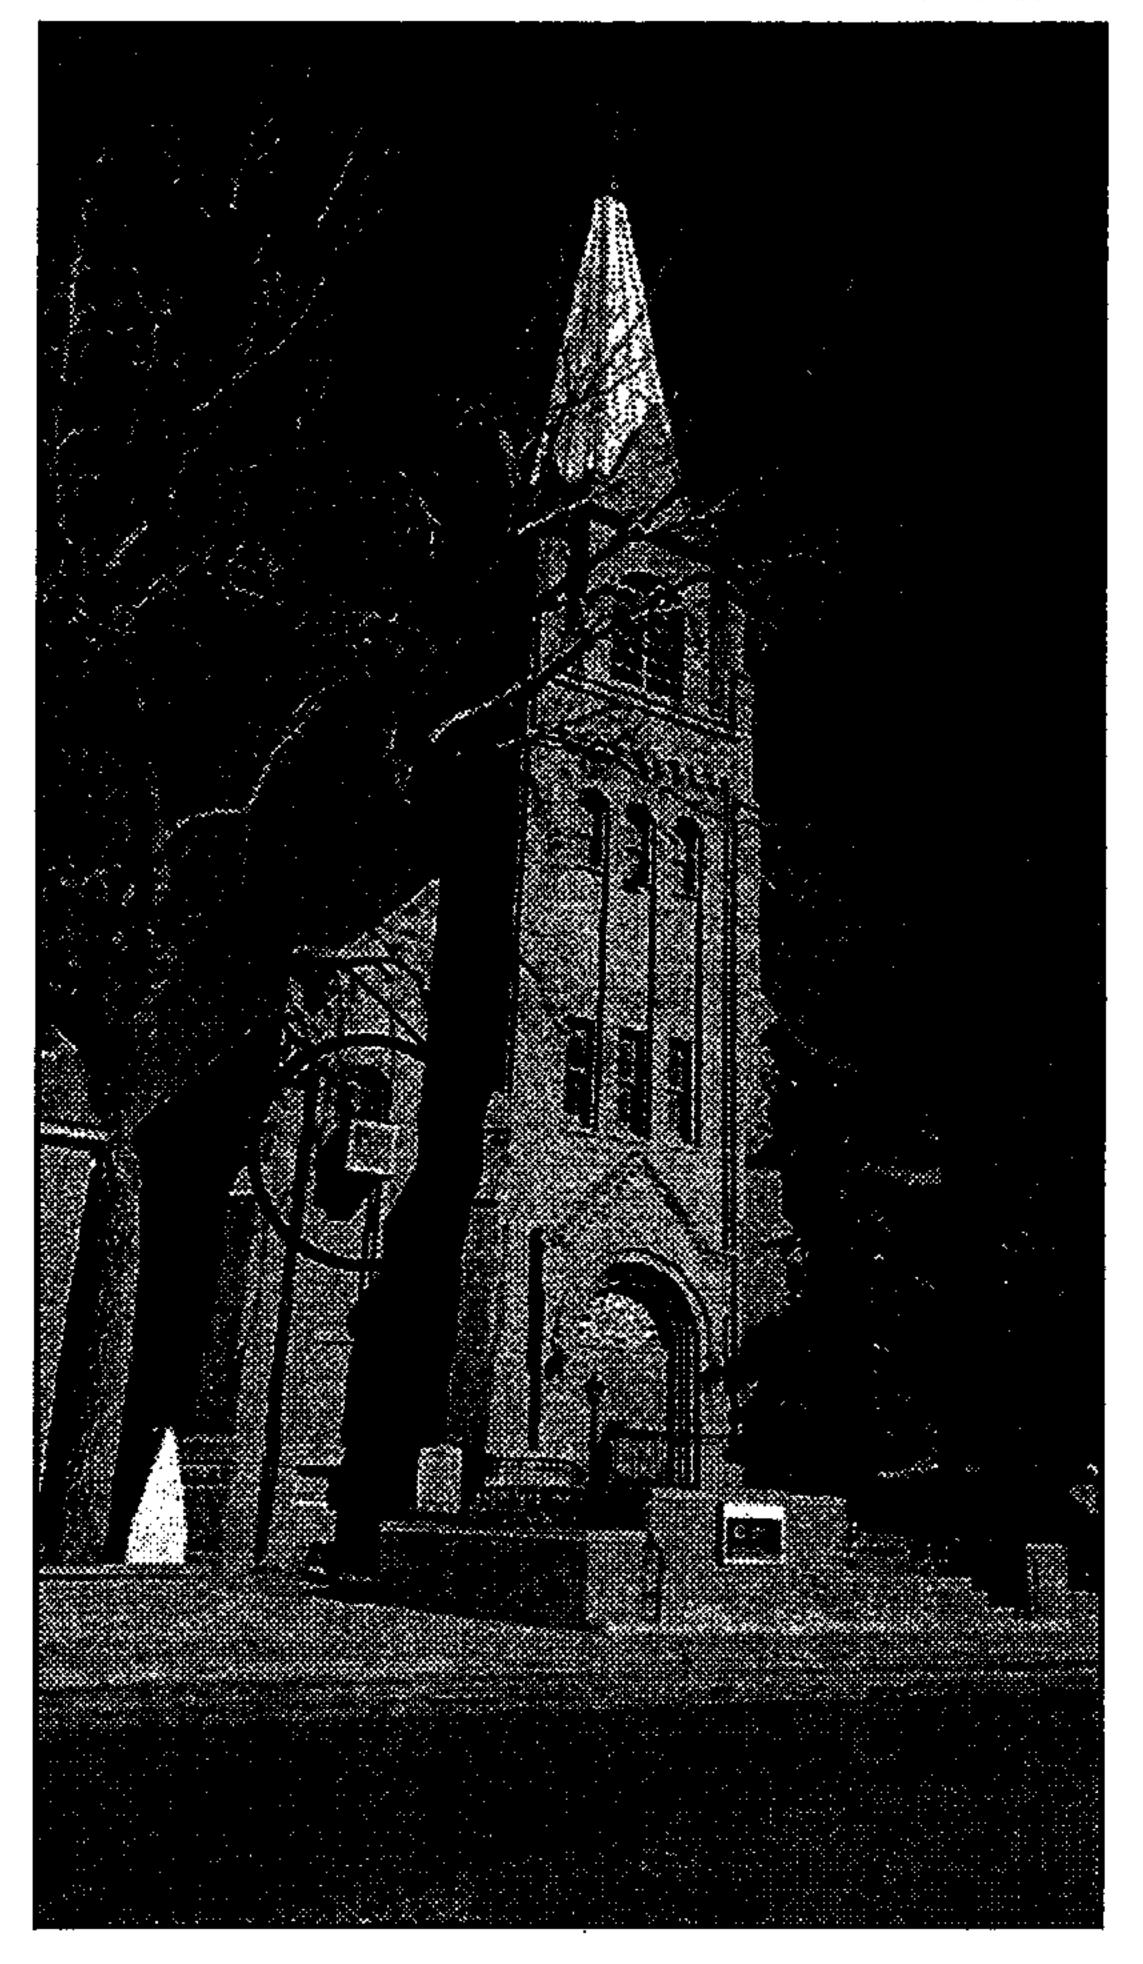
Note: Swamp cooler on front façade.

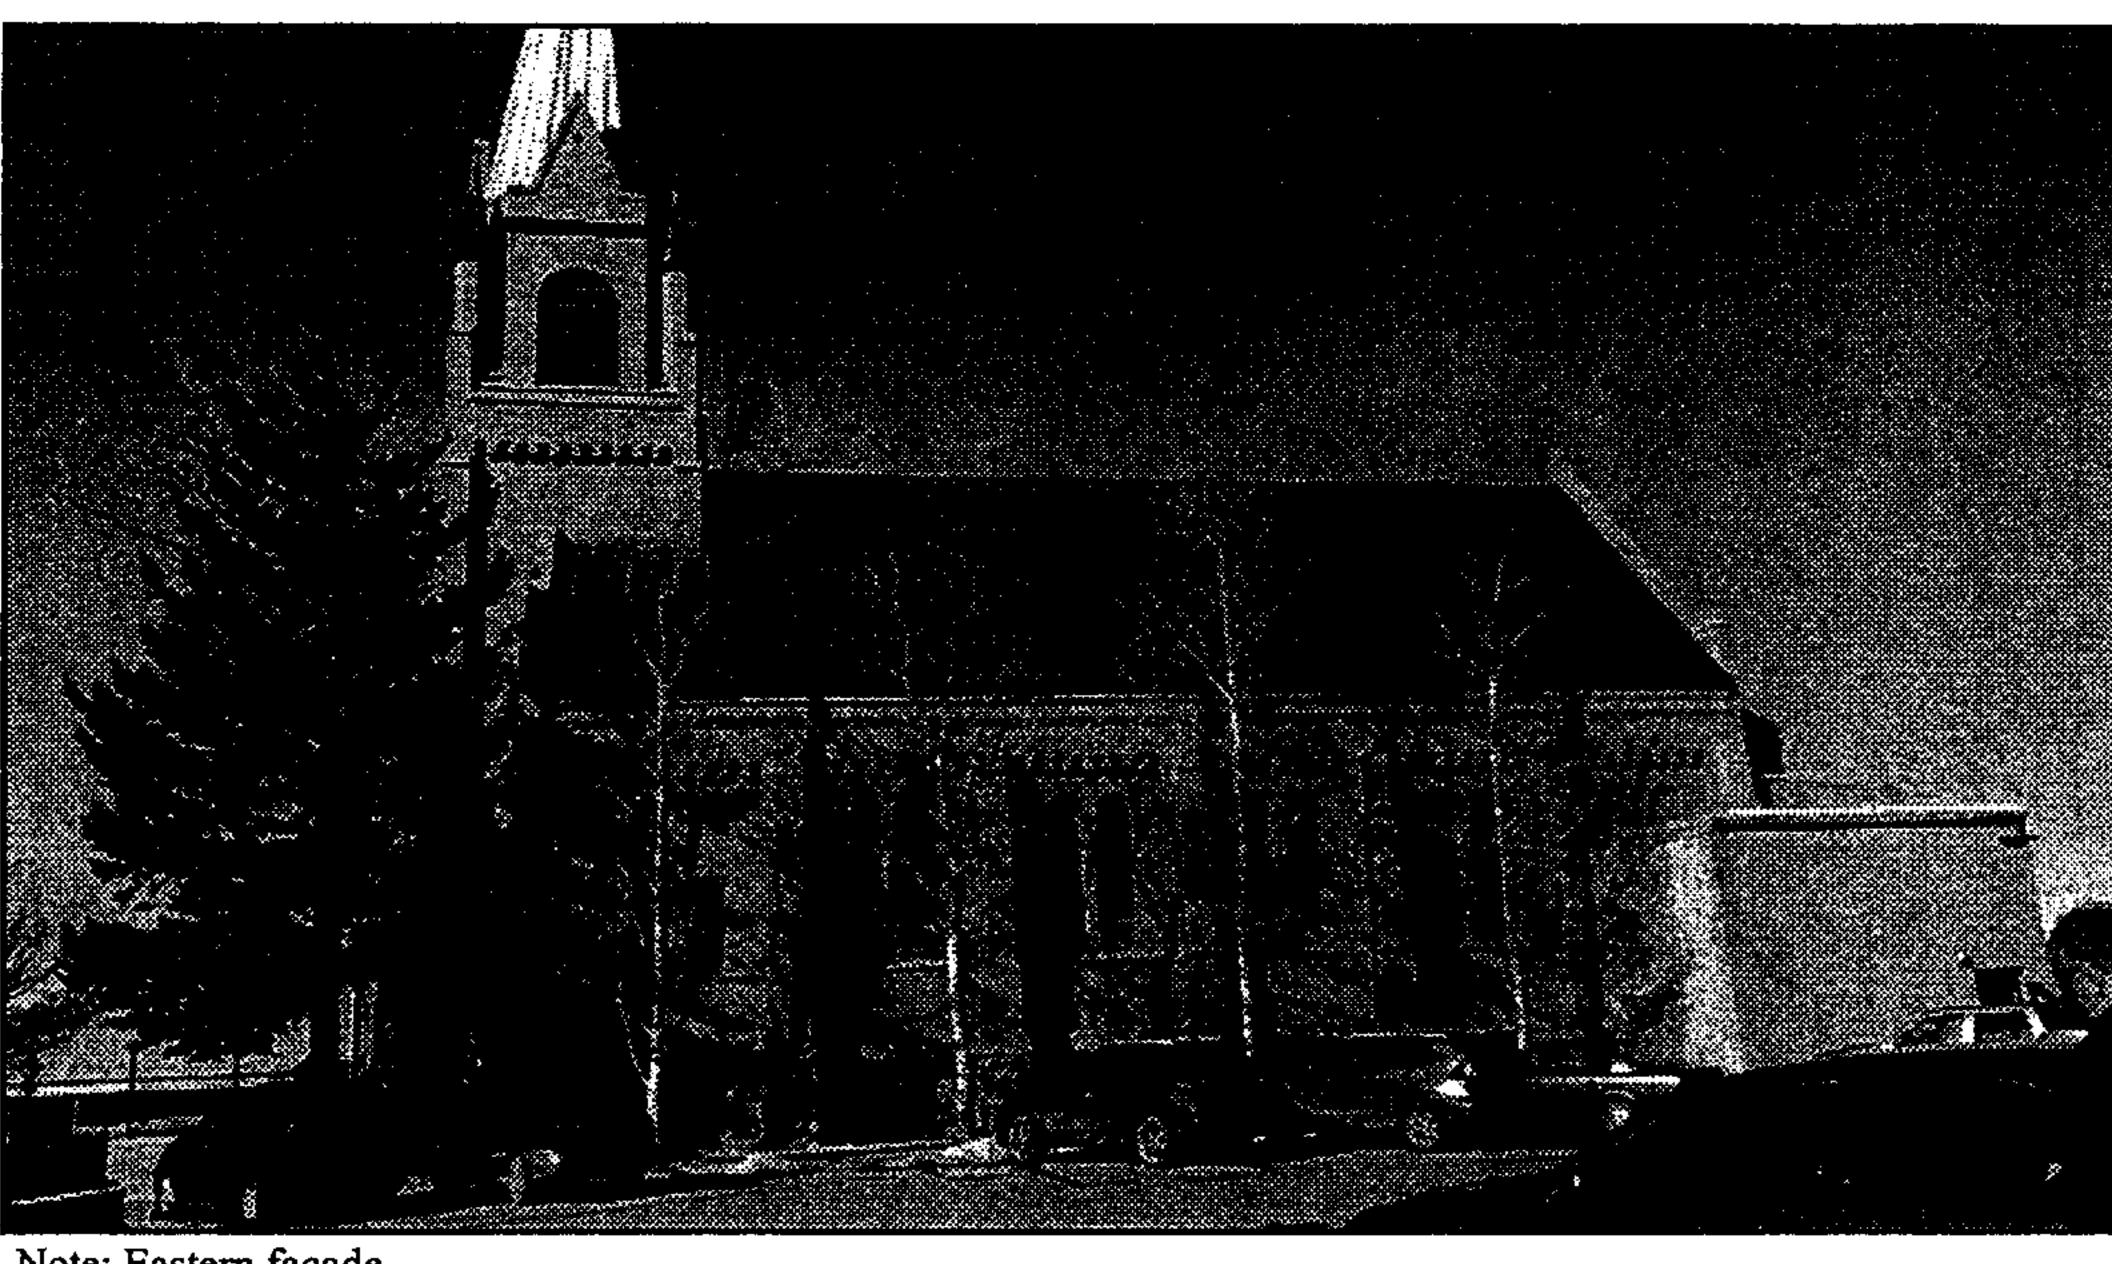
Note: Eastern façade.

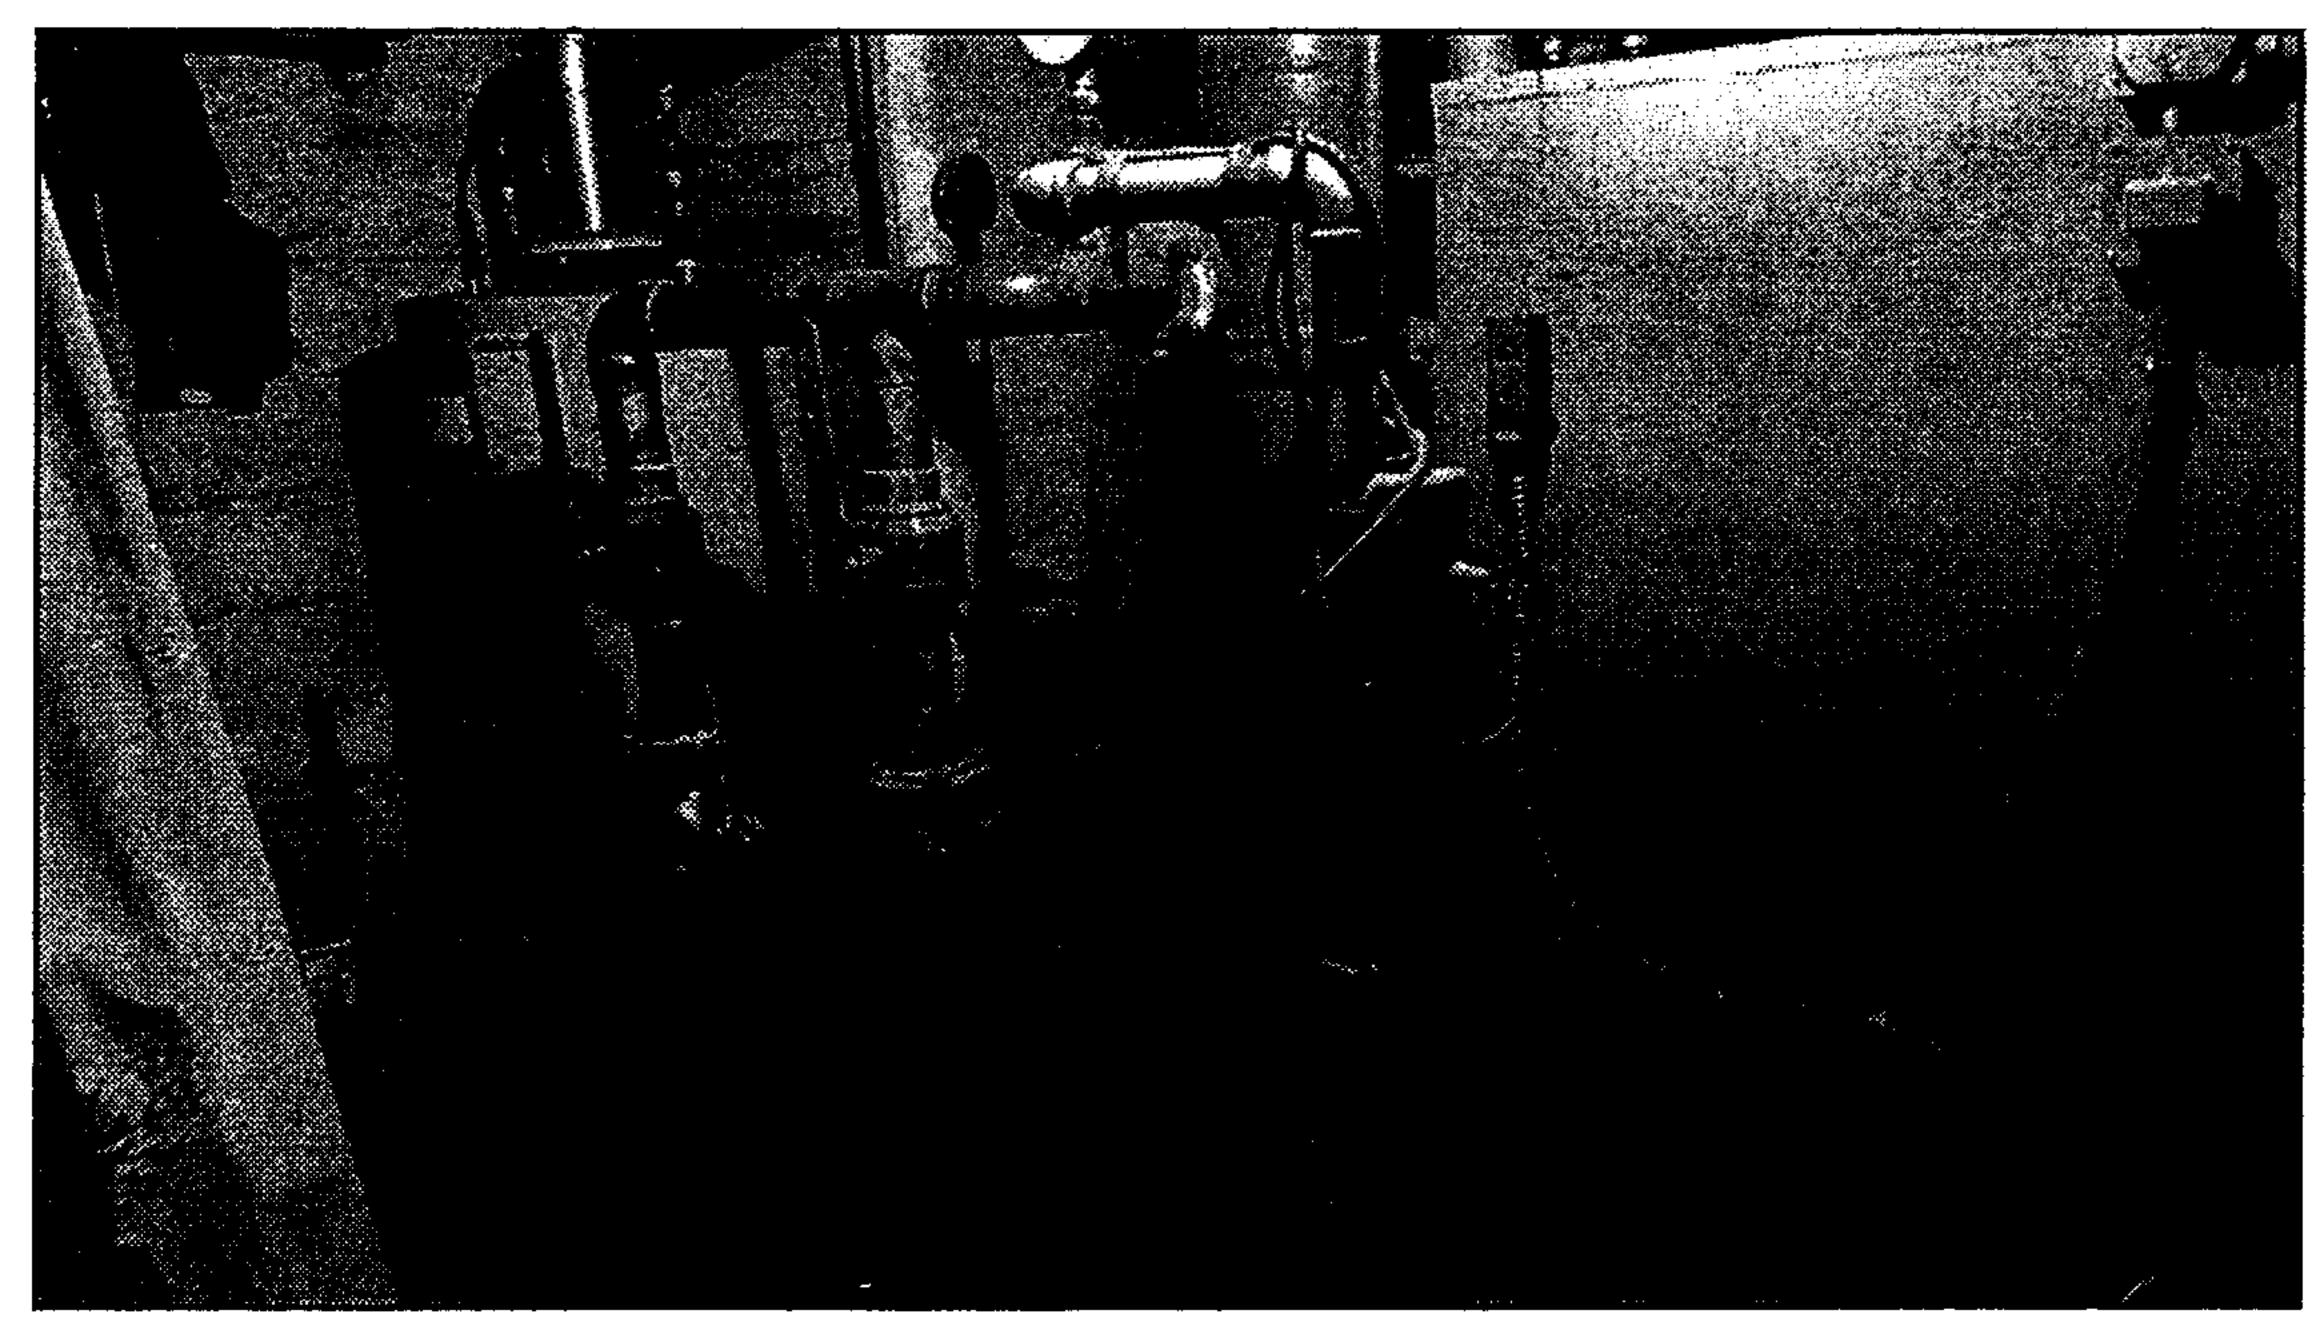
Note: Gas fired boiler

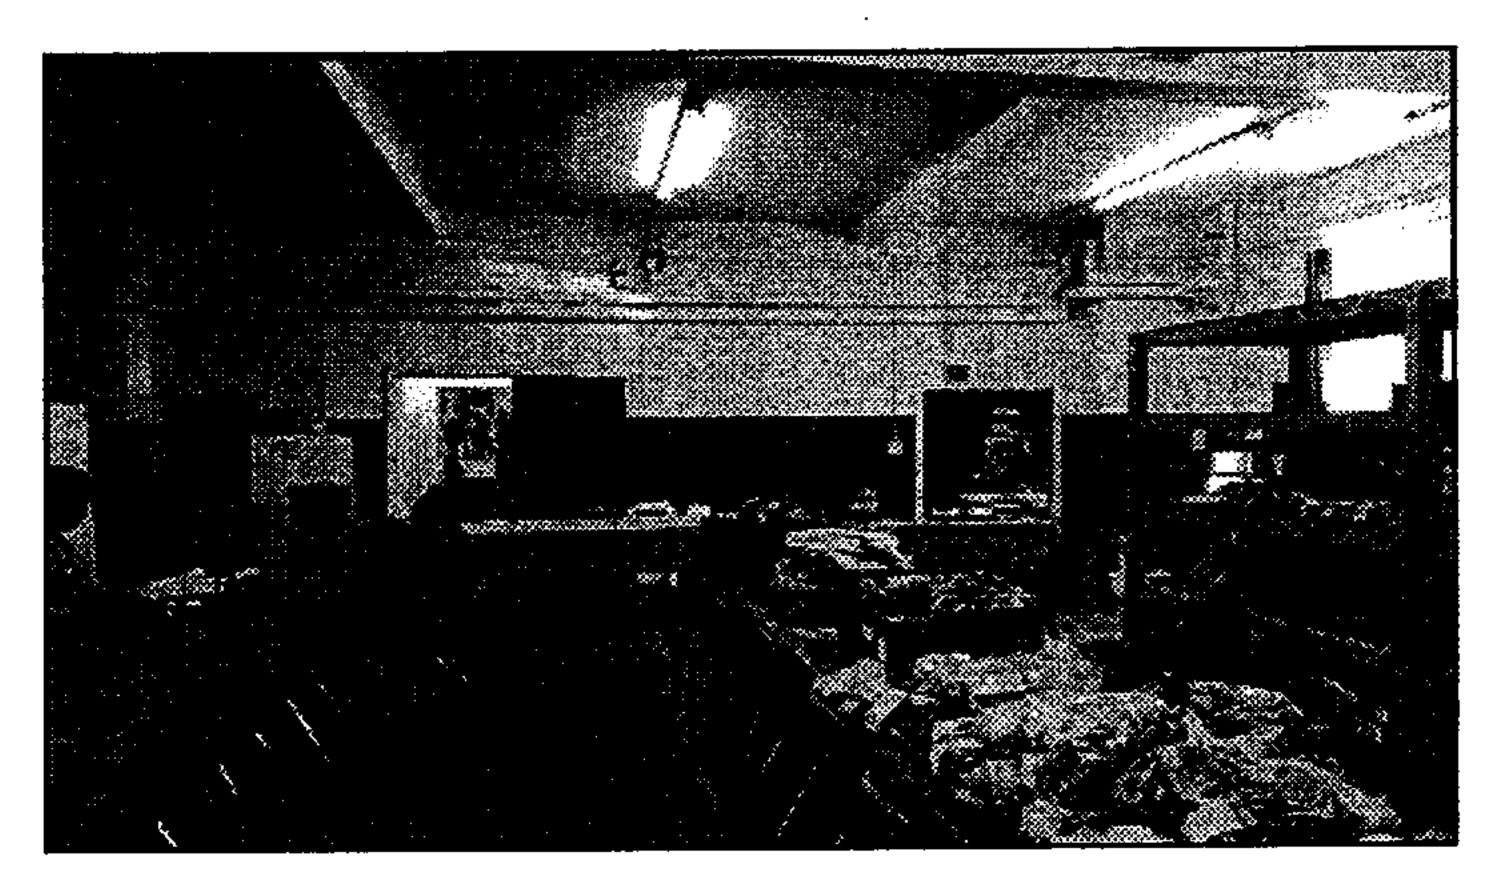
Note: Shelving and long tables

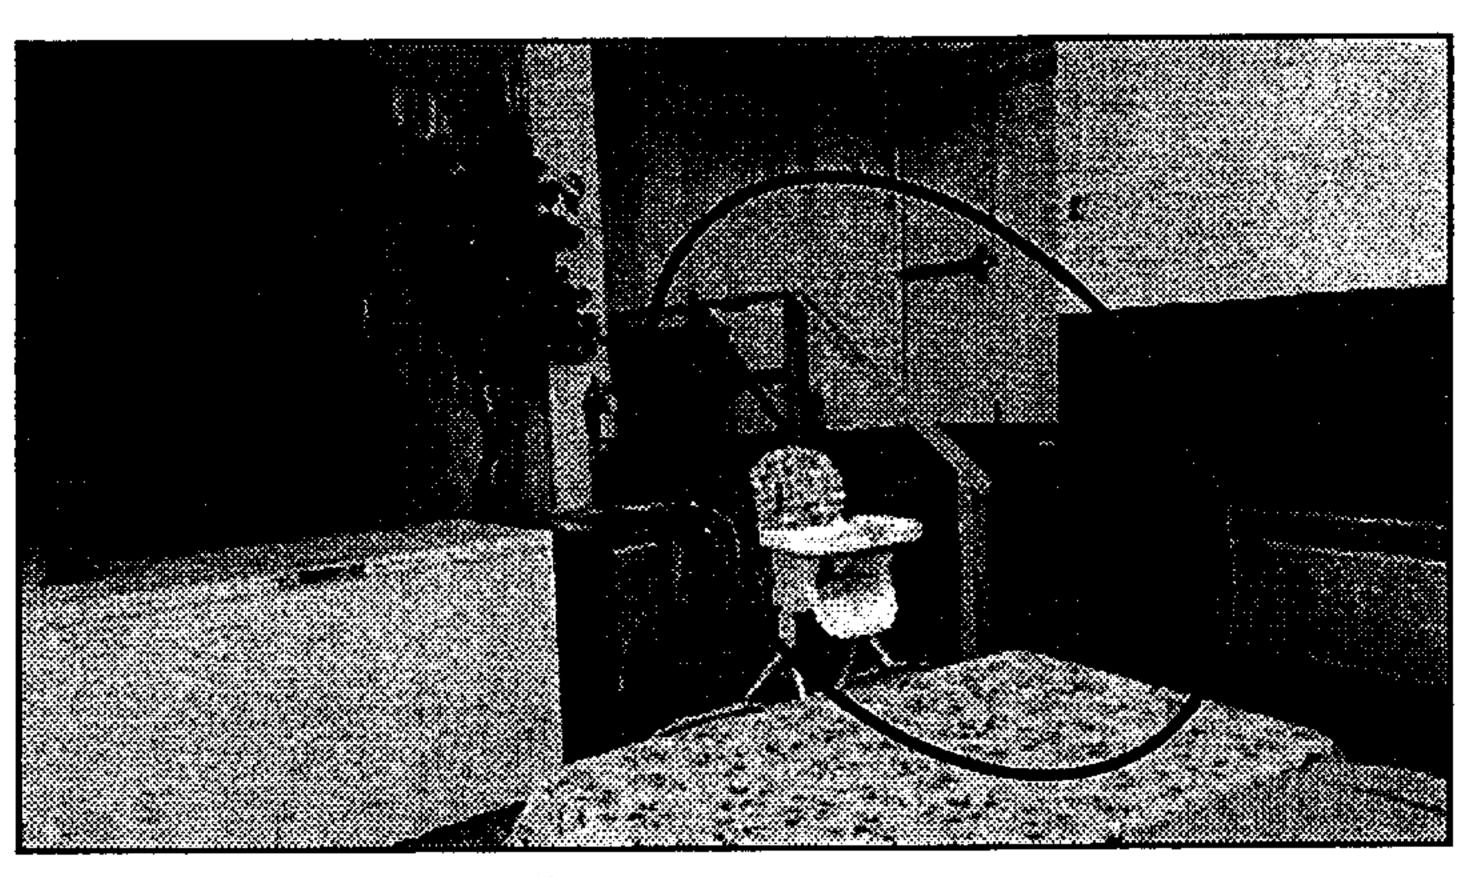
- Bathroom is non-compliant with current handicapped accessibility codes.
- Stairs to basement are non-compliant as a component of a means of egress system.
- Existing food service equipment is in operable condition.
- Kitchen spatial relationships and work spaces are less than adequate.
- Egress system to/from stage is non-compliant with current egress codes.
- Existing dining hall is in accessible and non-compliant with current egress requirements.
- Basement flooring is constructed directly on unexcavated soil.
- Air ventilation and lighting is poor.
- Fire area is non-sprinklered and lacks sufficient and compliant fire and life safety devices.

Note: Stairs not ADA Compliant

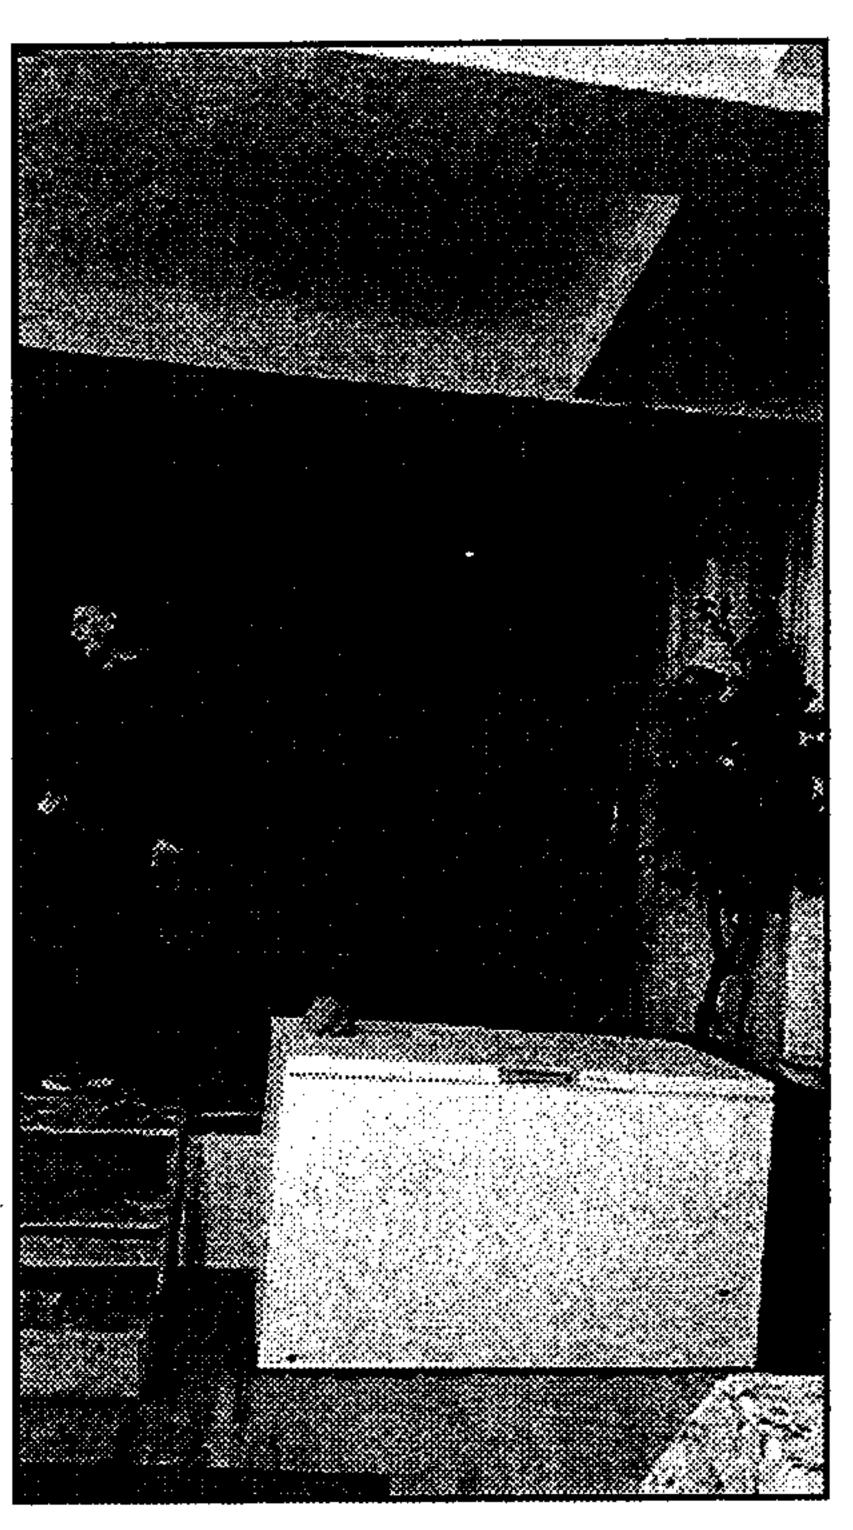
Note: Freezer

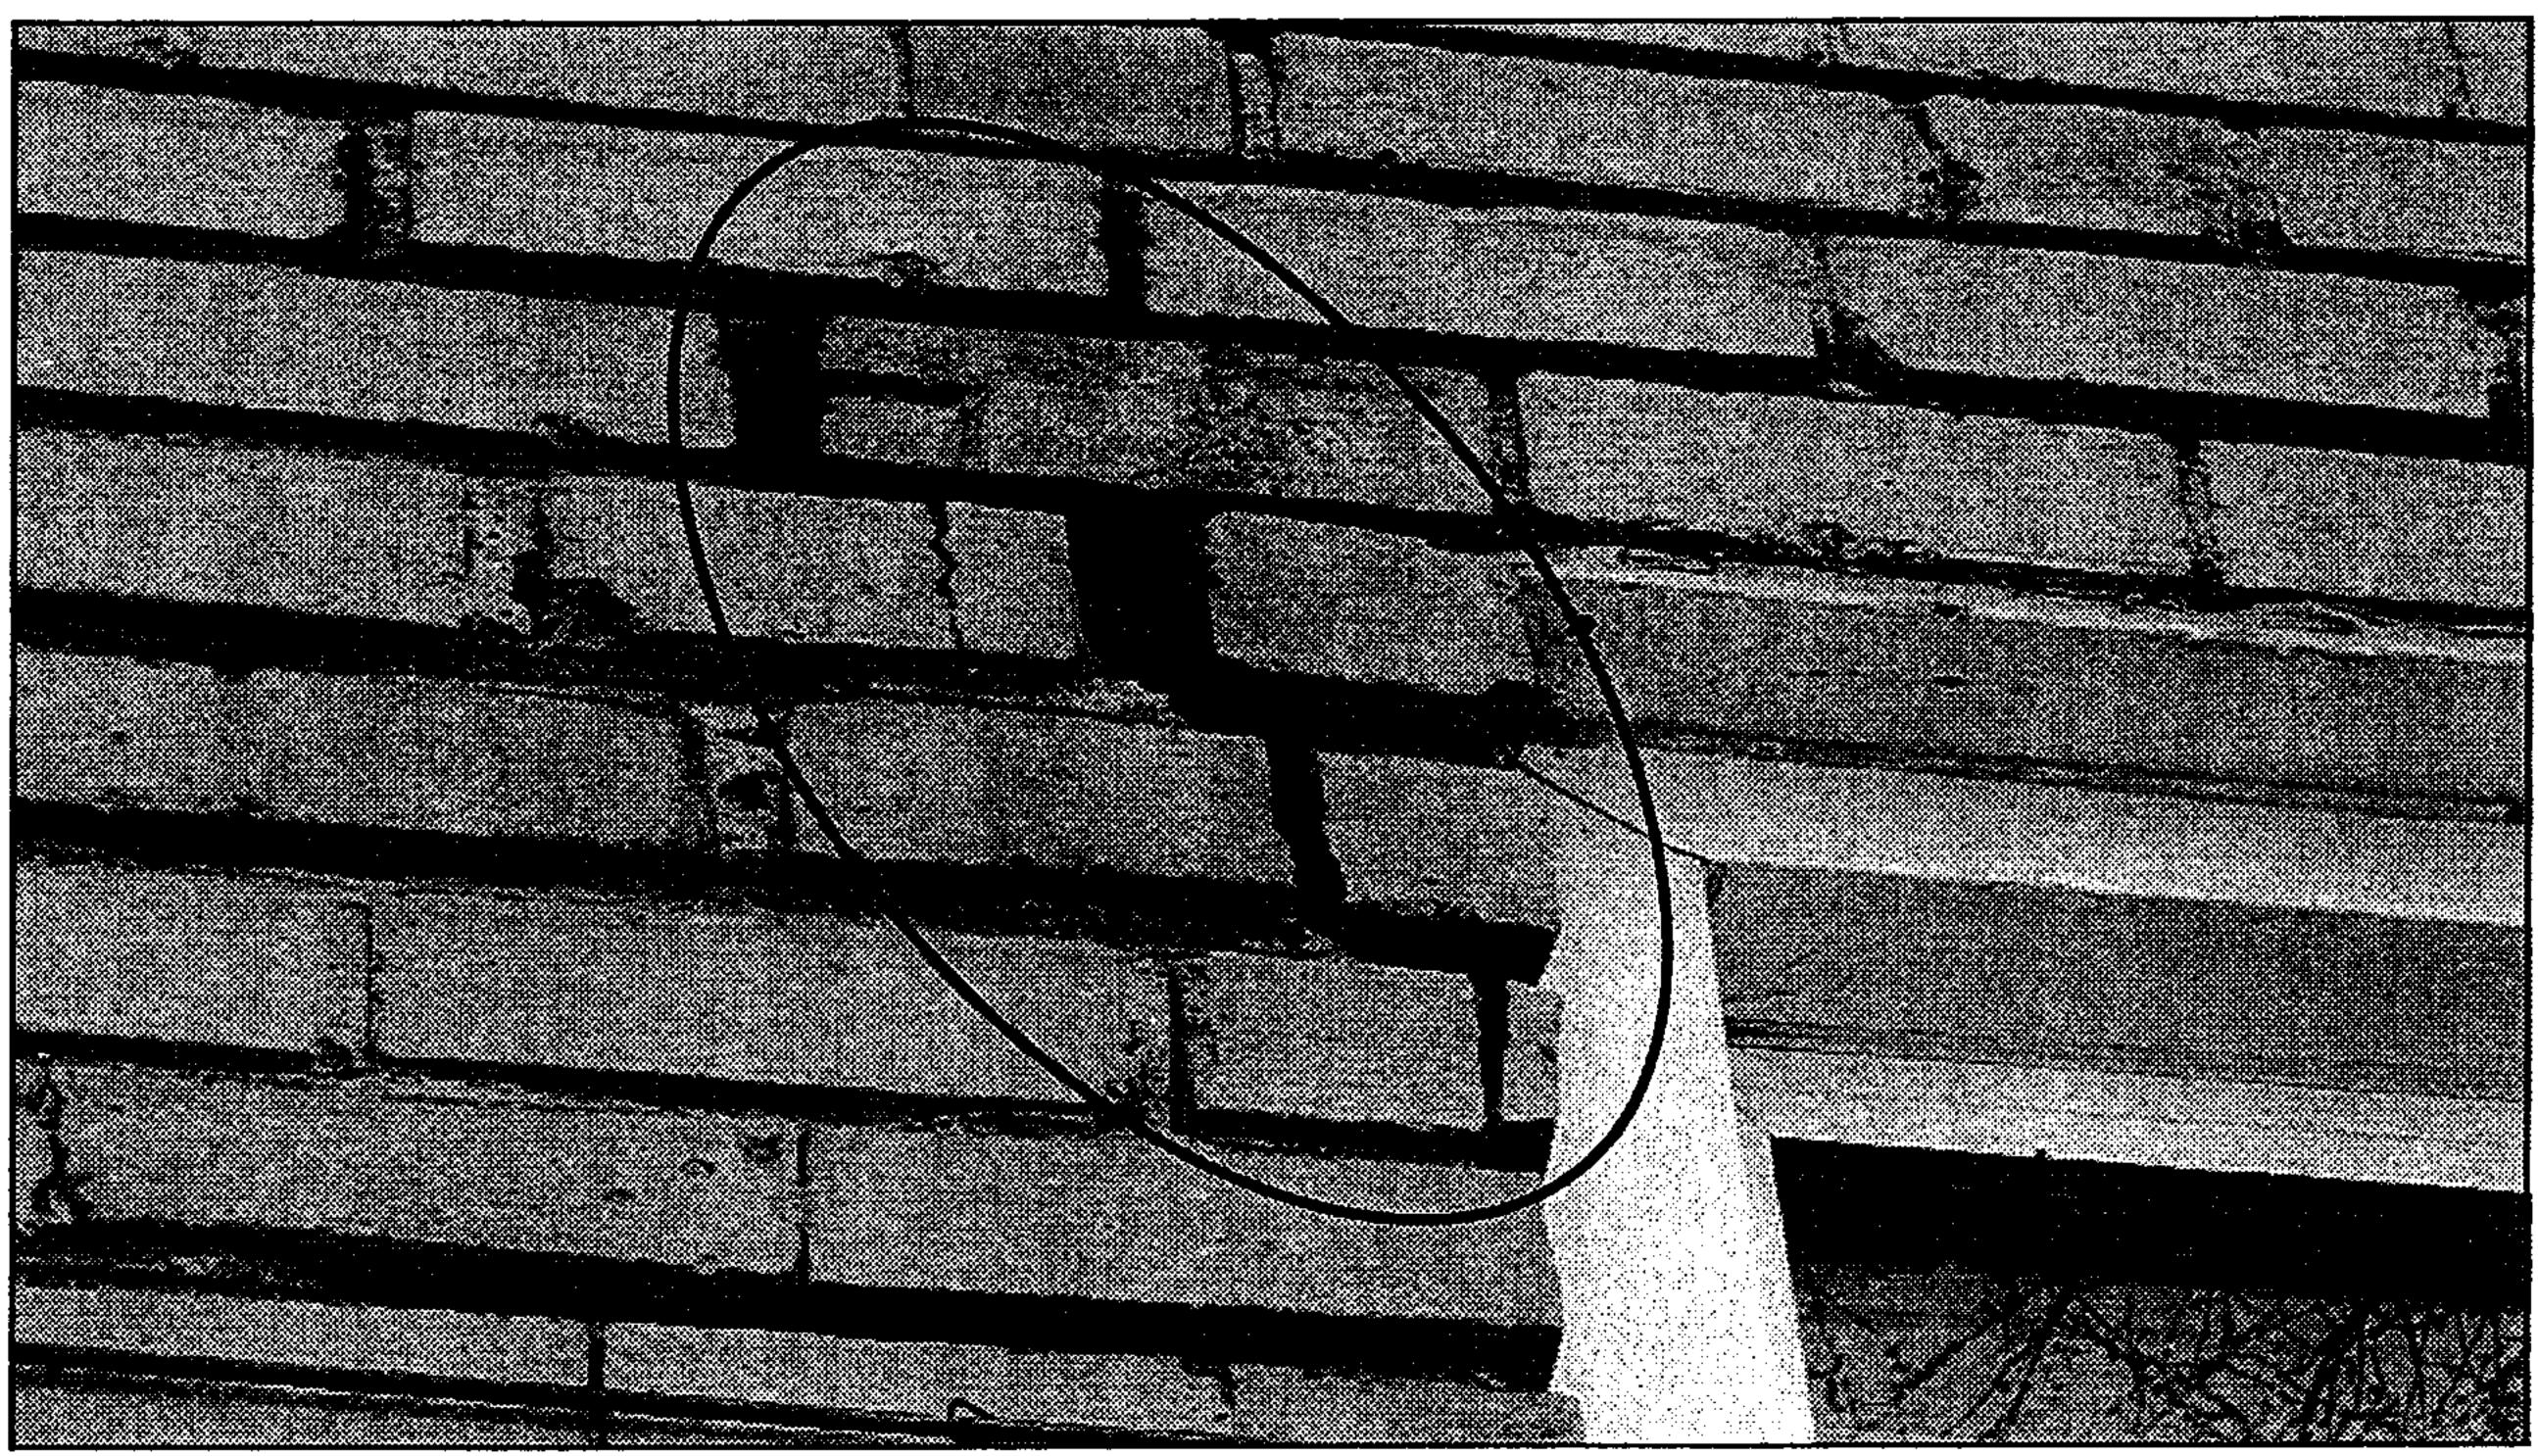
- Mortar erosion due to weathering and settlement.
- Significant water and air infiltration.
- Rusting and deterioration of steel lintels.
- Mortar deteriorating above 1st and 2nd floor windows.
- Cracks through brick brinks in several locations.
- Mortar joints are void in several locations.
- Evidence of moisture infiltration.

Note: Separation between bricks / split bricks
