**PROPERTY CONDITION REPORT
with 10-YEAR CAPITAL NEEDS**

**St. Pius X Catholic Parish
7200 Sarto Drive
Indianapolis, IN 46240**

Prepared for: **St. Pius X Catholic Parish**

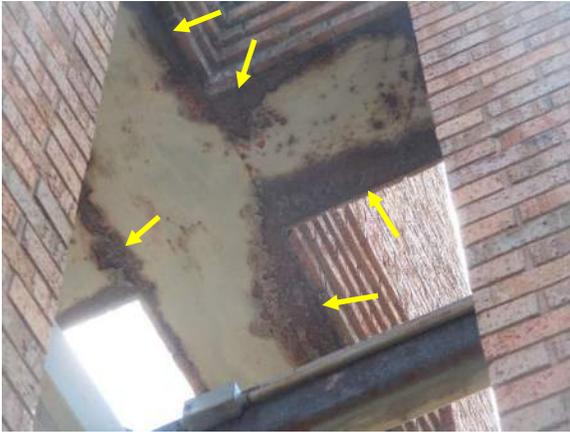
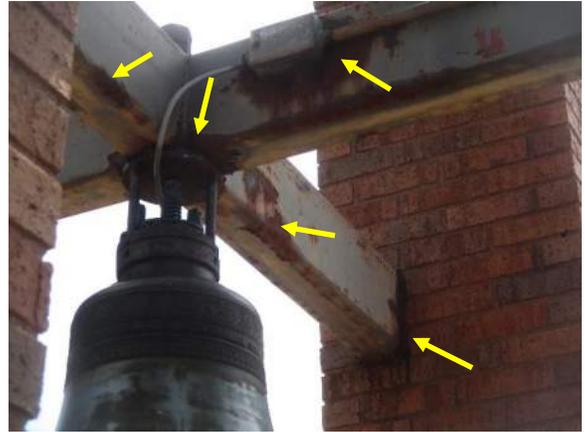
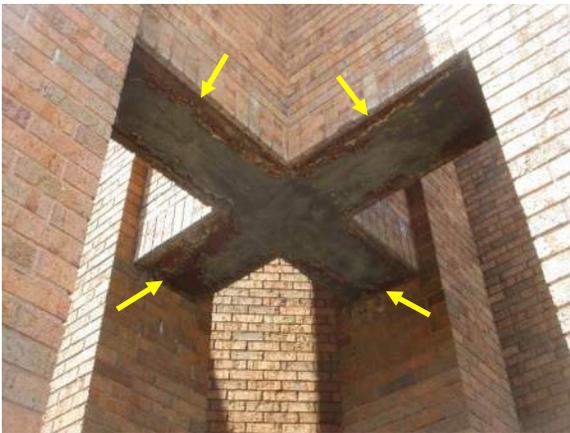
1. Structural steel plates and HSS (hollow structural steel) tube members at the exterior bell tower were observed with significant corrosion (Images A1 through A4). **While the structural members appear to be structurally stable, we recommend engaging a structural engineer to inspect the members and confirm excess section loss has not occurred, and then providing a rust inhibiting application and paint coating to protect them from the weather and further deterioration [Year 1 - \$16,000].**

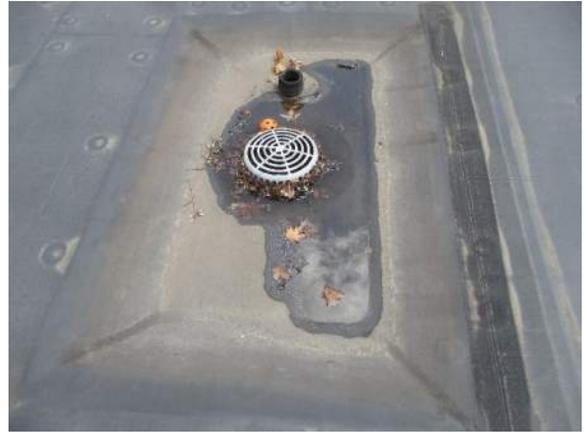
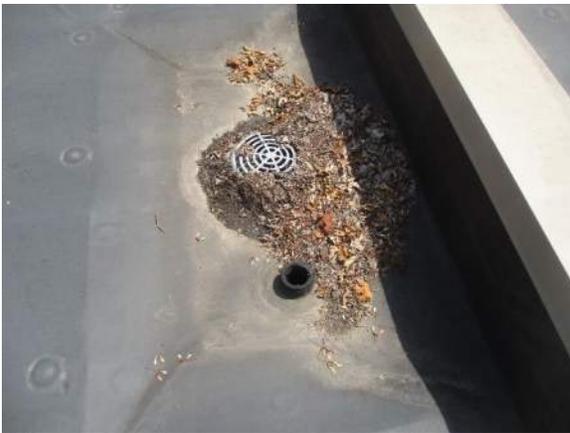
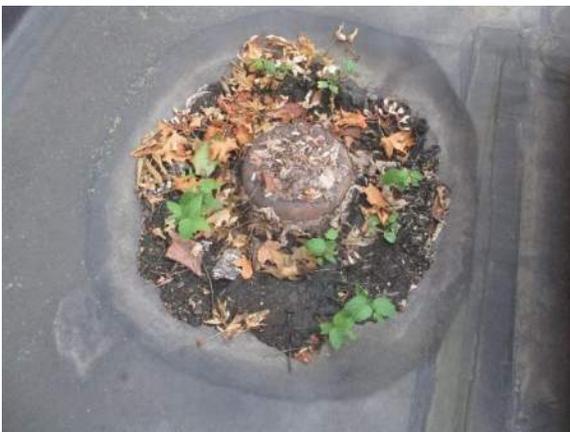
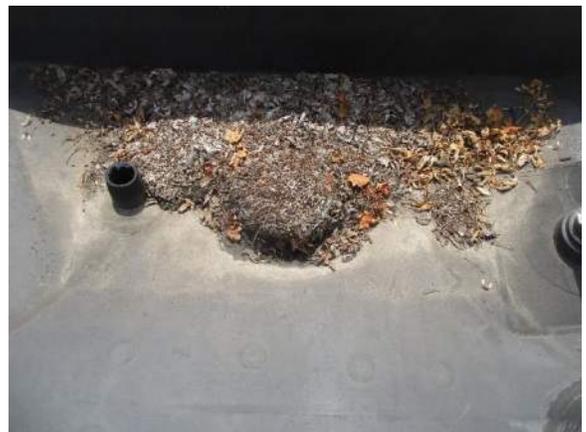
1. Select roof drains were observed to be clogged from leaves and debris with evidence of ponding water (Images B8 through B12). **We recommend clearing the leaves and debris from these roof drains as part of general maintenance so stormwater can drain properly.**
2. We observed several locations where evidence of ponding water exists due to insufficient slope to the drains (Images B2, B4 and B7). **Minimal ponding water is generally not a concern on 90-mil EPDM roofing systems like this one; however, we recommend monitoring these conditions and engaging the roofing contractor to make repairs as necessary if they continue to worsen [Year 3 - \$11,000].**

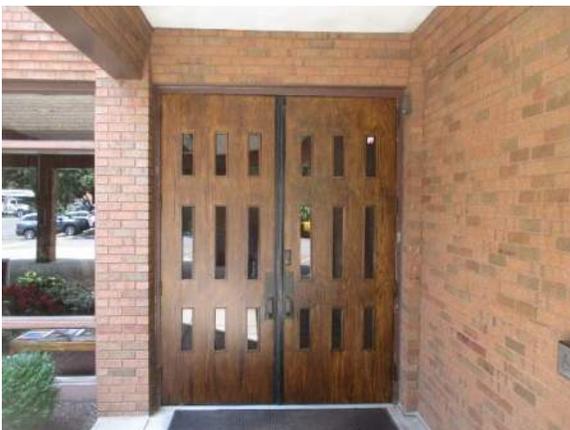
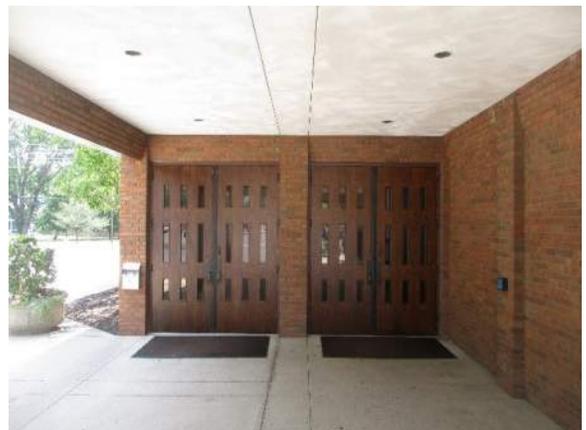
- Stained solid-core wood doors with glazed vision panels set in hollow-metal frames were in place at the two primary entrances on the east side of the building (Images C5 and C6). These doors were just provided with a sanding and stain finish earlier this year.

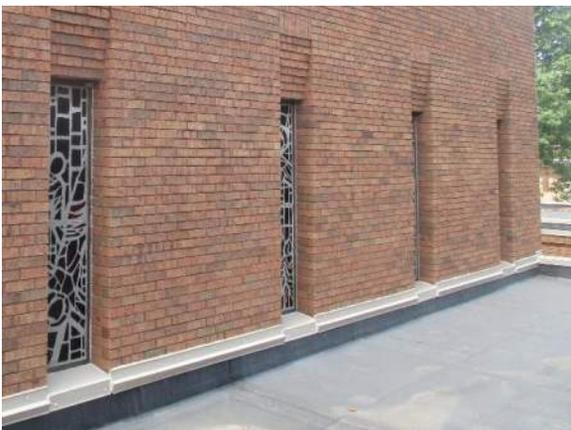
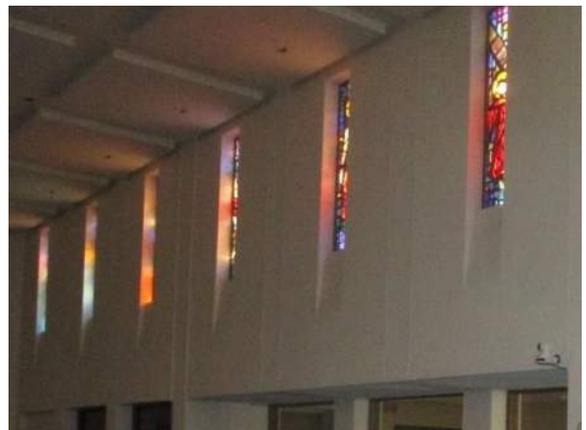
- Aluminum-framed windows were in place at the upper walls of the nave, which consisted of stained-glass fragments set in cast concrete (Images C11 and C12).

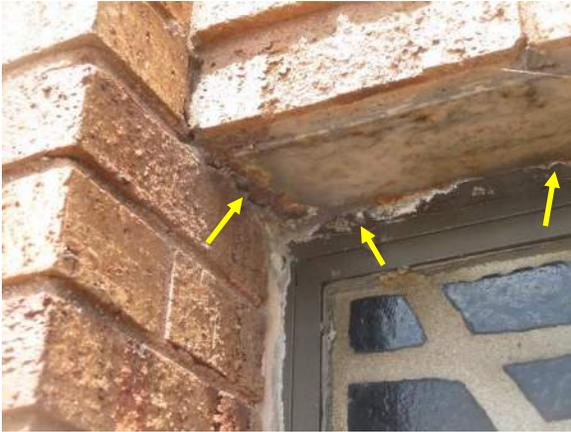
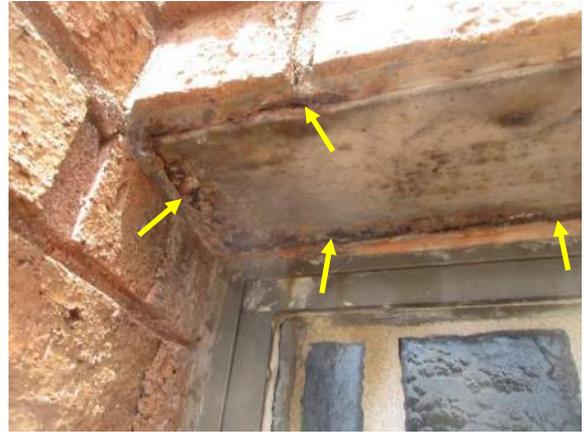
1. Select steel lintels located above door and window opening, primarily at the stained-glass windows at the roof level, were observed with corrosion (Images C13 and C14). **We recommend providing a rust inhibiting application and paint coating to the steel lintels to protect them from the weather and further deterioration [Year 1 - \$4,000].**

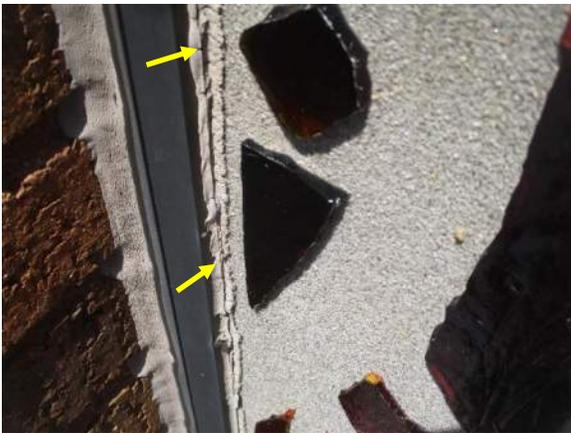
Image C15

2. Deteriorated sealant joints were observed around the perimeter of the stained-glass and concrete windows at the roof level (Images C15 and C16). **We recommend removing and replacing the deteriorated and failed sealant joints [Year 2 - \$7,300].**

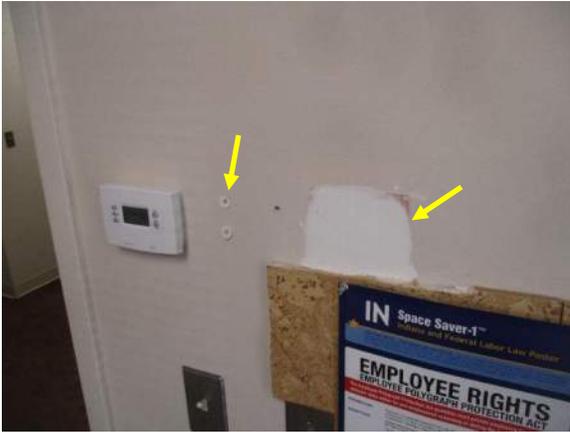
Image D13

1. Damaged wall surfaces from the removal of wall-mounted components were noted in the office area (Image D13). **We recommend repairing the damaged surface and providing new paint finishes in the near future from a cosmetic standpoint [Year 1 - \$900].**

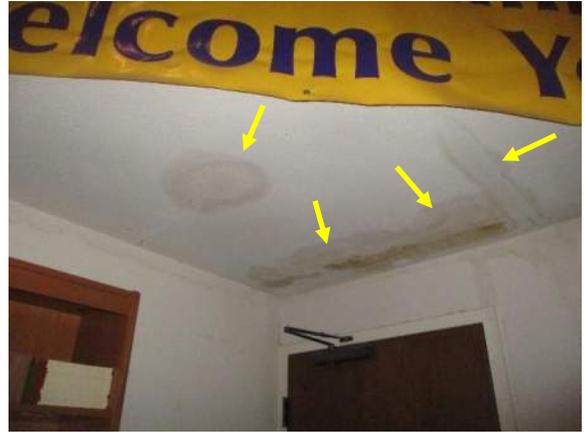
Image D14

2. Moisture-stained gypsum board was observed at a small area behind the sanctuary from previous roof leaks (Image D14). **We recommend repainting the ceiling at this location in the near future from a cosmetic standpoint [Year 1 - \$1,200].**

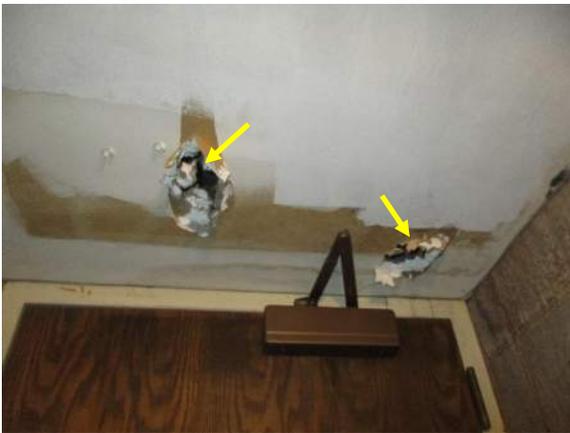
Image D15

3. Damaged gypsum board ceiling finishes were noted within a mechanical room, likely the result of previous roof leaks (Images D15 and D16). **We recommend repainting the ceiling at this location in the near future from a cosmetic standpoint [Year 1 - \$1,400].**

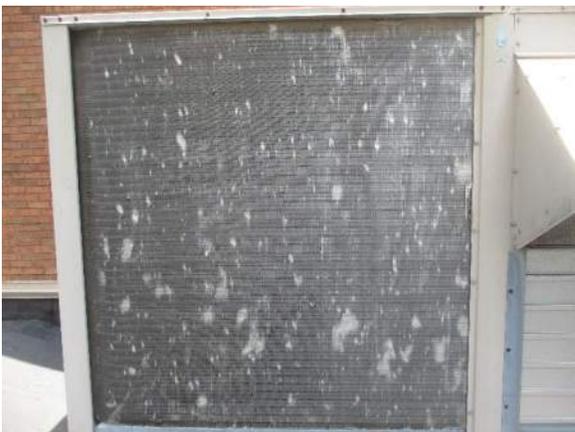
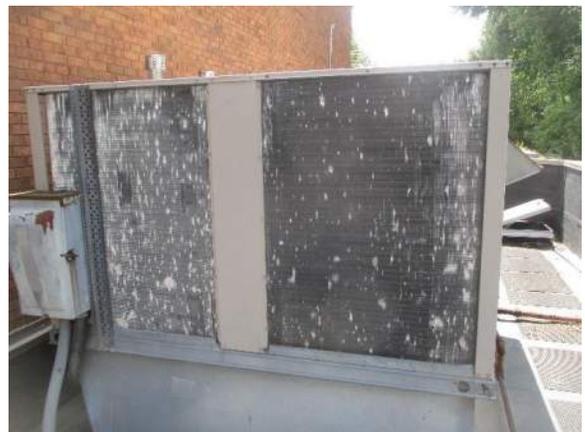
1. Hail dents were observed in many of the condenser cooling fins of the RTUs and rooftop condenser units (Images E10 through E12). **We recommend combing out the fins in the near future to provide optimal performance [Year 1 - \$1,200].**

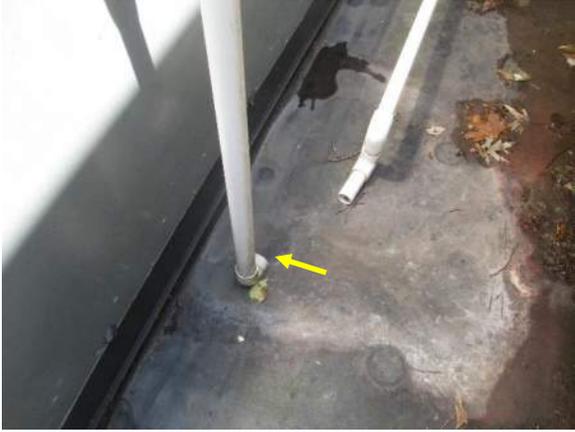
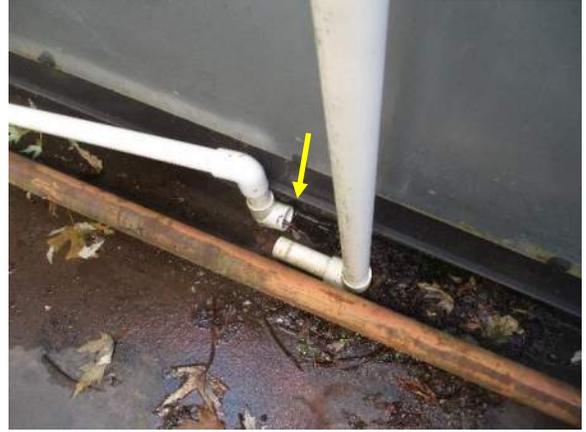
2. Condensate lines at the two large RTUs were observed with unattached sections (Images E13 and E14). **We recommend reattaching these condensate lines as part of general maintenance.**

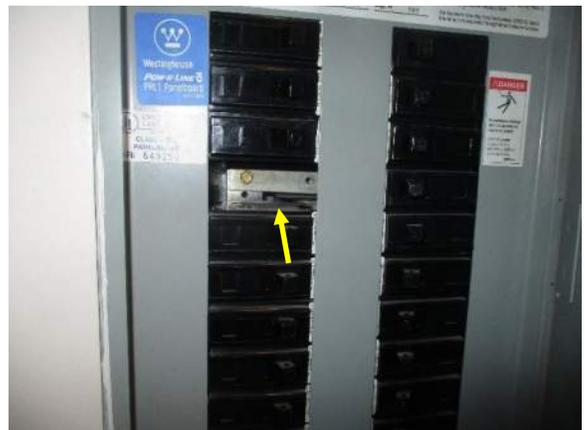
Image F6

1. A missing breaker switch with no cover was observed at one of the electrical panels (Image F6). **We recommend having the proper cover plate installed at the missing breaker in the near future for safety [Year 1 - \$300].**
2. Some of the interior lighting was noted to be LED light fixtures; however, there were still many areas that were noted with fluorescent light fixtures. **While the lighting in place is serviceable, we recommend programming a conversion to LED light fixtures in the future to improve lighting optics and provide energy cost savings [Year 5 - \$22,200].**

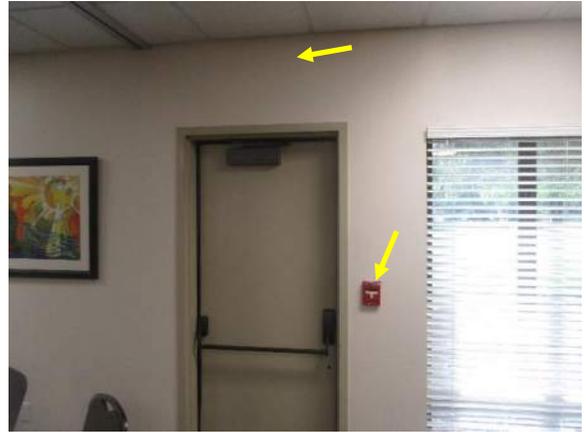
Image H8

1. Select emergency egress door locations were not equipped with exit signs (Image H8). **We recommend installing exit signs along all egress locations as required to provide adequate emergency egress and life safety [Year 1 - \$1,800].**
2. Various items were stored in front of an emergency egress door near the southwest corner of the building (Image H12). **We recommend storing these items in other locations that do not impede the path of travel to emergency egress locations.**
3. We recommend incorporating a budget for general emergency egress and life safety maintenance to be included in fire suppression inspections each year. **We recommend identifying annual capital funds for emergency egress and life safety maintenance and various inspections [Annual - \$1,500].**

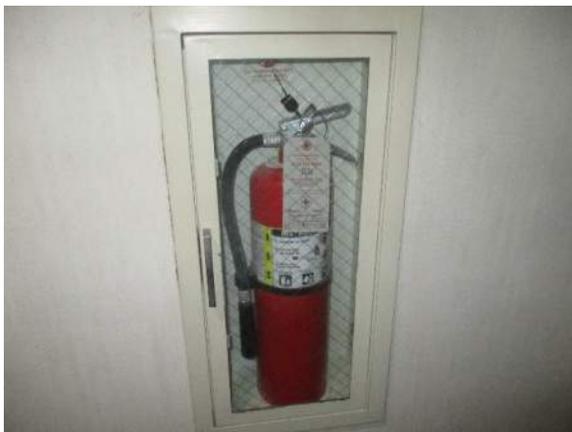
Image H11

The building is also equipped with individual dry canister fire extinguishers throughout the building, which were last checked in July 2022 (Image H11). The building egress and life safety systems appeared to be adequate for the facility for the most part; however, we did note the following conditions that should be addressed and considered over the next 10 years.

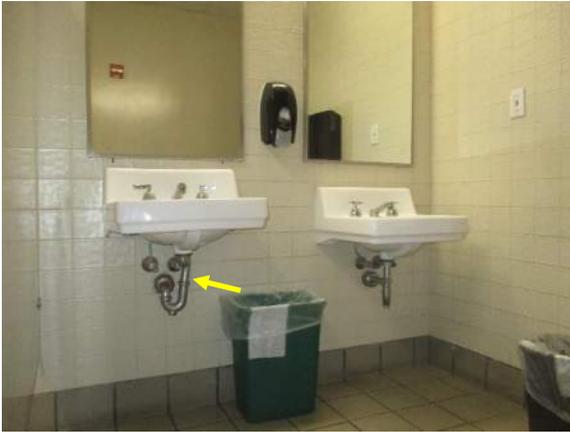
Image I1

1. All of the accessible lavatory sinks were missing pipe protection (Images I1 and I2). **We recommend providing pipe protection in the near future to align with Indiana Accessibility and ADA requirements [Year 1 - \$1,800].**
2. Mirrors at some of the accessible lavatory sinks were installed too high (Image I3). **We recommend adjusting the location of the mirror so the bottom of the reflective surface is no higher than 40 inches above finished floor [Year 2 - \$600].**
3. The accessible drinking fountain was installed too close to the sidewall and does not provide the proper 30-inch clear knee space centered on the drinking fountain (Image I4). **We recommend moving the accessible drinking fountain as required to meet Indiana Accessibility and ADA requirements as part of any future interior renovations [Year 4 - \$1,500].**

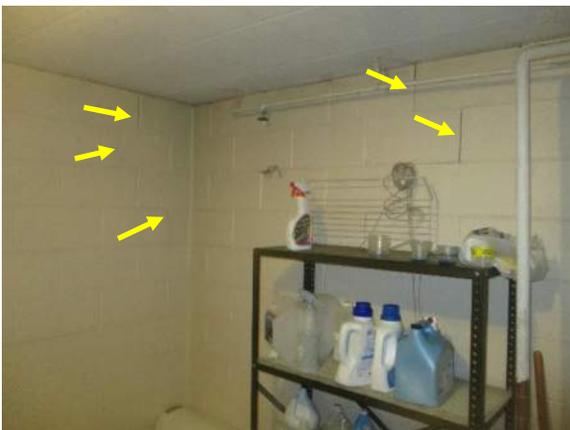
Image A5

1. Cracks were noted in the exterior CMU walls from inside the basement level at the northwest corner (Images A5 and A6). We did not observe any instability in the brick masonry veneer from the exterior at this location and believe the building to be structurally stable. **We recommend commissioning a structural inspection by a qualified engineer that can evaluate the current condition at the northwest corner in the basement and provide additional information and next steps [Year 1 - \$12,000].**

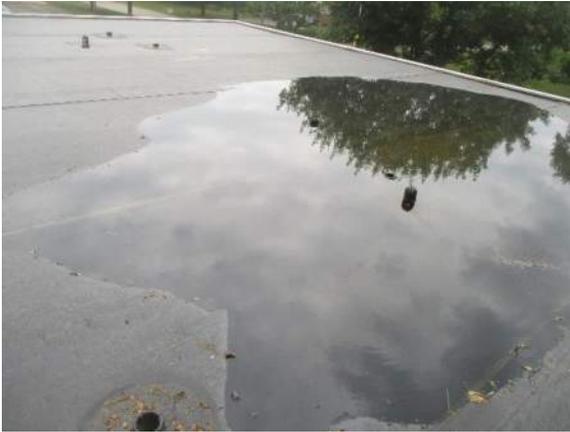
Image B1

1. Select roof drains were observed to be clogged from leaves and debris with evidence of ponding water (Images B1 and B4). **We cleared leaves and debris from around the drain assembly to permit drainage of the standing water on the upper roof; however, this is when the below-grade drainage pipe issue was noted that is discussed in the previous Section II. Site Observations above.**

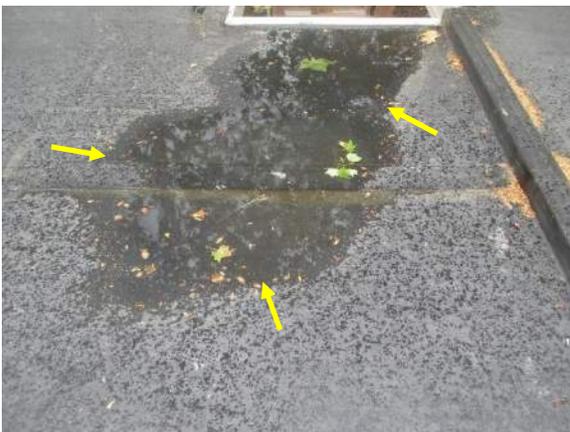
Image B5

2. We observed a couple of locations on the lower roof where water is ponding near the perimeter edge or gutter edge due to insufficient slope to the gutter (Images B5 and B6). **Where this roof system is less than a year old and likely still under a workmanship warranty, we recommend engaging the roofing contractor to make repairs in the immediate future [Warranty].**

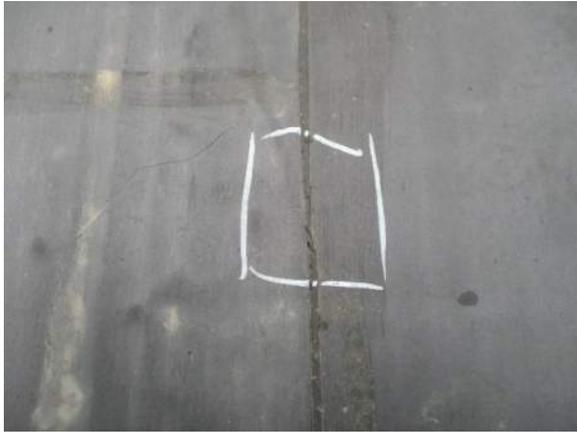
Image B7

3. We observed a couple of marked locations of scuffs and imperfections in the roof membrane (Images B7 and B8). **Where this roof system is less than a year old and likely still under a workmanship warranty, we believe these were marked by the roofing contractor and likely in the process of making the necessary repairs [Warranty].**

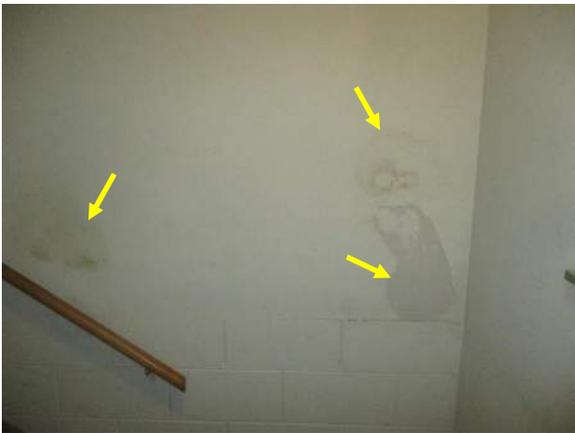
Image D9

2. Cracked and damaged plaster wall and ceiling finishes were noted at a few different locations (Images D9 through D11). **We recommend repairing and painting these wall and ceiling locations in the near future from a cosmetic standpoint [Year 2 - \$1,400].**

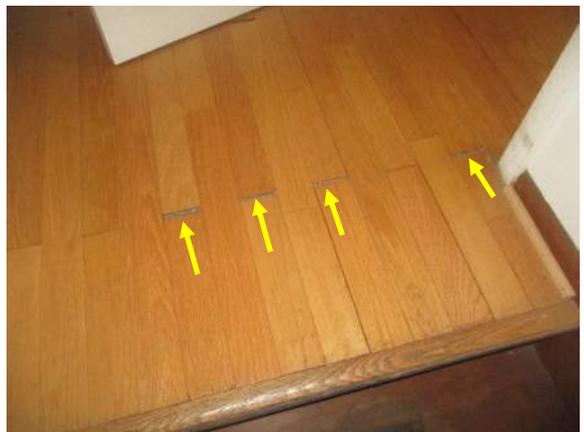
Image D12

3. Open joints were observed in some of the older hardwood flooring sections near the stairs (Image D12). **We recommend programming replacement of some of the remaining older hardwood flooring areas with damage in the near future [Year 3 - \$3,800].**

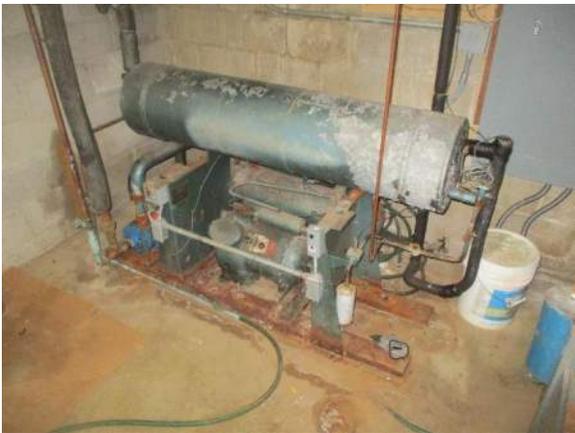
Image E3

- An old chiller was also in place in the basement mechanical room near the boiler, but we understand this unit is no longer in service (Image E3).
- The boiler provides approximately 203,000 BTU/H on the heating cycle and the condenser provides approximately five tons of cooling.
- The boiler appeared to be approximately 40 years old, and the condenser was approximately 21 years old.
- Heating and cooling is supplied throughout the residence to terminal fan and coil units through a closed loop system, where conditioned air is supplied to the individual rooms (Images E4 through E6).

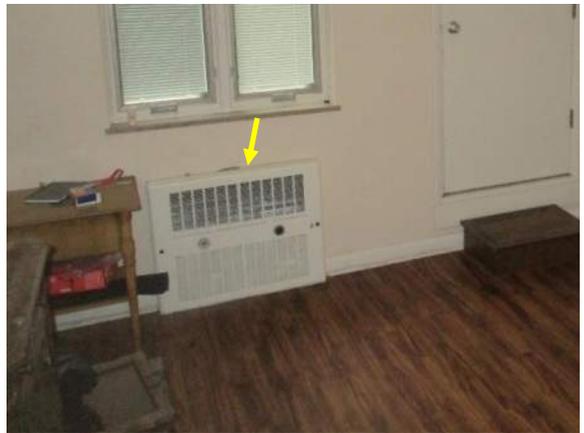
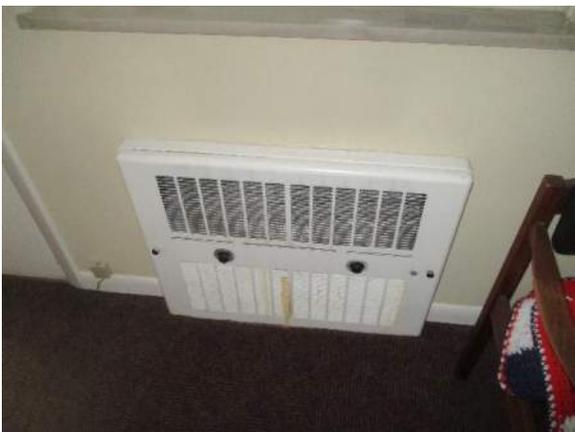
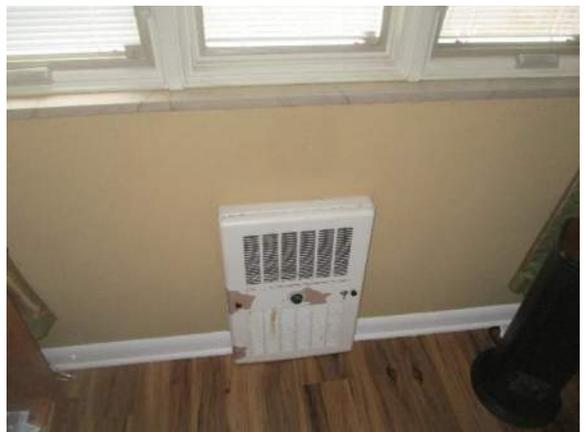
1. While most aspects of these mechanical components appeared to be serviceable, we believe they are both beyond their typical expected useful life. **We recommend programming the exterior condensers for replacement [Year 1 - \$12,500], the boiler for replacement [Year 2 - \$11,500], and the various terminal fan and coil units throughout the residence for replacement [Year 3 - \$20,200].**

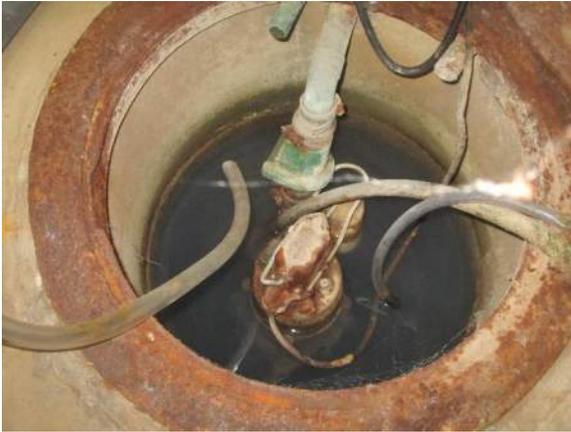
Image G1

- Single-user bathrooms included toilets, sinks and showers or tubs (Images D7 and D8).
- The kitchen was equipped with a stainless steel sink (Image D3).
- A sump pit and pump were located within the basement mechanical room (Image G1).

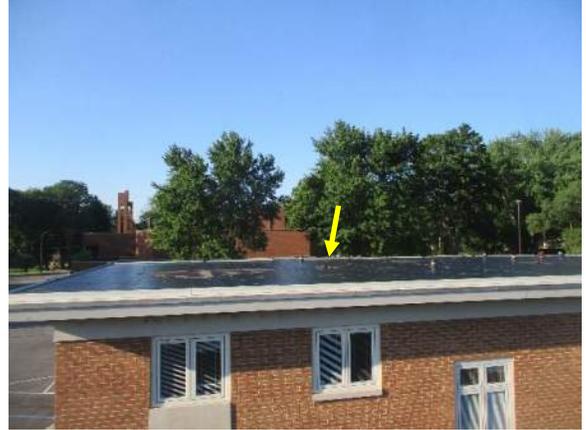
Image B2

- The roof area slopes from elevated portions along the perimeter of the roof to two internal storm drains that transfer storm water through internal pipes below grade and offsite to the municipal stormwater system (Image B2).
- We understand this roof system was replaced around 2017, making it approximately six years old. We were unable to locate what, if any, warranty was provided with the system from the documentation we reviewed. These types of 60-mil EPDM roof systems will typically come with a 15- or 20-year warranty.

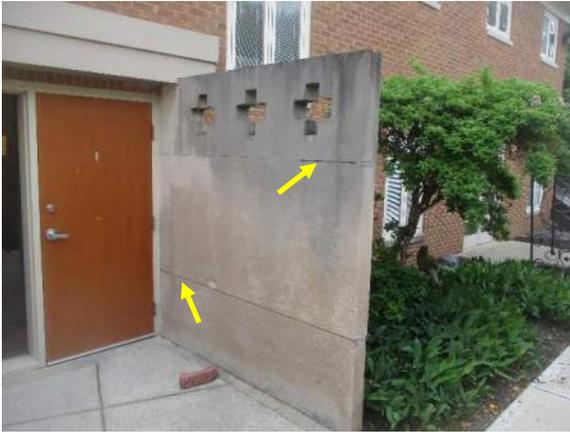
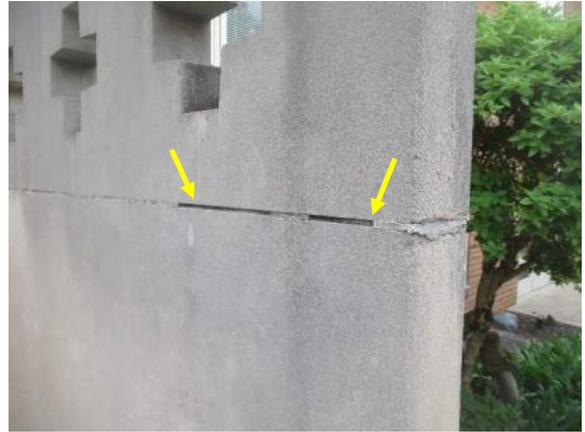
1. Open mortar joints were observed at the limestone panels of the privacy wall near the main entrance (Images C7 and C8). **We recommend removing loose mortar and tuckpointing or sealing the limestone joints to prevent water infiltration and further degradation [Year 1 - \$1,200].**

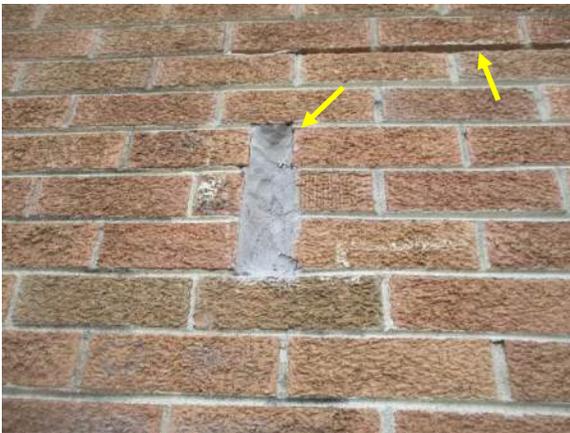
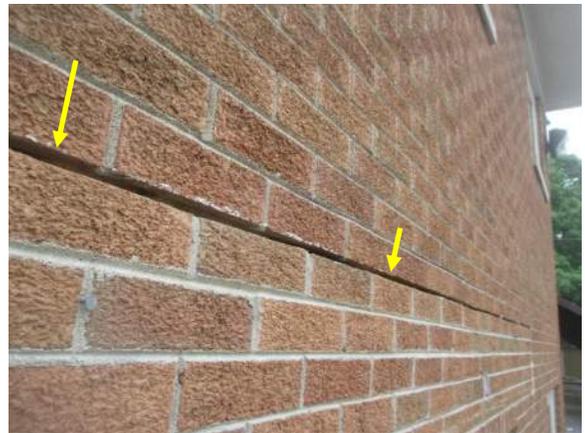
2. We observed cracked mortar patchwork and an open mortar joint along the north side of building where an apparent exterior roof cover used to be located (Images C9 and C10). **We recommend cutting out the mortar patchwork, installing brick masonry units, and tuckpointing the open mortar joint [Year 2 - \$2,400].**

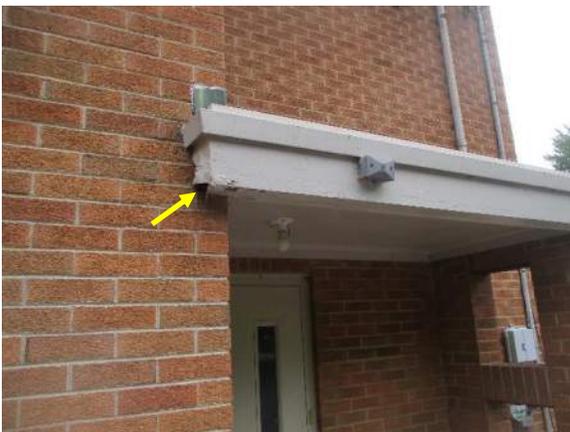
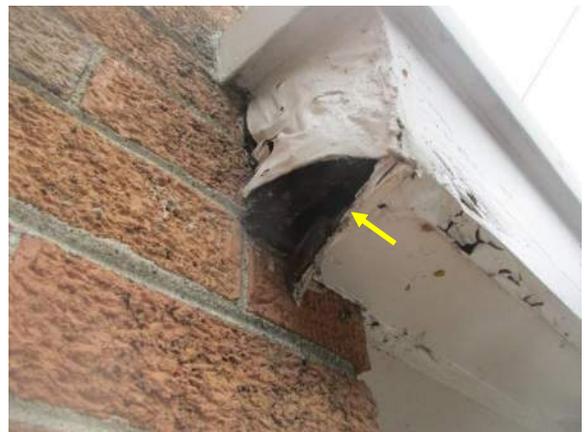
3. Significant wood rot was observed at the trim at the end of the canopy over the entrance at the southwest corner of the building (Images C11 and C12). **We recommend removing and replacing these damaged trim sections and repainting them to prevent water infiltration and further degradation [Year 2 - \$1,200].**

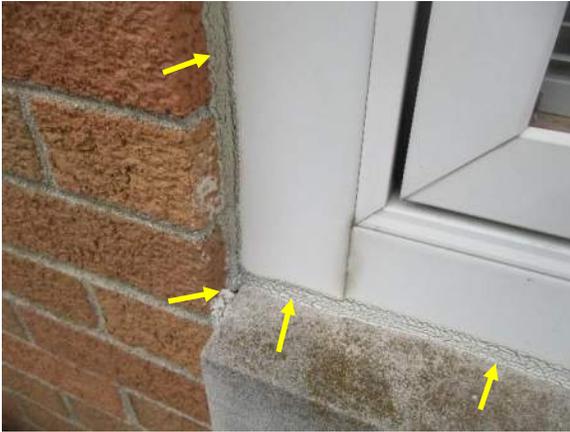
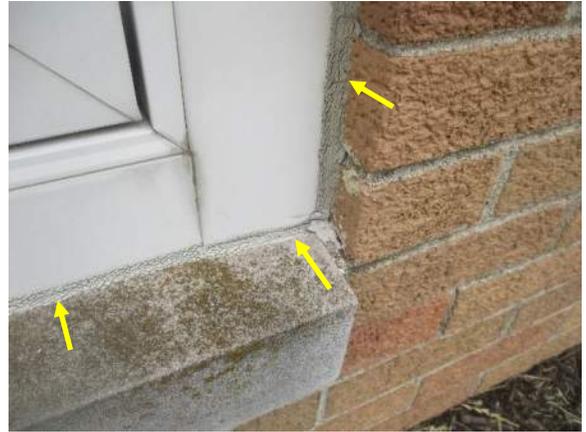
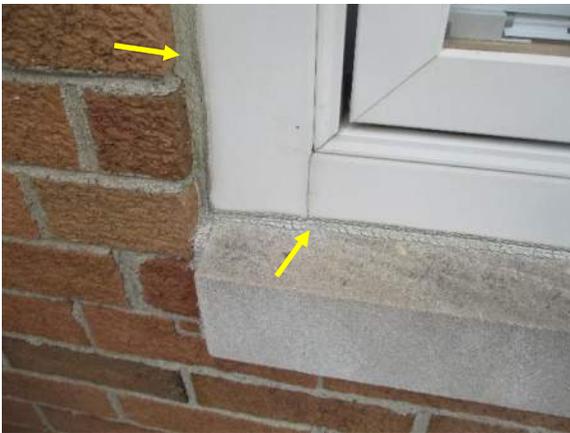
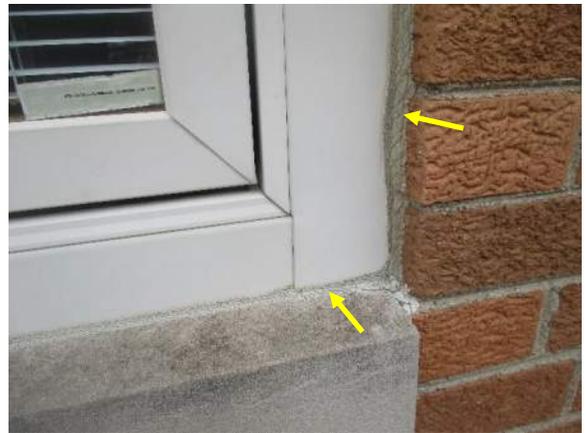
4. Deteriorated sealant joints were observed around the perimeter of many of the window openings (Images C13 through C16). **We recommend removing and replacing the deteriorated and failed sealant joints in the next couple of years [Year 3 - \$6,600].**

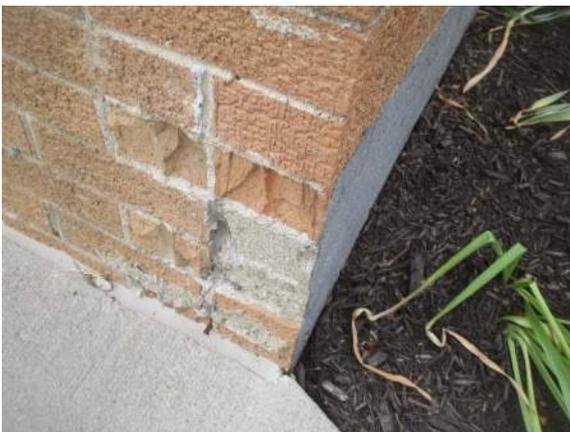
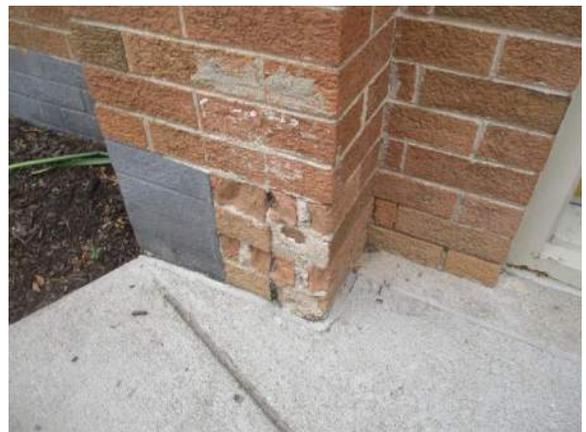
5. Spalled and damaged brick masonry sections were noted near the northeast corner of the building and next to the main entrance (Images C17 and C18). **We recommend patching and sealing the spalled brick masonry units similar to the adjacent conditions in order to minimize the opportunity for further damage [Year 4 - \$1,400].**

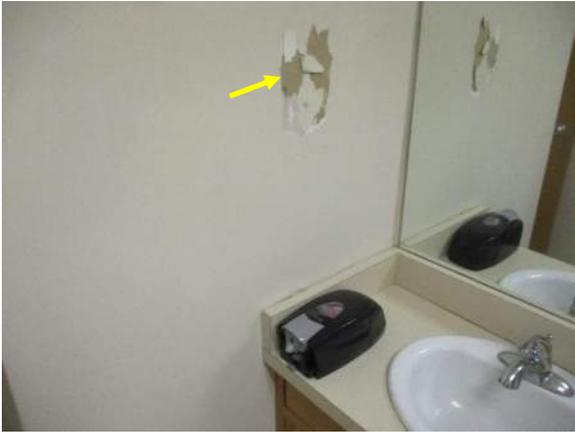
Image D7

1. Damaged wall surfaces from the removal of wall-mounted components were noted in one of the toilet rooms at the upper floor level (Image D7). **We recommend repairing the damaged surface and reinstalling the soap dispenser in the near future from a cosmetic standpoint [Year 1 - \$600].**

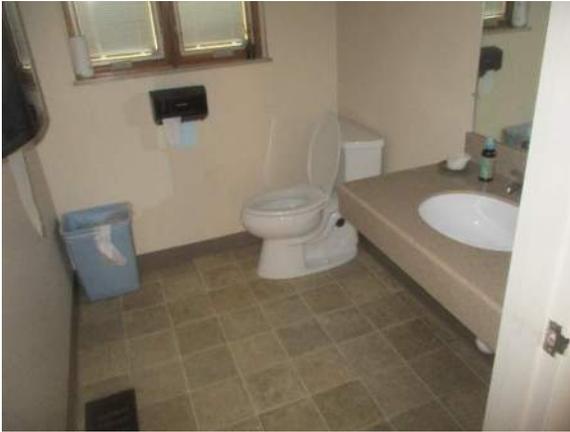
Image G1

- A single-user unisex and multi-user men’s and women’s toilet rooms were located within the building (Images D6, G1 and G2).
- A kitchen area at the southwest corner was equipped with a stainless-steel sink (Image G3).
- A sump pit and pump were located within the basement mechanical room (Image G4).

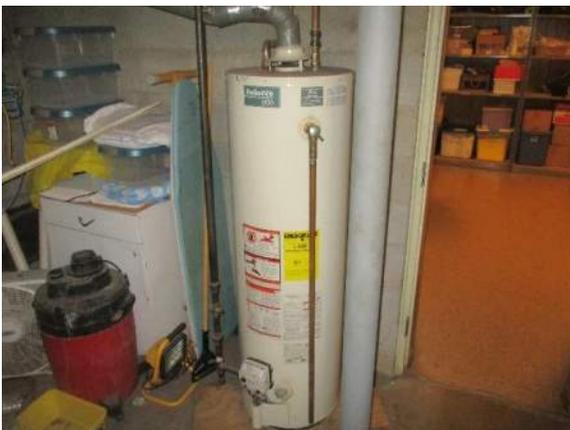
Image G5

Hot water for plumbing fixtures throughout the building is provided by a 40-gallon gas-fired water heater located in the basement that was approximately 12 years old (Image G5). Gas-fired water heaters of this type typically have an expected useful life of approximately 15 years or so before major repairs or replacements are required.

1. We were informed after our assessment that the exterior hose bibbs do not work properly and leak into the basement when turned on. **We recommend engaging a plumber to replace these leaking hose bibbs in the near future [Year 1 - \$3,000].**
2. The sump pump in the basement appeared to be in working order; however, these typically only have a useful of approximately five years or so and believe it should be programmed for replacement a couple of times over the next 10 years. **We believe the sump pump should be programmed for replacement in the next few years [Year 2 - \$1,200, Year 7 - \$1,500].**
3. At 12 years old, the water heater is likely nearing the end of its useful life and should be programmed for replacement in the near future. **We recommend programming this water heater for replacement in the next few years [Year 3 - \$5,500].**

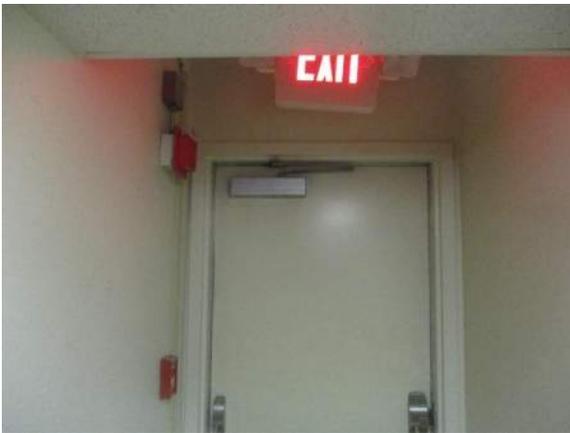
Image H3

2. The illuminated exit sign (Image H3) located at the west end of the upper floor level hall is mostly concealed by the suspended acoustic ceiling (Image H10). **We recommend placing an emergency egress sticker on the face of the door in the immediate future, and then adjust the location of the suspended acoustic ceiling in a manner that the illuminated exit sign with emergency lighting can be viewed from within the hallway to provide adequate emergency egress and life safety [Year 1 - \$2,400].**

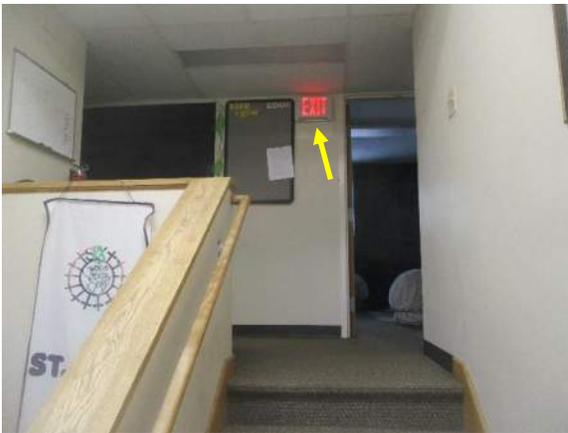
Image H9

1. The illuminated exit sign at the top of the stairs did not appear to indicate the proper location to an emergency egress location (Image H9). **We recommend adjusting or changing the location or orientation of this exit sign to provide adequate emergency egress and life safety [Year 1 - \$1,200].**

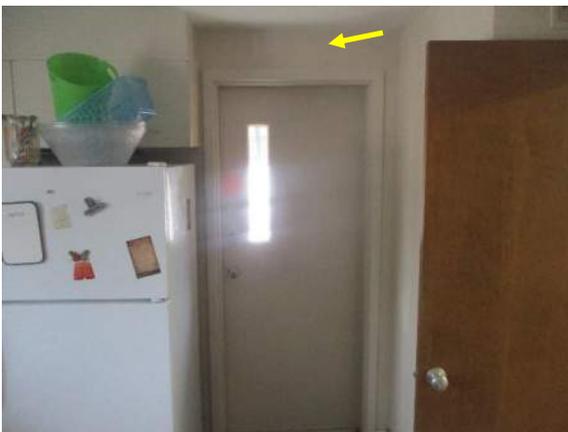
Image H11

3. The emergency egress door in the kitchen area was not equipped with an exit sign (Image H11). **We recommend installing an exit sign at this location to provide adequate emergency egress and life safety [Year 2 - \$2,800].**

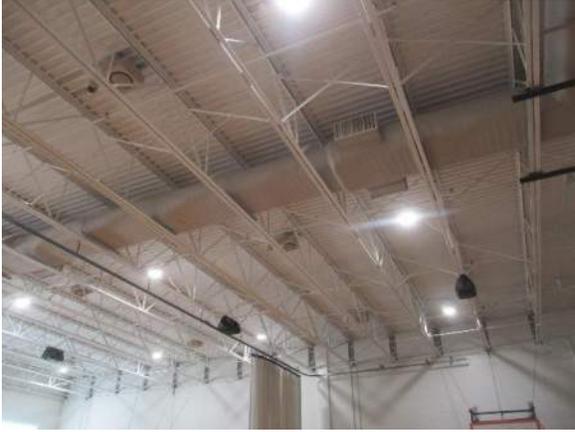
Image A1

- Metal roof decking is supported by steel bar joists at some of the more recent building addition areas (Image A1).
- The roof systems at many of the original building areas are comprised of segmented precast concrete structural slab systems that consist of interlocking, steel-reinforced concrete units.
- The roof structures are supported by exterior and interior CMU walls.
- The main floor system consists of concrete slab-on-grade construction.
- Load-bearing CMU walls are assumed to bear on steel-reinforced concrete foundations and footings.

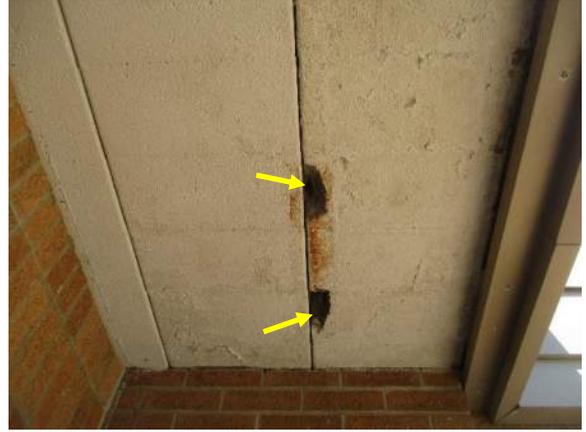
Image A2

1. Sections of the segmented precast concrete structural roof slabs along the south side of the building were observed with spalled sections at the exterior (Image A2). **While the structural integrity appears to be stable, we recommend patching the spalled sections to prevent further deterioration [Year 1 - \$3,600].**

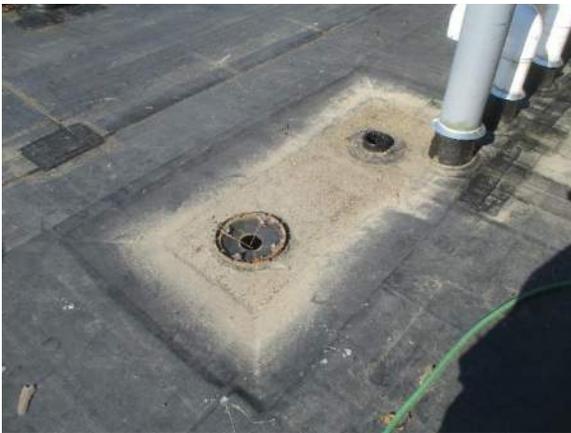
Image B9

2. Some of the roof drains were observed with missing strainer caps (Images B9 and B19). **We recommend replacing missing roof drain strainer caps in the near future [Year 1 - \$1,200].**

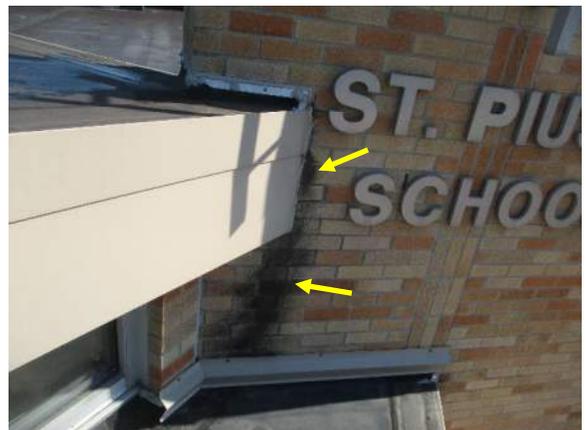
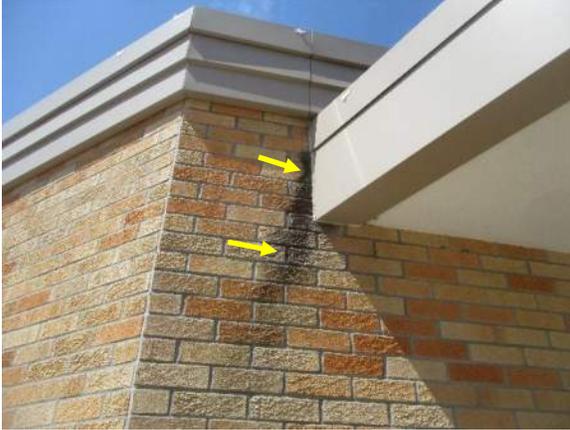
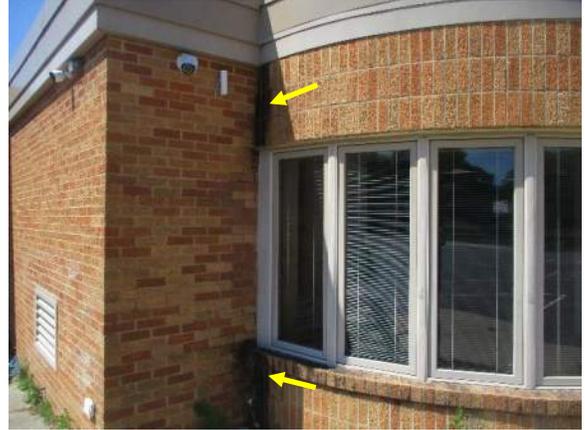
1. Dark stains were observed on the face of the brick masonry veneer at various locations originating from the metal and roof flashing systems above (Images C12 through C14). **We recommend cleaning the brick masonry veneer from a cosmetic standpoint and sealing voids to prevent water from down these locations [Year 1 - \$2,400].**

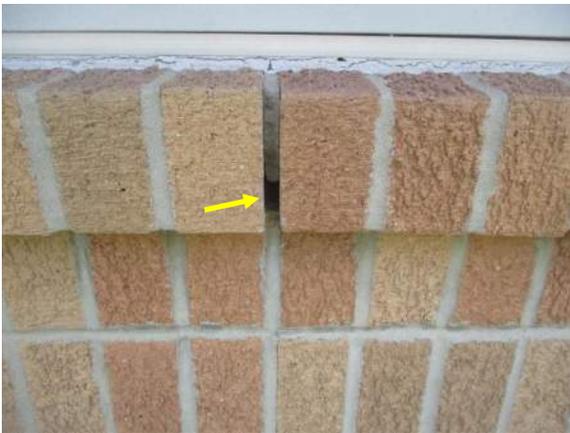
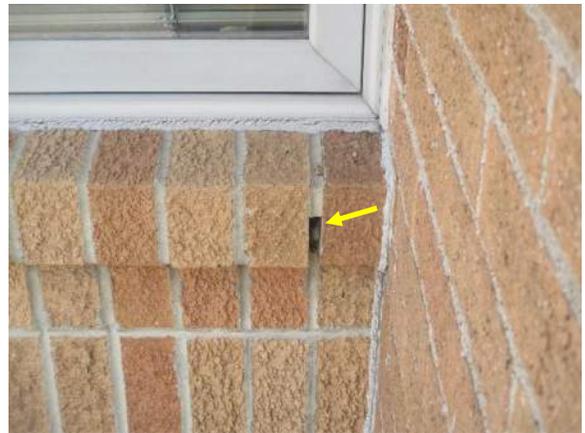
2. An open mortar joint was observed at the brick sill below a window near the northwest corner of the building (Images C15 and C16). **We recommend tuckpointing any brick masonry veneer sections with open mortar joints [Year 2 - \$1,000].**

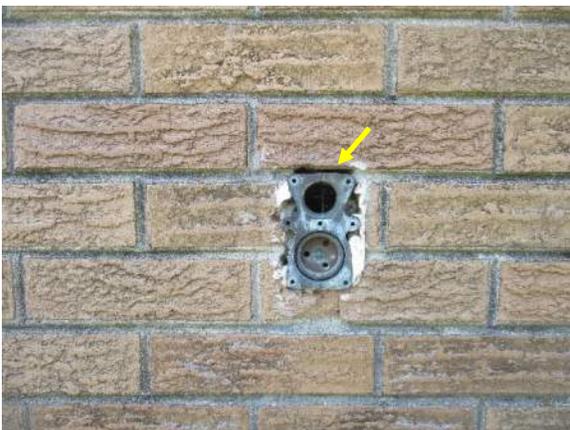
Image C17

3. Open voids were observed at an abandoned hose bibb at the north end of the building (Image C17). **We recommend installing a cover plate in a manner to seal these voids and prevent water intrusion at this location [Year 2 - \$600].**

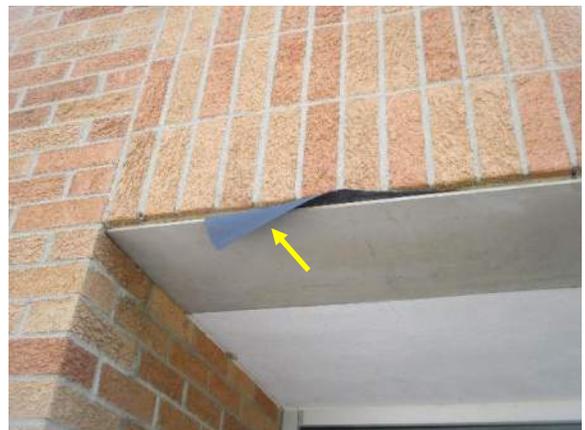
Image C18

4. A section of through-wall flashing membrane has come loose along the west side of the building (Image C18). **We recommend trimming this section of membrane flashing back flush to the steel lintel to prevent further damage [Year 2 - \$200].**

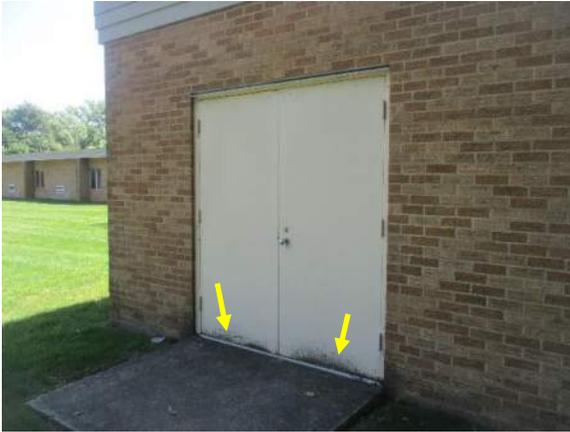
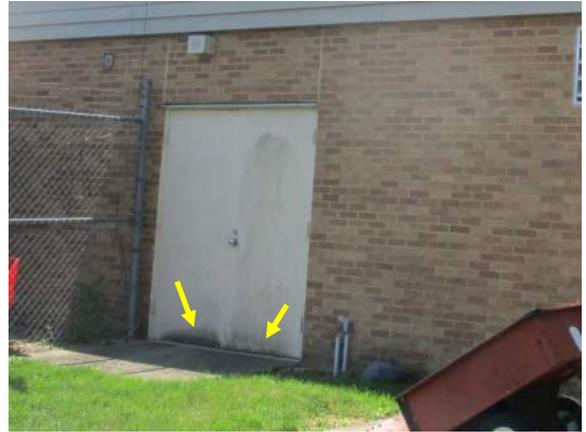
5. Corrosion was noted along the bottom of both sets of hollow-metal double doors accessing the mechanical space at the northwest corner of the gymnasium (Images C19 and C20). **We recommend providing a rust inhibiting application and paint coating to the exterior surface of the doors and frames as needed [Year 2 - \$1,000].**

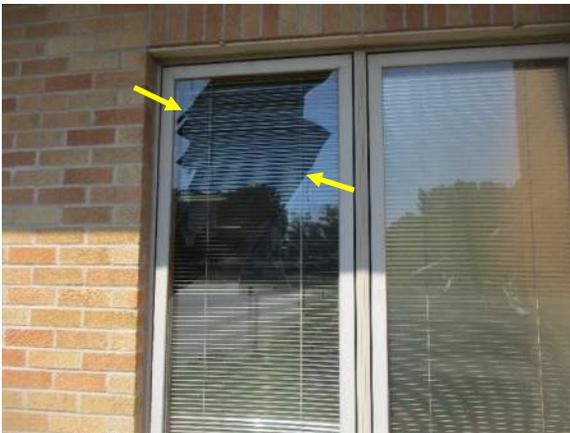
Image C21

6. A broken glazing pane was noted on one of the windows along the east elevation at the north wing (Image C21). **We recommend replacing this glazing pane in the near future for safety [Year 1 - \$1,800].**

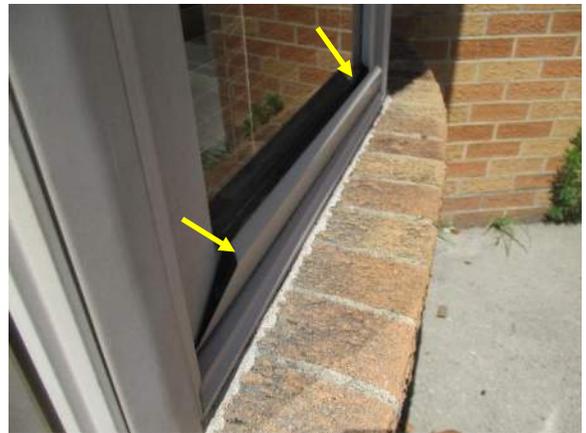
Image C22

7. One of the window sashes at the northeast corner of the building was observed with damaged trim sections (Image C22). **We recommend repairing this damaged sash to prevent water infiltration at this window system [Year 1 - \$800].**
