**PROPERTY CONDITION REPORT
with 10-YEAR CAPITAL NEEDS**

**St. Pius X Catholic Parish
7200 Sarto Drive
Indianapolis, IN 46240**

Prepared for: **St. Pius X Catholic Parish**

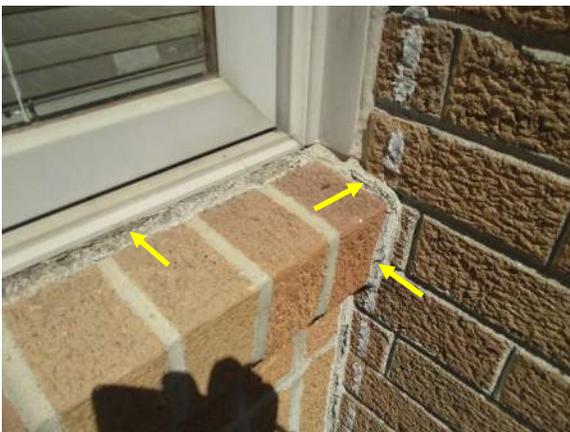
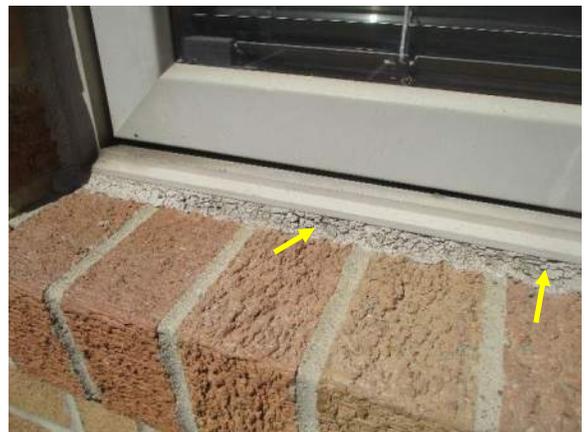
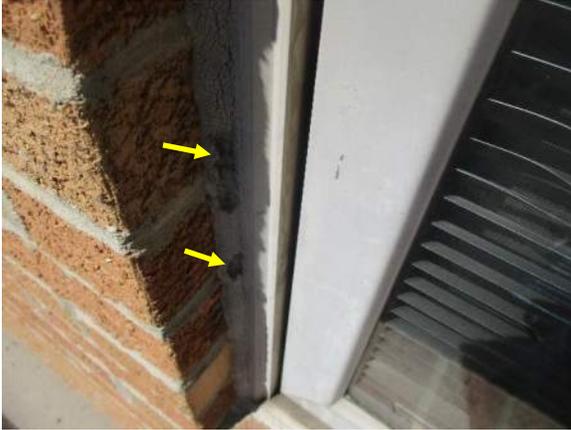
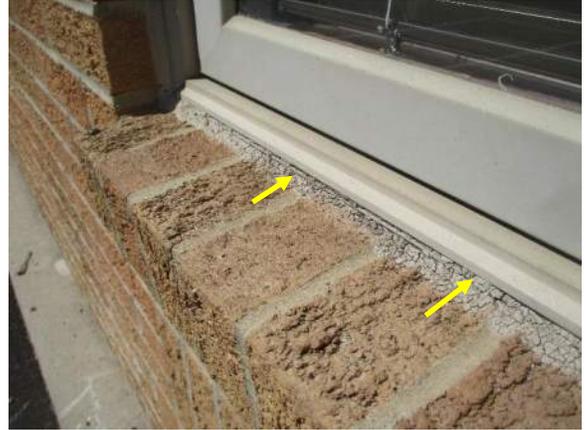
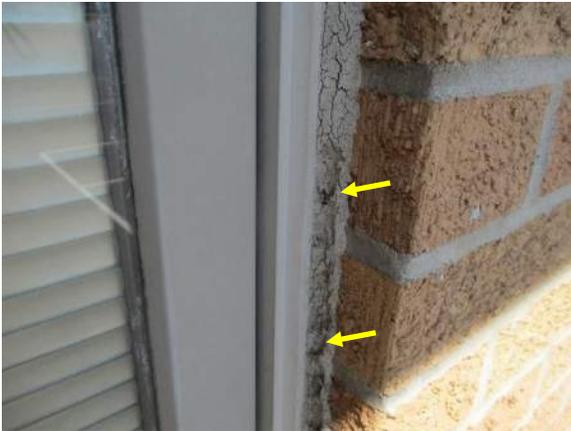
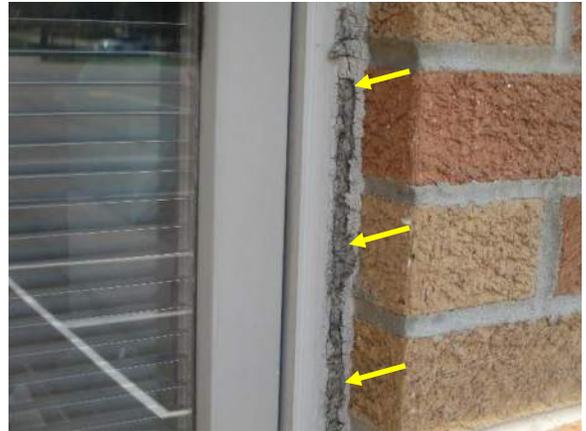
8. Deteriorated sealant joints were observed around the perimeter of many of the window systems, typically at the north side of the east wing and around the north wing of the building (Images C23 through C28). We also reviewed that many of the window systems at the office areas and kindergarten rooms have been replaced over the last few years. **We recommend programming approximately 30 windows located along the north side of the east wing and around the north wing for replacement with new perimeter sealant joints over a 3-year period [Year 3 - \$16,000, Year 4 - \$16,700, Year 5 - \$17,500].**

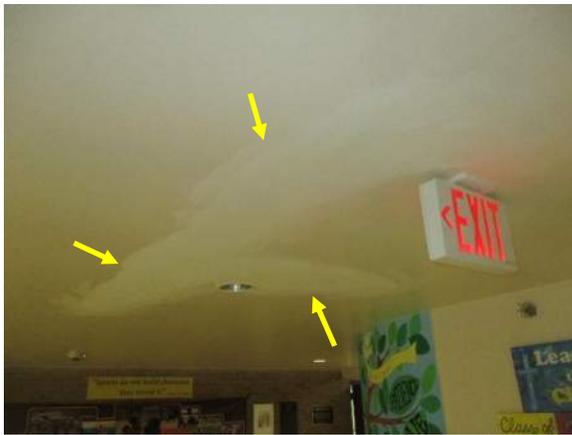
Image D19

1. Moisture-stained gypsum board ceiling and acoustic ceiling tiles were observed at a couple of locations from previous roof leaks (Images D19 and D20). **We recommend repainting the gypsum board ceiling and replacing acoustic ceiling tiles now that the roof system has been replaced from a cosmetic standpoint [Year 1 - \$2,200].**
2. The Elementary wing hallway and classroom flooring was observed to be dated and worn in various locations. **We recommend programming the flooring in this wing for replacement in the next couple of years [Year 2 - \$135,000].**
3. Based on the existing finish conditions and review of maintenance and painting items that have been completed over the past few years, we believe a budget should be programmed into general finish upgrades each year. **We recommend identifying annual capital funds for general interior finish maintenance [Annual - \$4,000].**

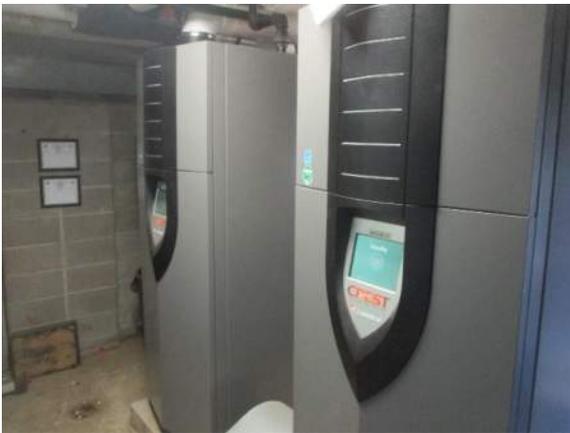
Image E3

- The remaining portions of the building are primarily conditioned by a two-pipe loop system consisting of the following.
 - Two Lochinvar gas-fired boilers with associated pumps are in place in the primary mechanical room on the west side of the building that provide $\pm 1,203,000$ BTU/H of heating each (Images E3 and E4). These Lochinvar boilers are approximately three years old.

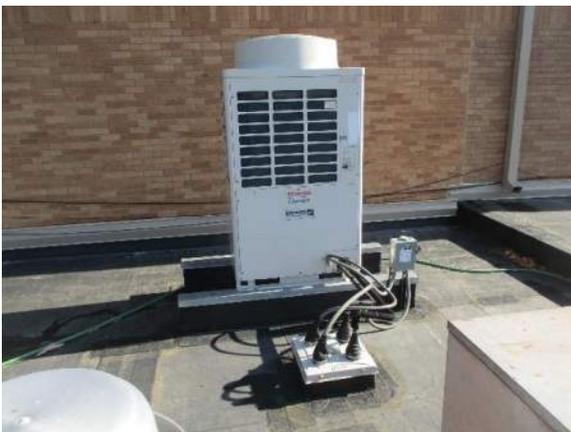
Image E11

- Additional mini-split systems were located on the roof for supplemental cooling to kitchen and server rooms (Images E11 and E12).
- Supply and return air ductwork are located above the ceiling assemblies that provide conditioned air to each of the spaces.

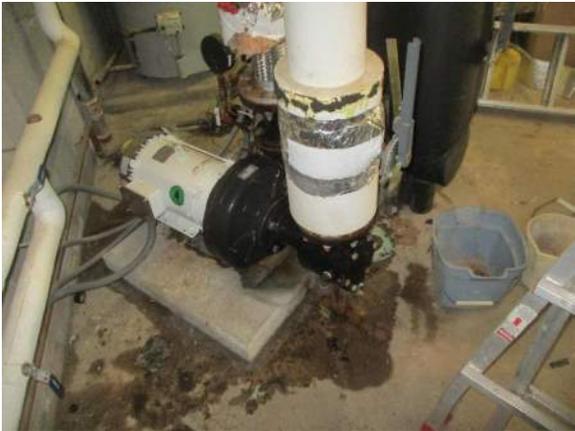
Image E15

1. One of the chiller pumps for the loop system appeared to be recently replaced; however, insulation was missing from the pipe and valves creating excessive condensation (Images E15 and E16). **We recommend installing the appropriate insulation around this pipe to prevent unnecessary condensation and corrosion of the pipes [Year 1 - \$500]. We also recommend installing the appropriate insulation around condensate pipes above actively stained ceiling areas to prevent unnecessary condensation and stained finishes [Year 1 - \$2,000].**

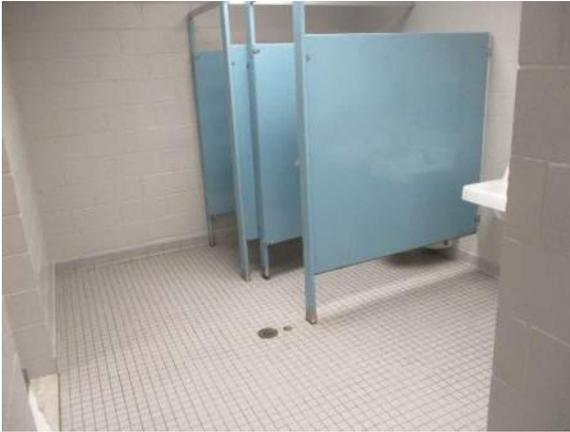
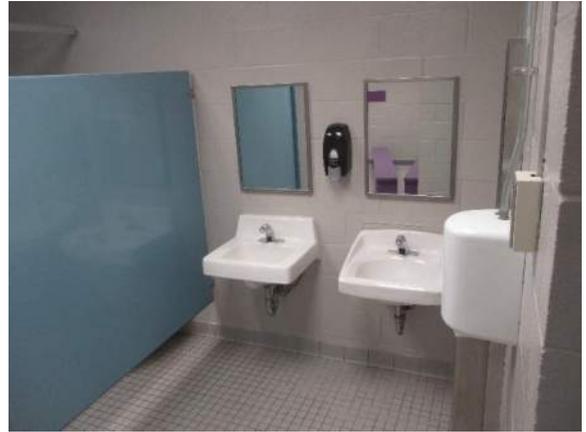
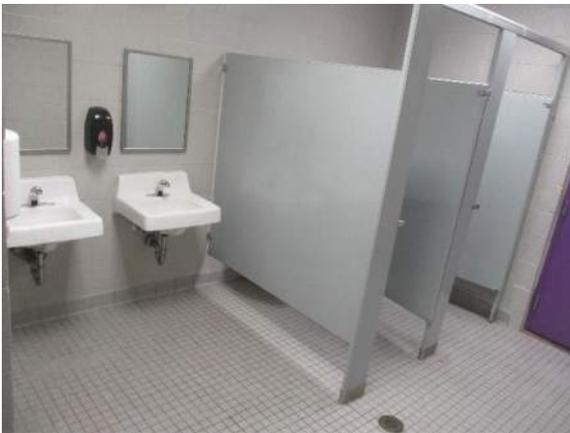
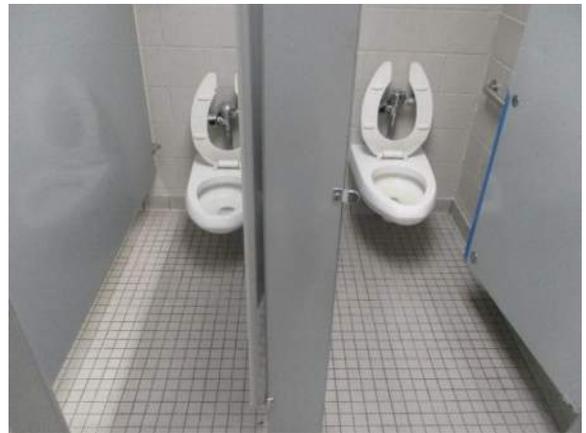
- Multiple men’s (boys) and women’s (girls) multi-user toilet rooms were located throughout the building (Images D13 through D18 and G1 through G4).
- Additional single-user toilet rooms were in place at various other locations around the building (Images G5 and G6).
- Accessible type drinking fountains were in place near many of the multi-user toilet rooms (Images G7 and G8).
- The cafeteria kitchen is equipped with large multi-bay stainless-steel sinks and additional hand-washing sinks (Image G9).
- A kitchenette area with stainless-steel sink was located within the break room (Image G10).
- Floor-mounted mop sinks were provided within utility closets (Image G11).

1. The gymnasium and children’s hallway toilet rooms with associated janitor closets and mop sink rooms were observed in poor condition overall with worn and dated finishes (Images G1 through G4 and G13 through G18).
 - **We recommend updating the Elementary hall toilet rooms and first set of Intermediate hall toilet rooms in the immediate future [Year 1 - \$141,000].**
 - **We recommend updating the Gymnasium toilet rooms and far north set of Intermediate toilet rooms in the near future [Year 3 - \$155,000].**
2. While the water heater in place was serviceable and in good condition for its age, we believe it may need to be programmed for replacement over the next 10 years. **We recommend programming the water heater for replacement [Year 8 - \$22,000].**

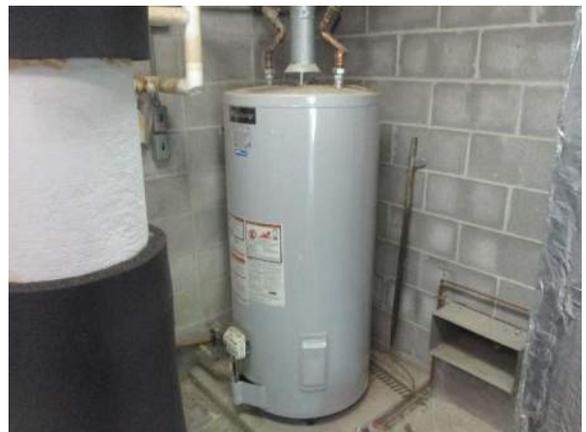
Image G12

Hot water for plumbing fixtures throughout the building is provided by a 75-gallon gas-fired water heater located within the primary mechanical room that was approximately six years old (Image G12). Gas-fired water heaters of this type typically have an expected useful life of approximately 15 years or so before major repairs or replacements are required.

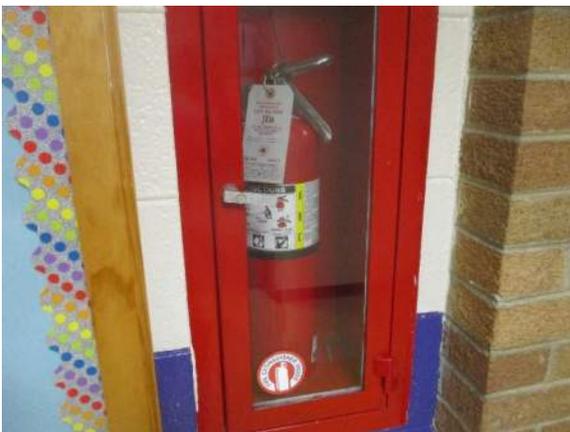
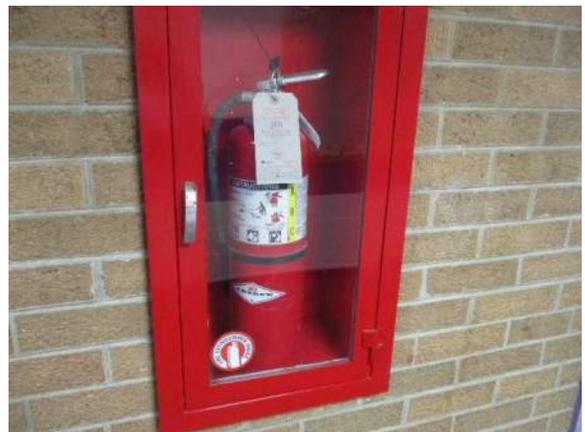
The building is also equipped with individual dry canister fire extinguishers throughout the building, which were last checked in July 2022 (Images H11 and H12). The building egress and life safety systems appeared to be adequate for the facility for the most part; however, we did note the following conditions that should be addressed and considered over the next 10 years.

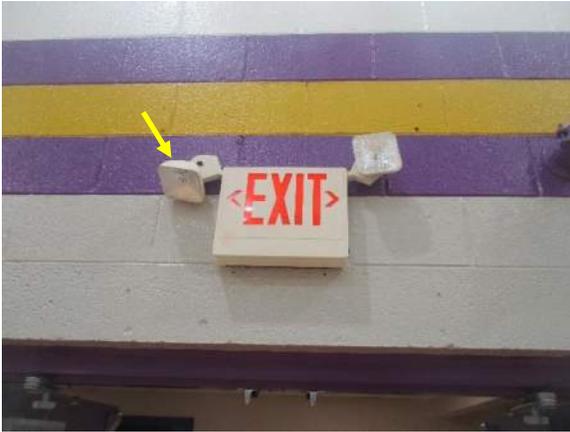
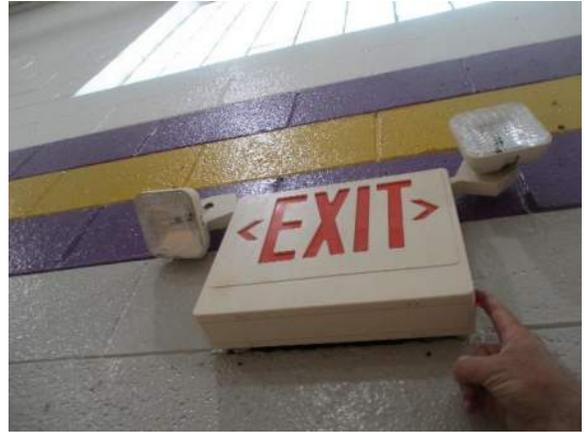
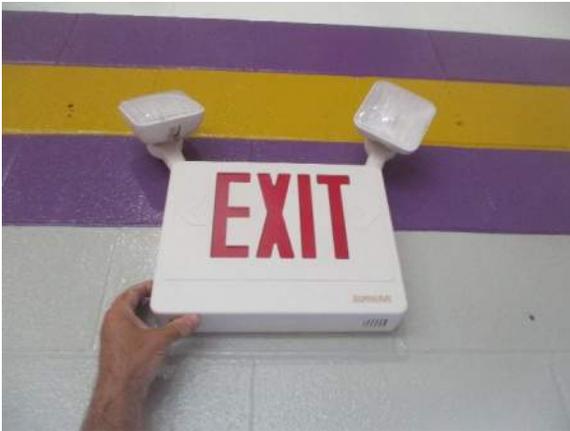
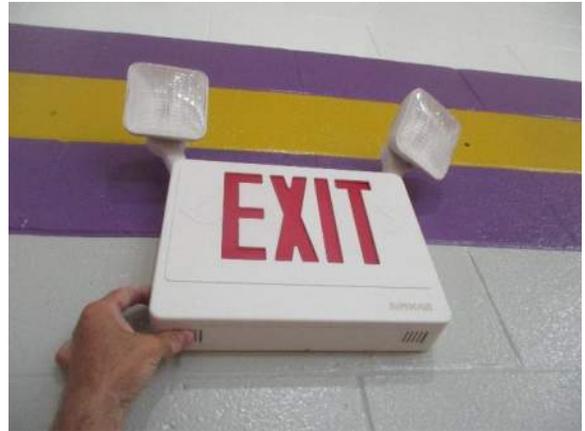
1. Select illuminated exit signs and emergency lighting units, primarily within the gymnasium, were not in working order, likely due to impacts from sports equipment (Images H13 through H16). **We recommend replacing broken exit sign and emergency lighting units, and installing protective wire cages over them to provide adequate emergency egress and life safety [Year 1 - \$4,800].**
2. We recommend incorporating a budget for general emergency egress and life safety maintenance to be included in fire suppression inspections each year. **We recommend identifying annual capital funds for emergency egress and life safety maintenance and various inspections [Annual - \$2,000].**

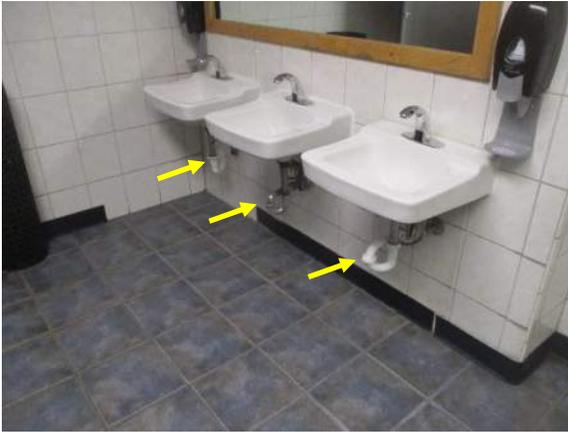
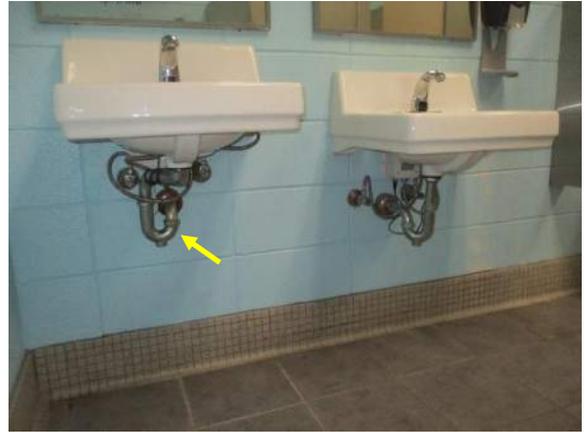
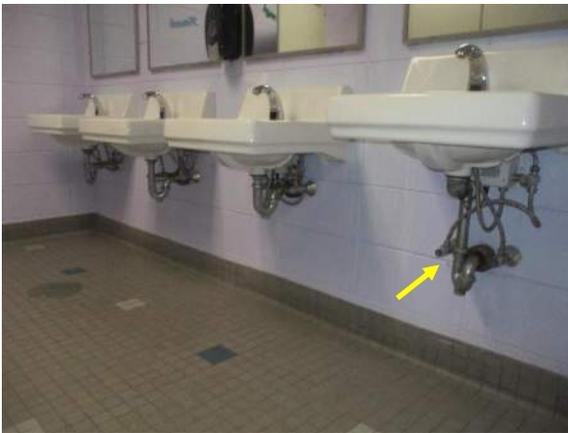
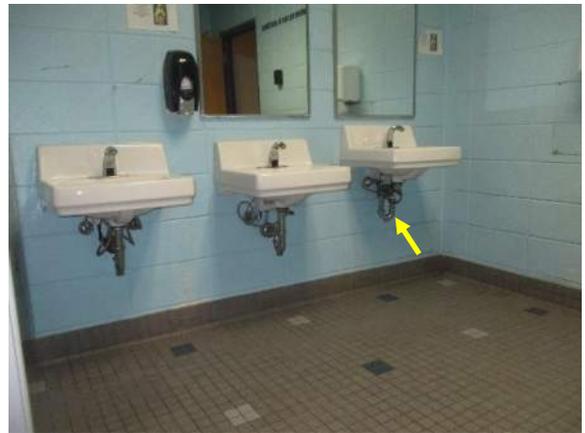
1. Many of the accessible lavatory sinks were missing pipe protection (Images I1 through I4). **We recommend providing pipe protection in the near future to align with Indiana Accessibility and ADA requirements [Year 1 - \$3,800].**
